APPENDIX H
ARBORIST STUDY

Mark Porter, California Arbor Care

**Inventory and Tree Condition Report Sierra Gate Center as per
Fontana Tree Preservation Ord 1126, § 1, 8-16-94**

Northgate Market Project Fontana, CA

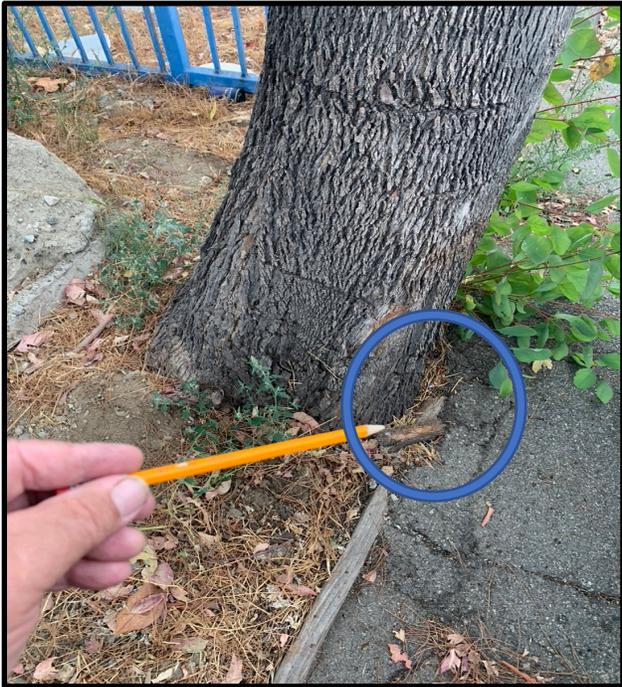
Tree 1 -Flooded Gum

Emerging population of lerp psyllid pest. Chlorotic foliage. Water stress x 5 years.
kinked root, restricted soil volume, root buttress injury.
Codes: Cod, Cr, Dk, Inc, Binj, RF Sh, Xing. Condition 60%.

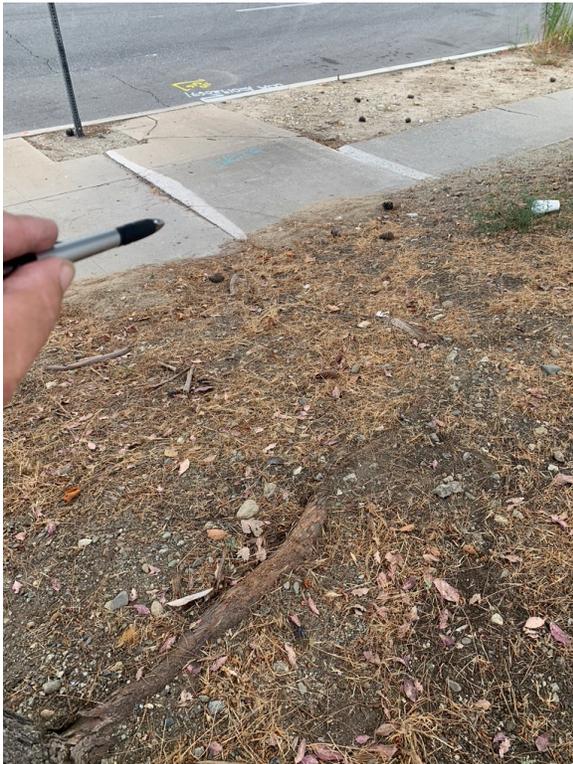
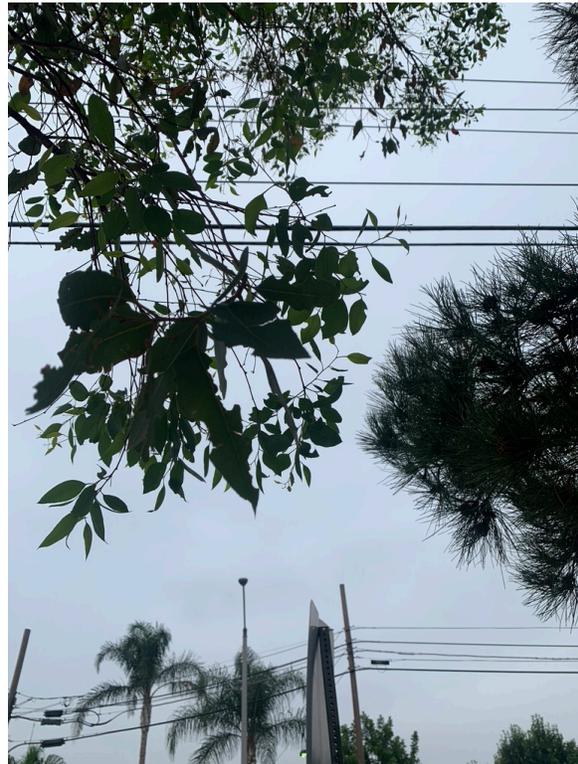
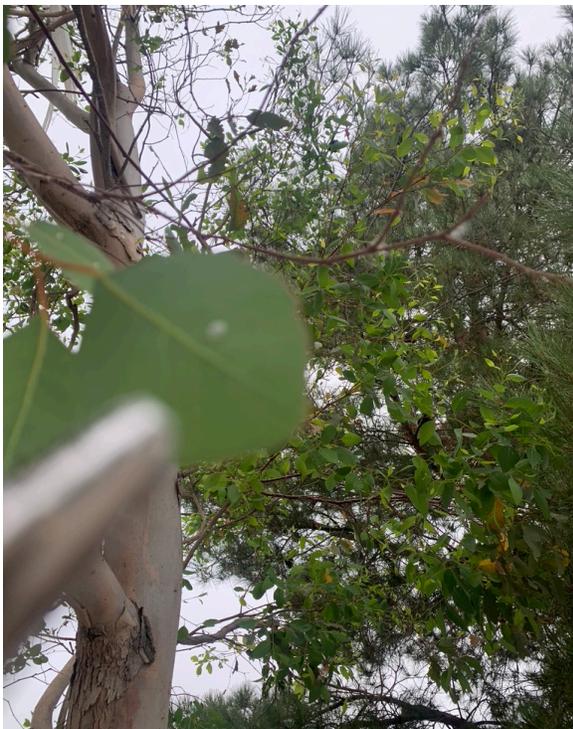
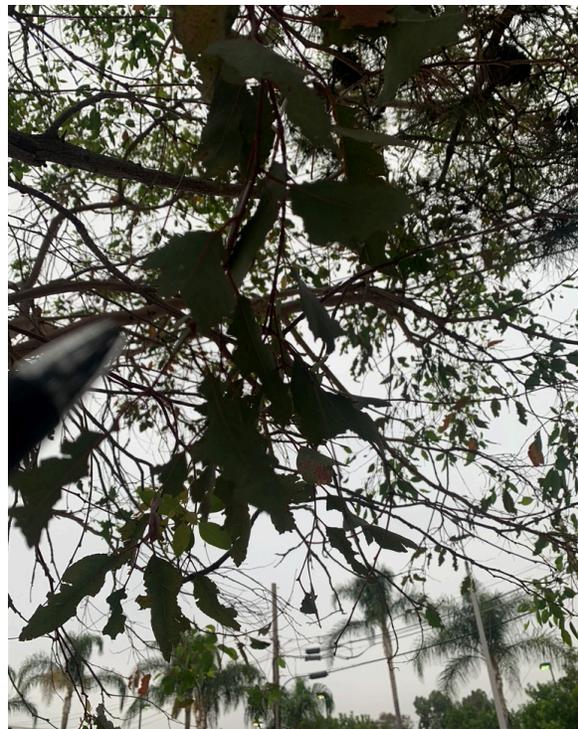
TREE 3 Flooded Gum

Sidewalk damage, surface roots, lerp psyllid, soil compaction, tortoise beetle. poor health, poor structure. Water stress x 5 years. Codes: 1s, Health D, Structure D. Condition 60%.

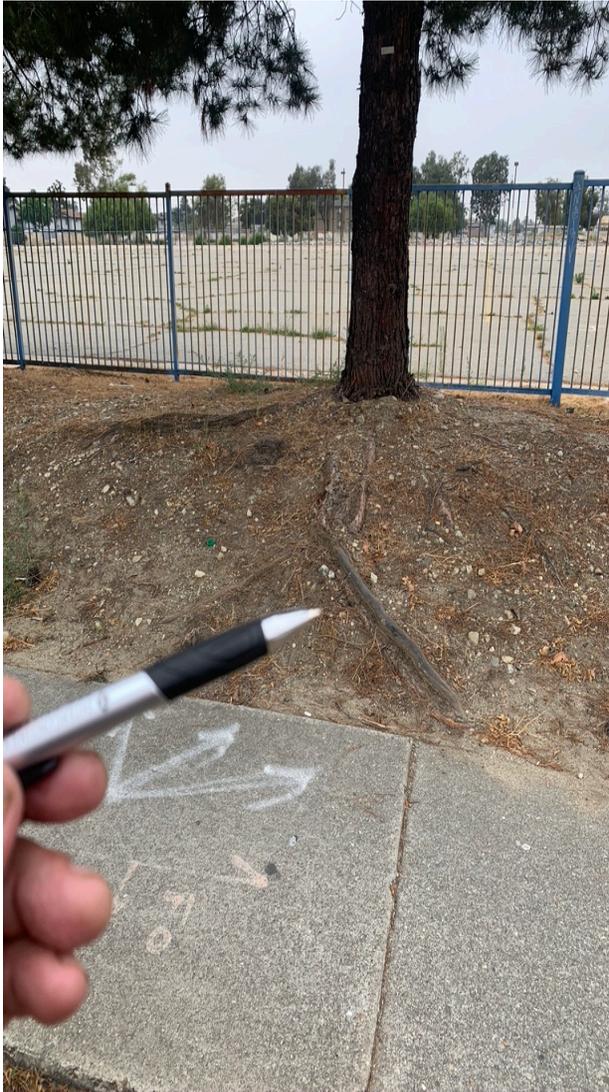
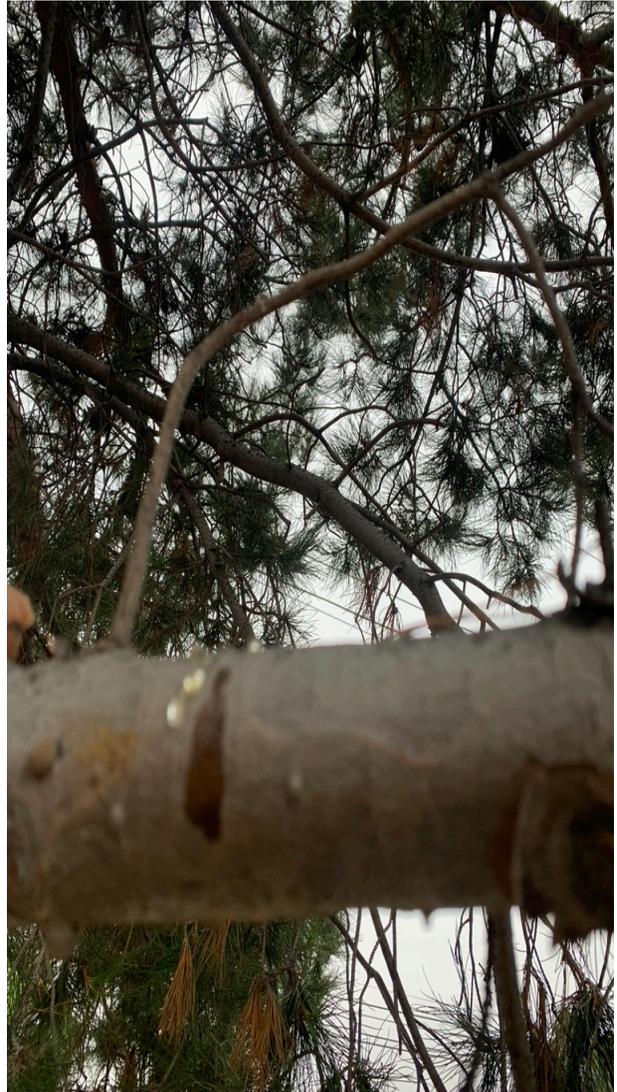
Tree 5 Mondell Pine

Multiple surface roots, **soil compaction**, water stress, dripping sap. Health C. Structure C. Condition 70%

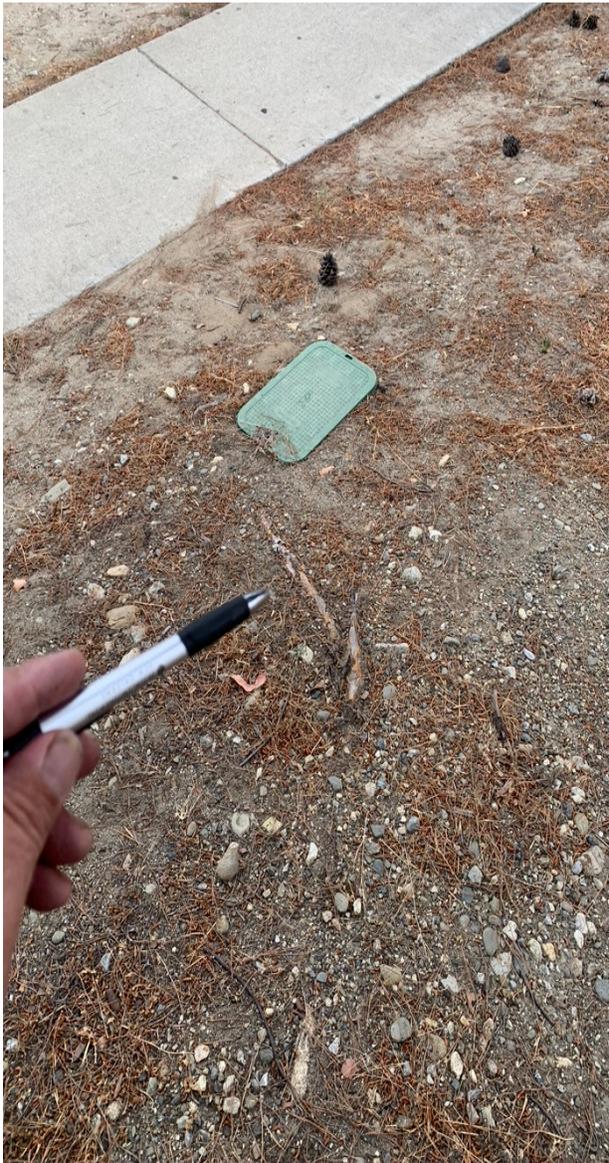
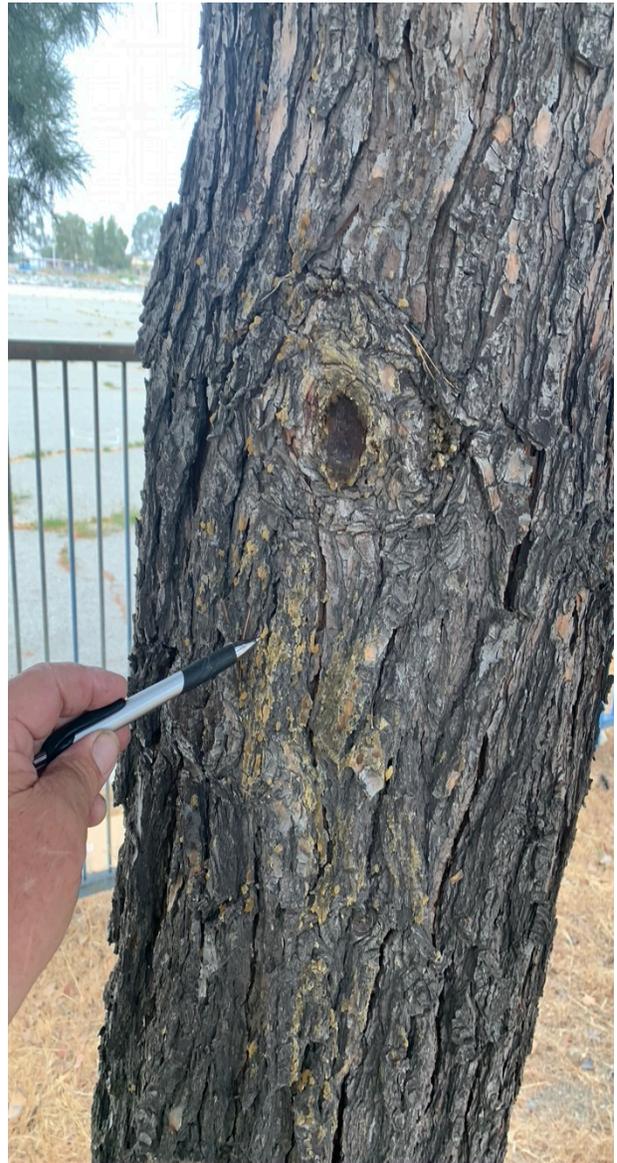
Tree 6 Mondell Pine

Water stress x 5 years, compacted soil, (Sh) sap dripping, wound closure slow. Surface roots and water meter conflict. Condition 70%

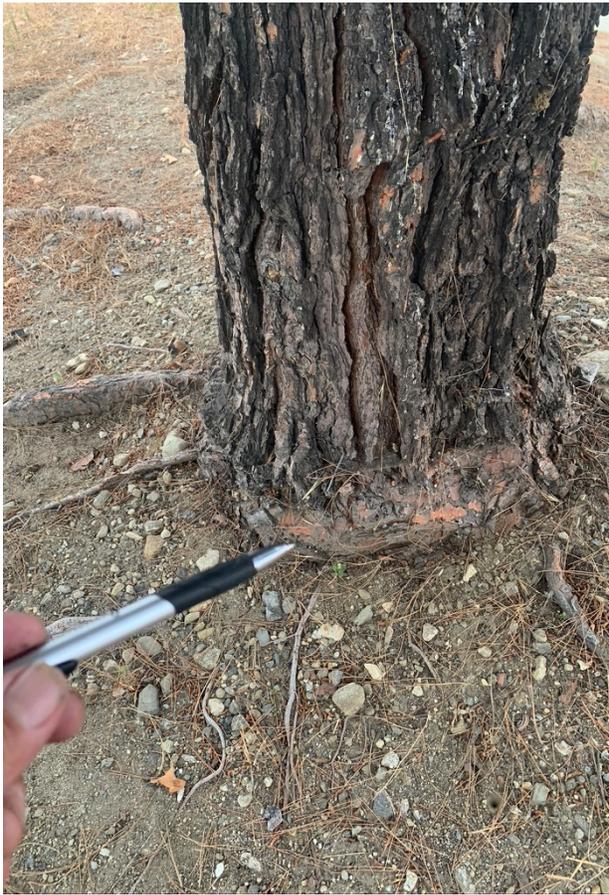
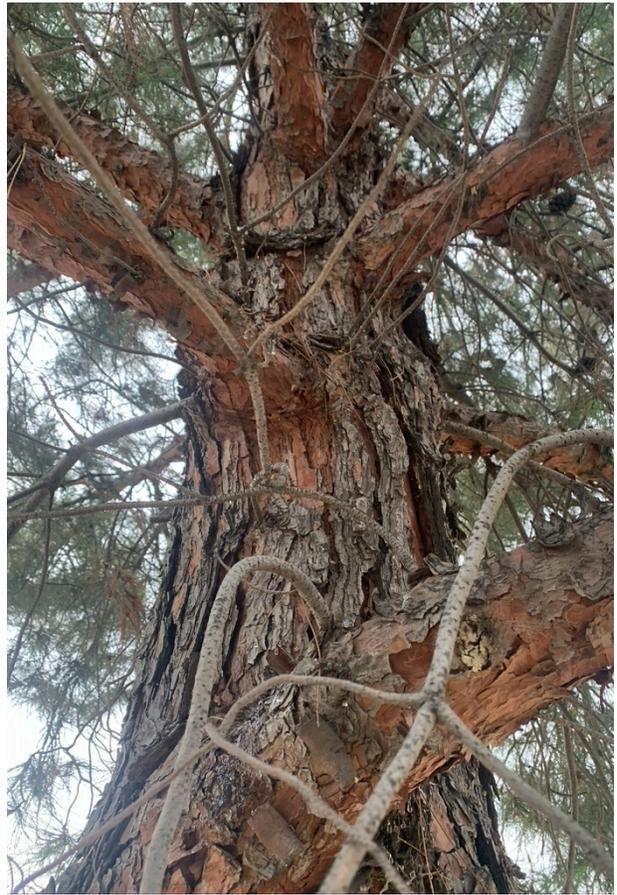
Tree 8 Mondell Pine

Stem girdling root, surface roots, compacted soil, sap dripping, water stress x 5 yrs.
Form fair, health poor. Condition 65%

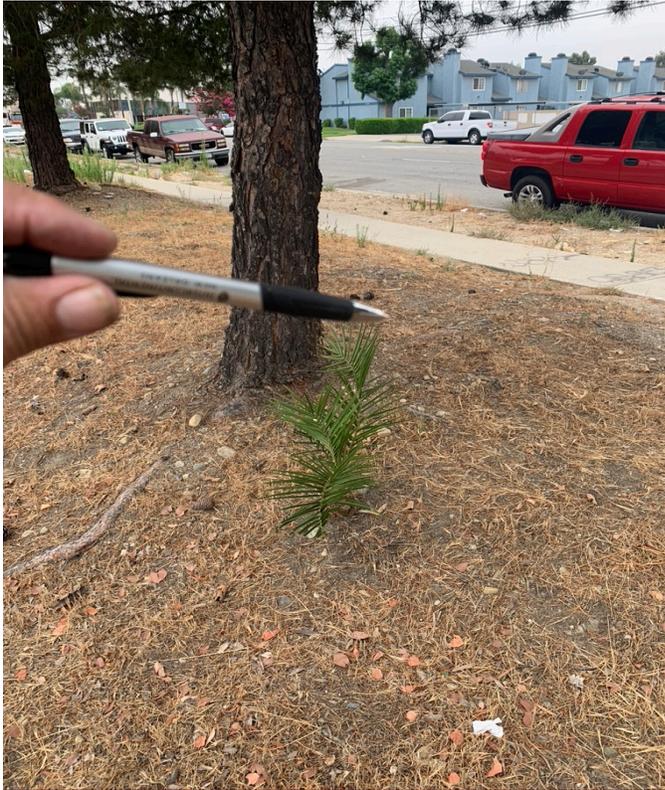
Tree 9 Mondell Pine

Surface roots, water stress x 5 years, low vigor, soil compacted.
Condition 70%

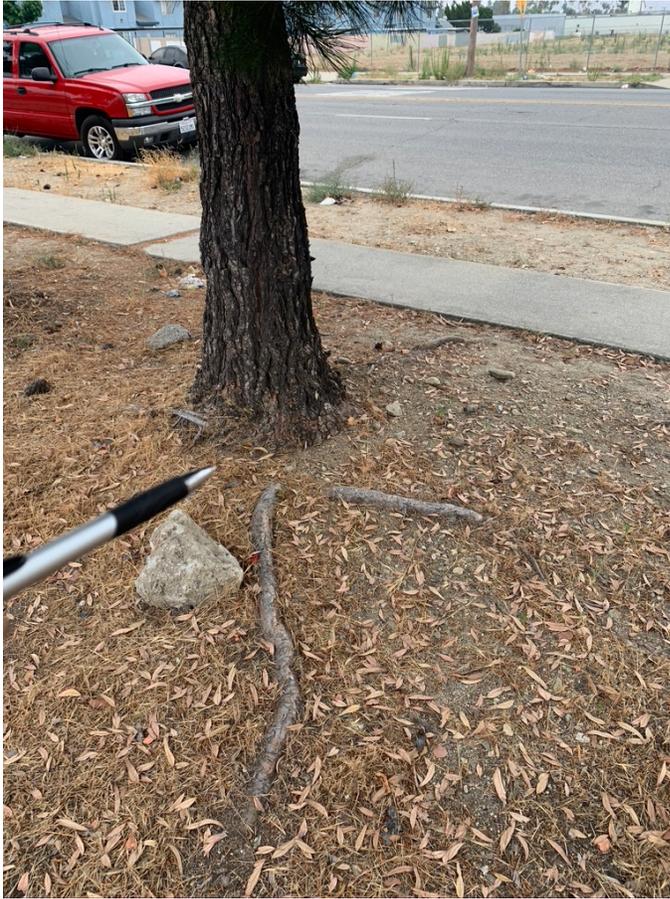
Tree 10 Mondell Pine

Surface roots, water stress x 5 years, low vigor, soil compacted. Stem girdling root formation. Form poor, structure fair, health poor. Condition 65%.

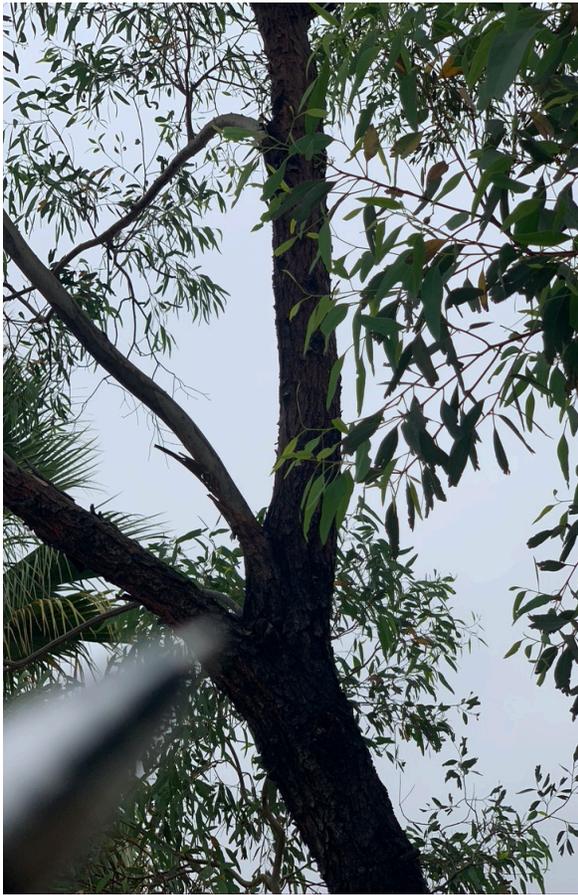
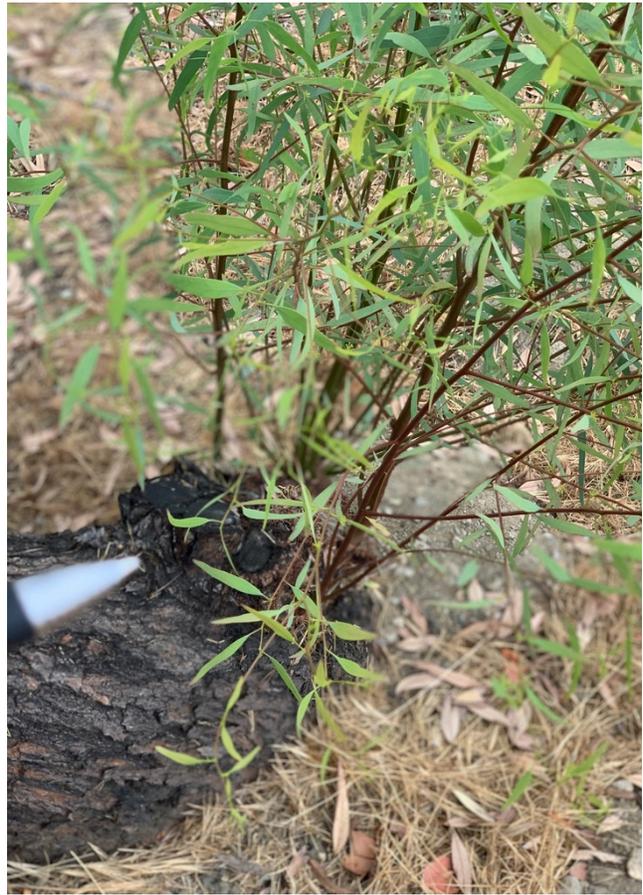
Tree 11 Red Iron Bark

Tortoise beetle, scaffold branch aspect ratio near 60% (weak attachment), water stress, chlorotic foliage, trunk lean (DI), epicormic shoots. Condition 60%

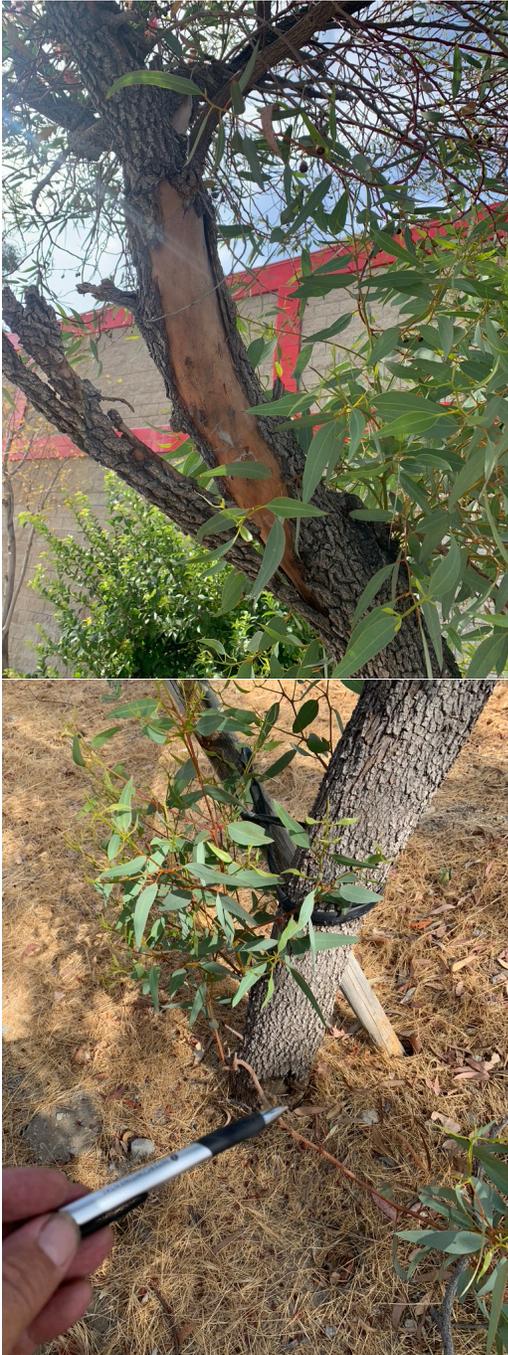
Tree 12 Nichol's Willowleaf Peppermint

Dieback in crown, sections of dead bark, trunk wound at buttress. Condition 55%

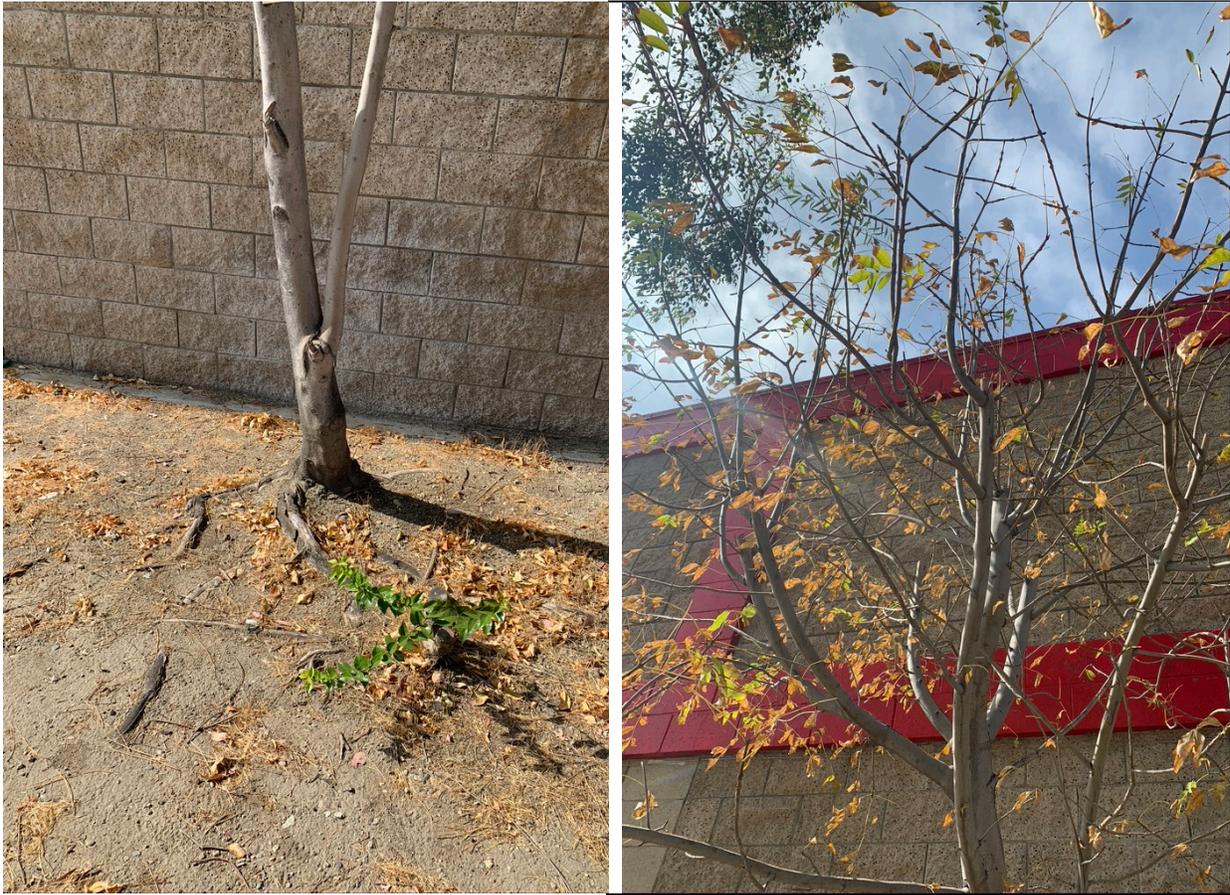
Tree 13 Evergreen Ash

Water stress and soil compaction leading to surface rooting. Upper crown showing leaf scorch, dieback and overall poor vigor. Rating code: Cod, Cl, Db. Condition 50%

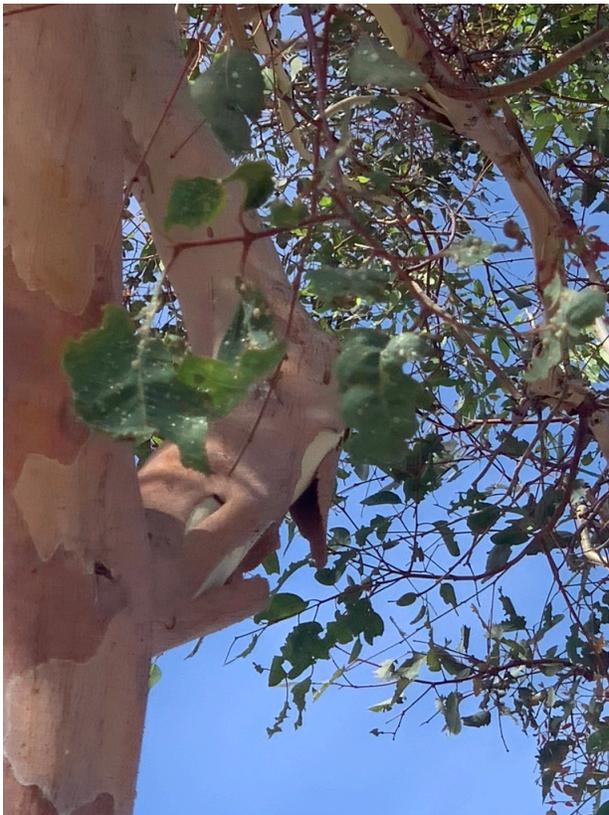
Tree14 Silver Dollar Gum

Lerp Psyllid, tortoise beetle, helical growth lower trunk abnormality (torsional loading and twisting). Multiple stems of the same diameter (codominant). Condition 65%

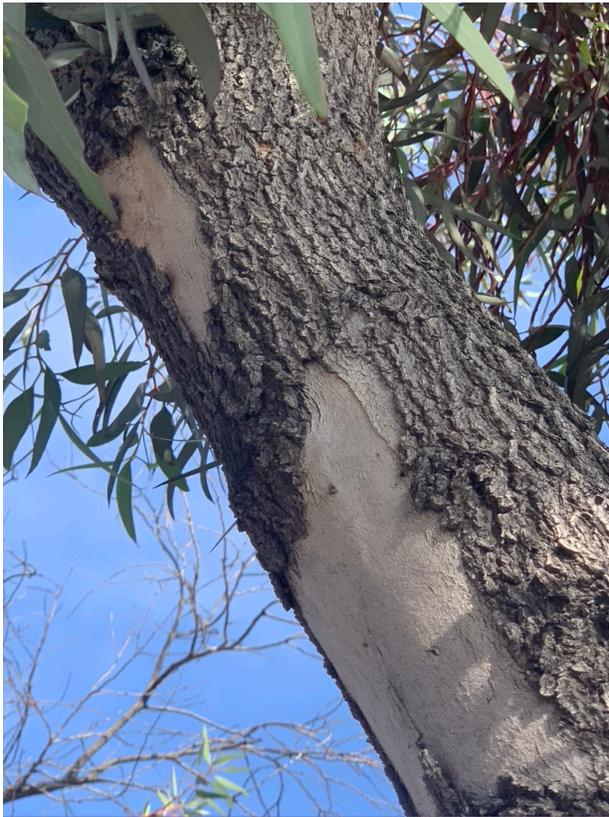
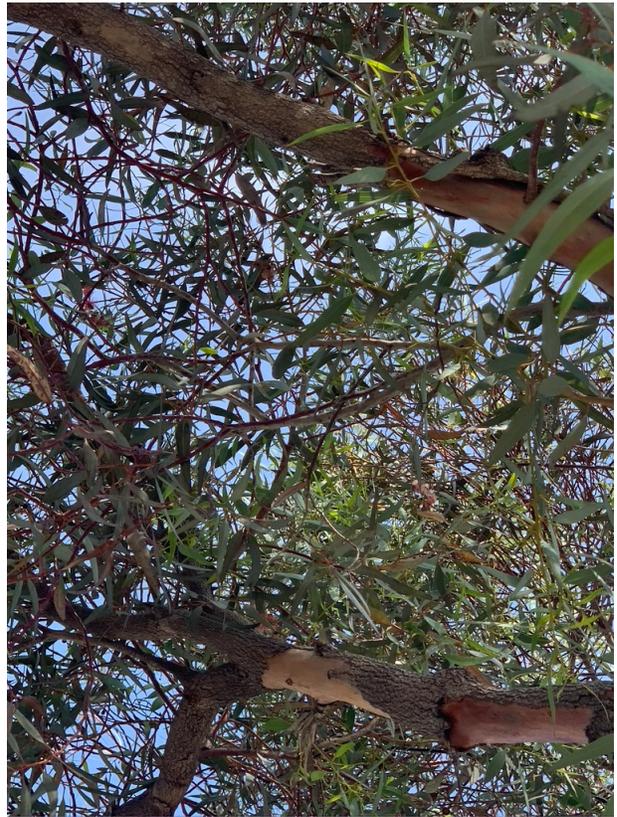
Tree 15 Nichol's Willowleaf Peppermint

Water stress x 5 years sections of dead bark, structural defects. Condition 60%.

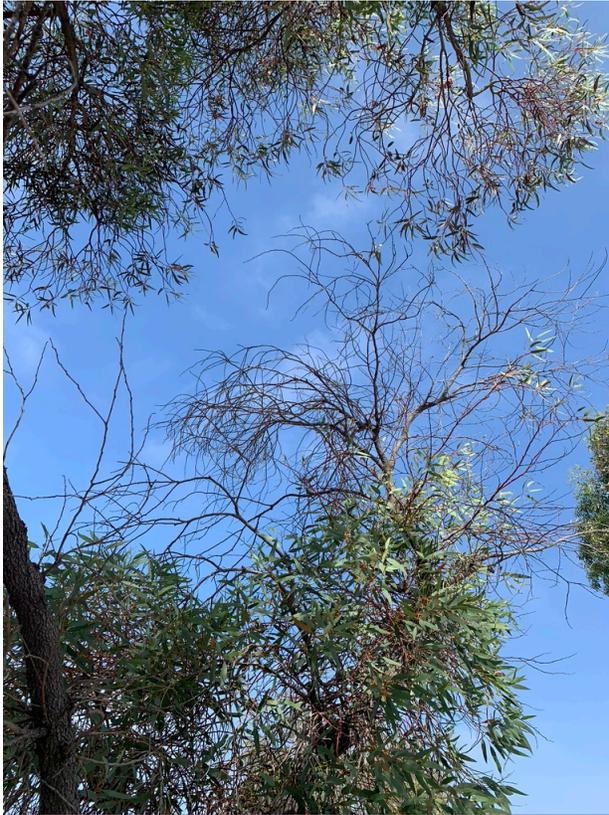
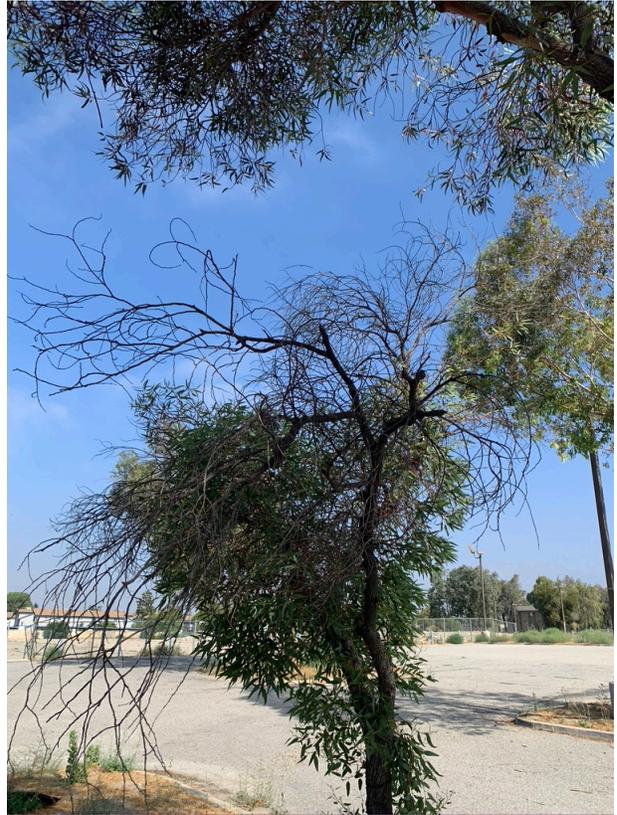
Tree 16 Nichol's Willowleaf Peppermint

Poor vigor, poor health. Condition 55%.

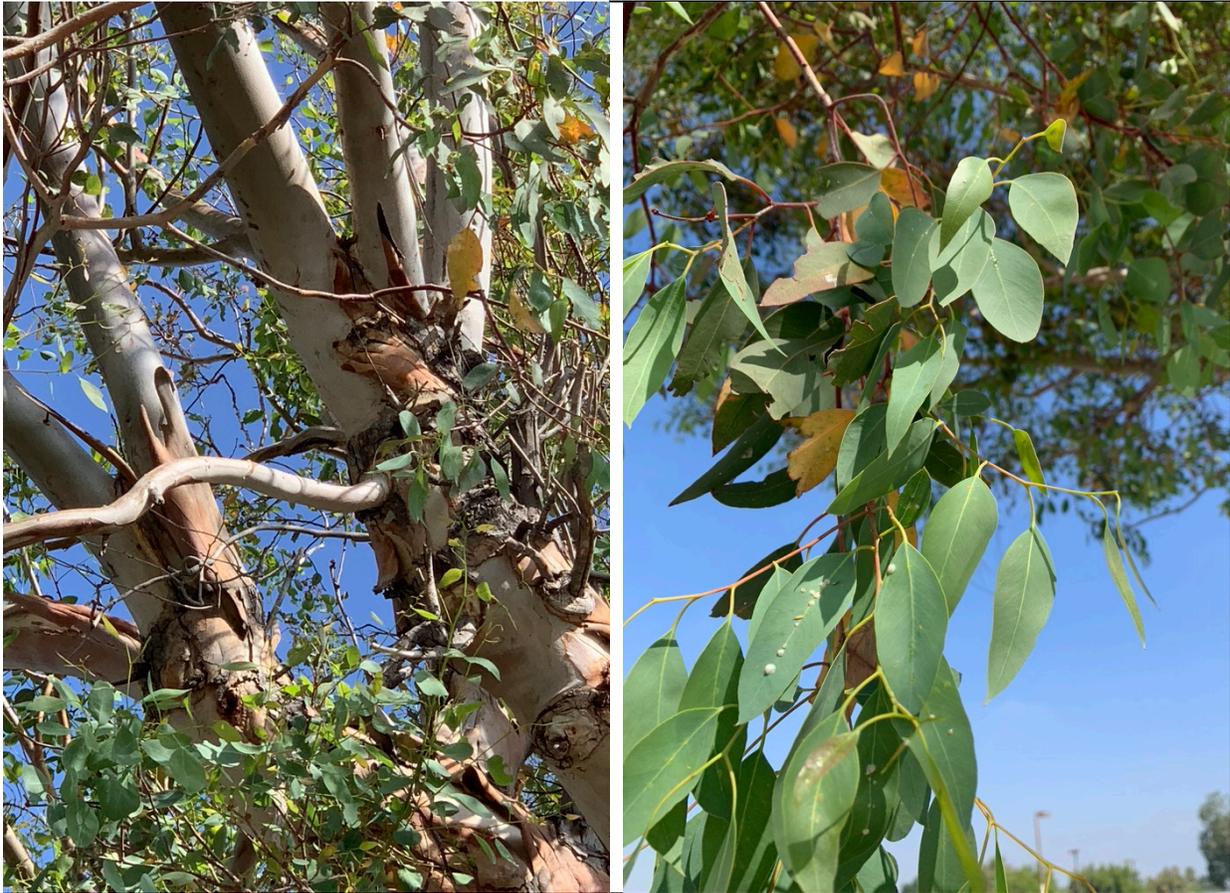
Tree 17 Silver Dollar Gum

Multiple leaders tightly spaced (poor structural development of branch structure, lerp psyllid, tortoise beetle, water stress. Condition 65%

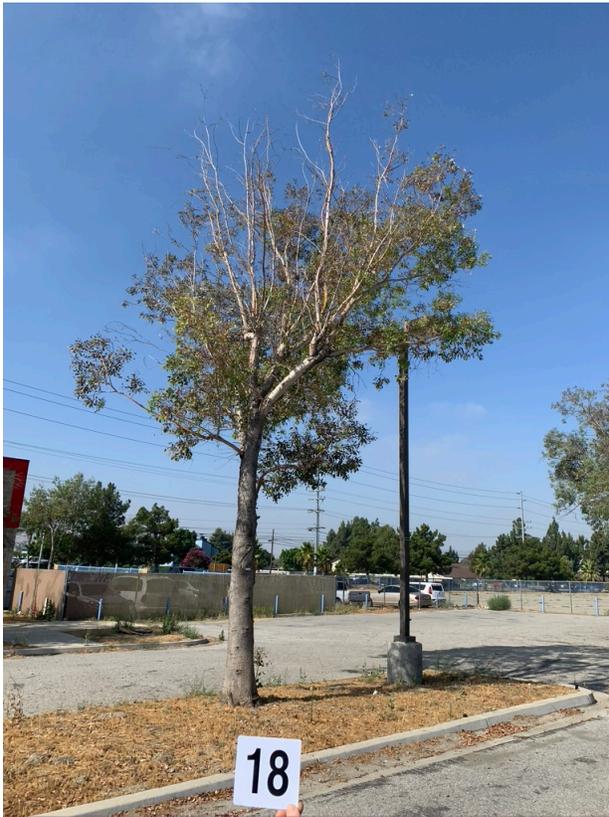
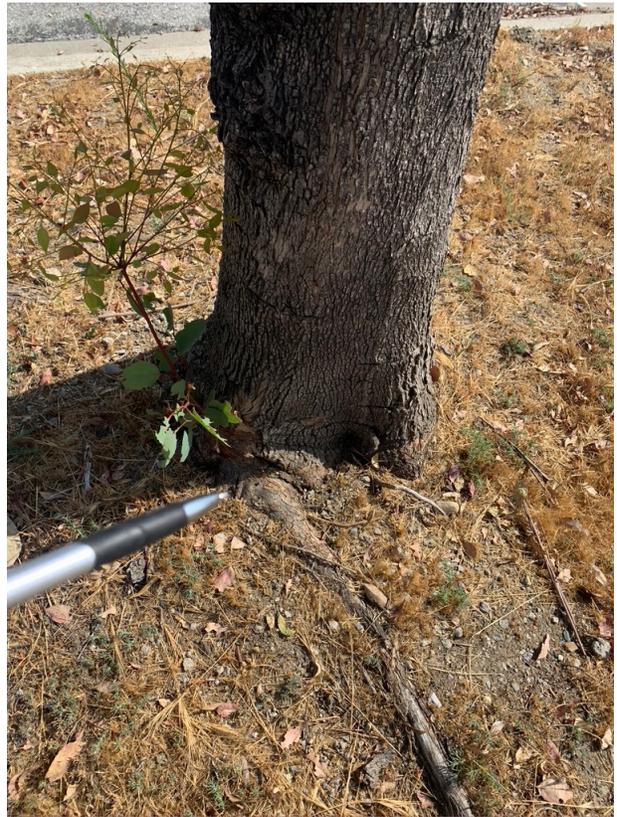
Tree 18 Silver Dollar Gum

Crown diebank, kinked root, tortoise beetle. Condition 60%

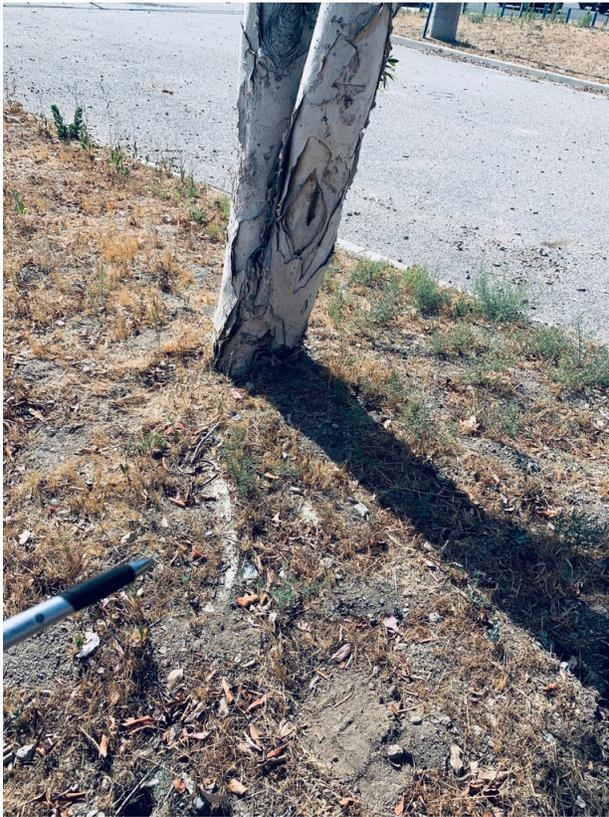
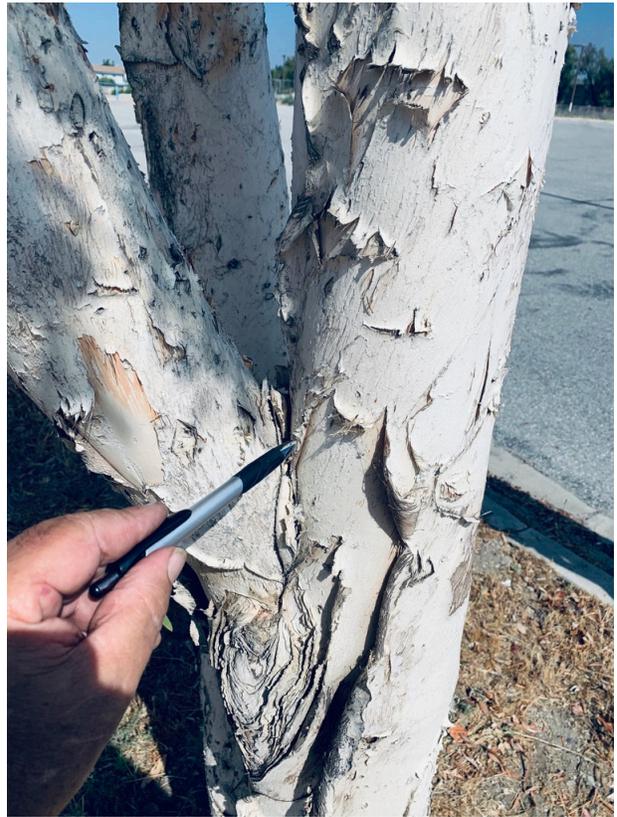
TREE 19 Flaxleaf Paperbark

Surface roots, water stress, branch aspect ratio 1:1. Codominant stems bark inclusion (defective structure. Condition 65%.

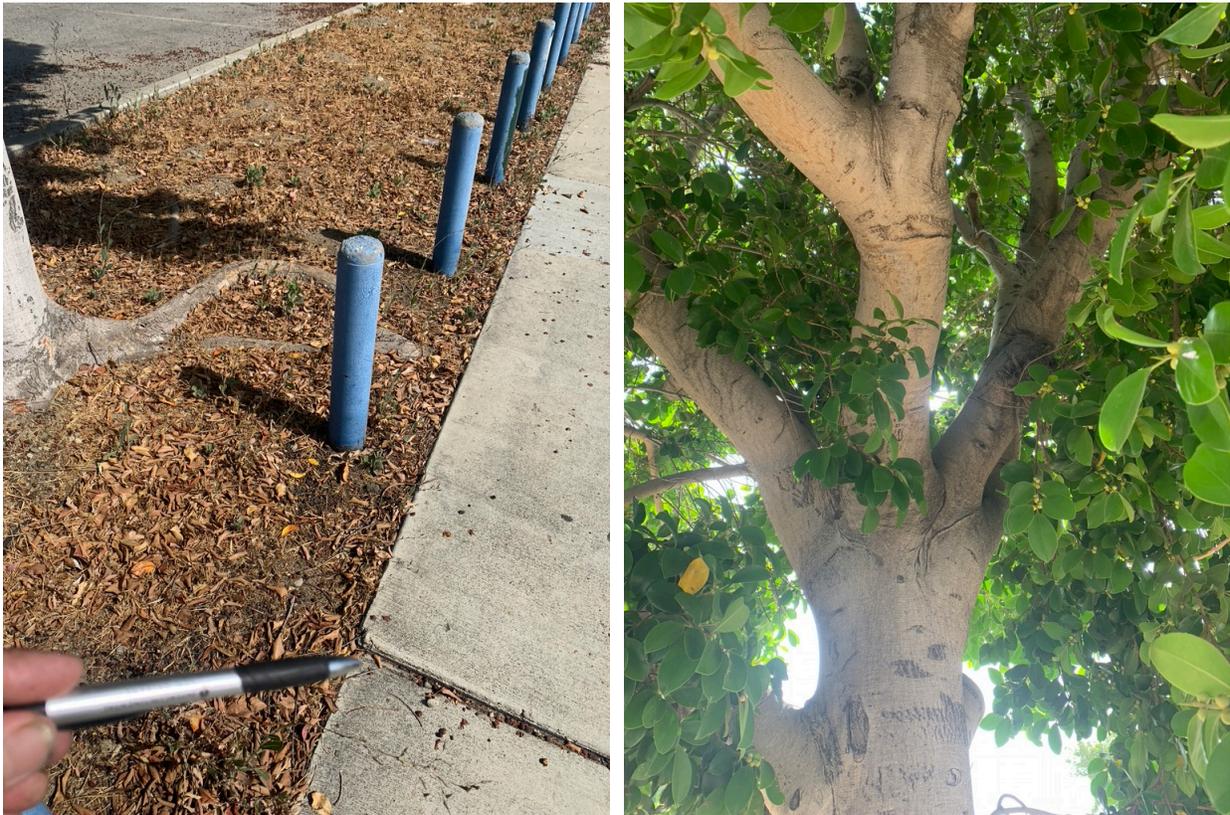
Tree 20 Indian Laurel Fig

Surface roots, Sidewalk displacement, multiple branches growing from same point (aspect ratio 1:1 = weak structure). Foliage Healthy Structure problems correctable. Condition 70%

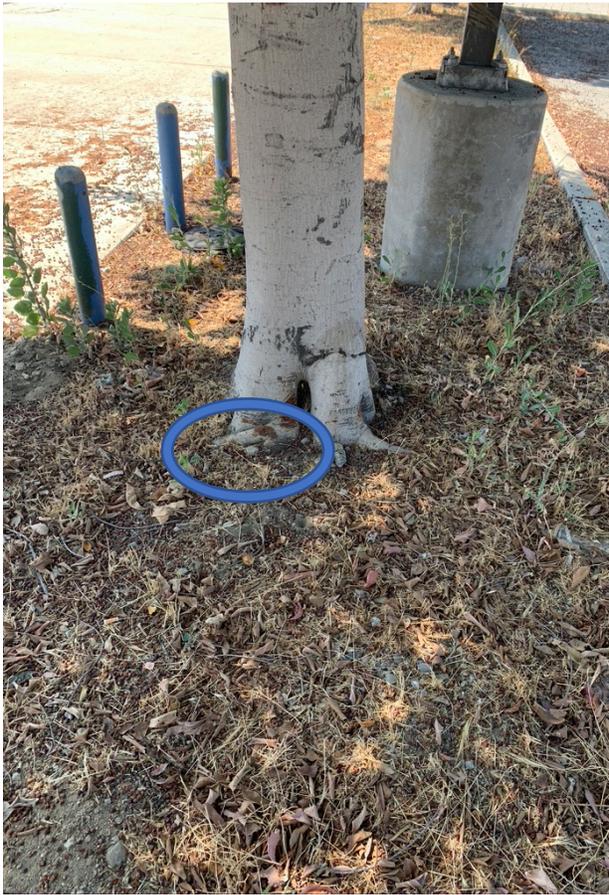
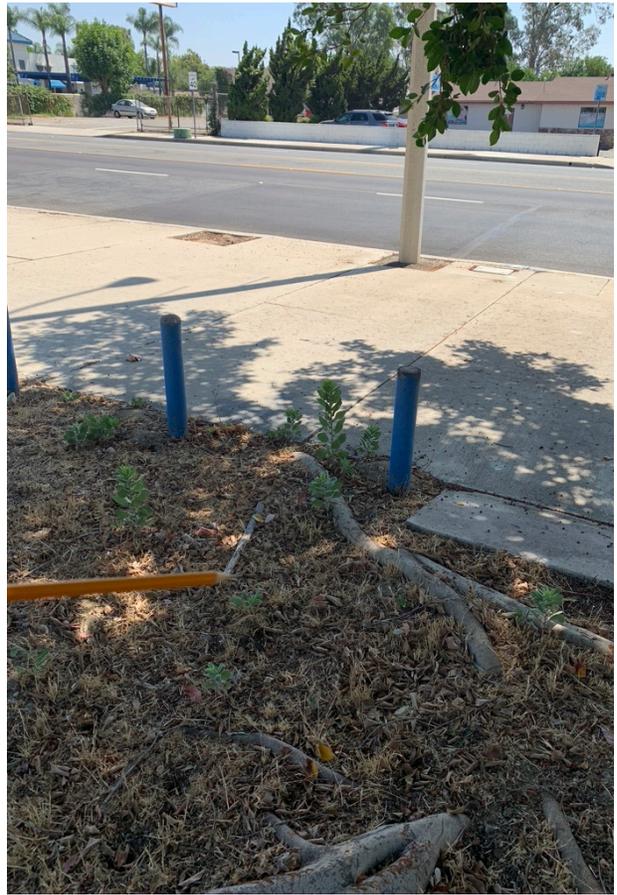
Tree 21 Indian Laurel Fig

Surface roots may invite sidewalk displacement. Water stress. Multiple scaffold branches growing from one spot. Defective branch structure (branch aspect ratio 1:1), Infrastructure damage expected soon (sidewalk displacement). Leaf health good Structural issues and root issues. Kinked root. Condition 65%.

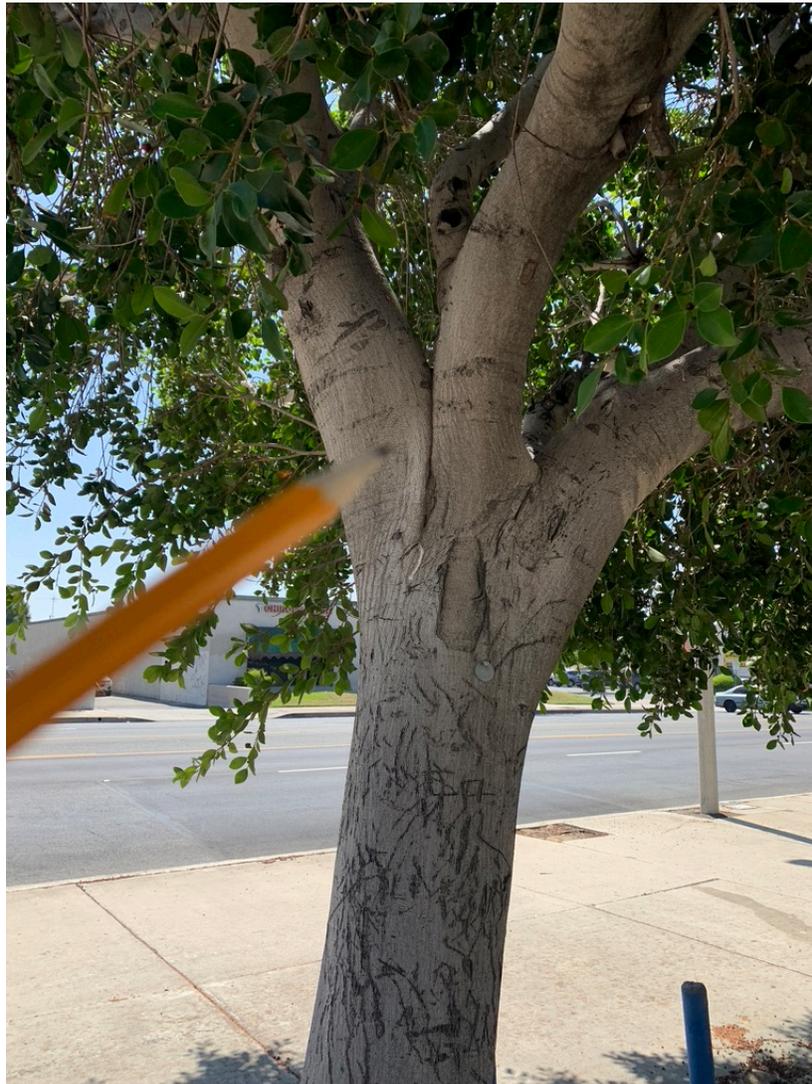
Tree 23 Indian Laurel Fig

Structural defects, multiple codominant stems, bark inclusion, scaffold branch aspect ratio 1:1 (weak connections). Leaf health good Structural problem (defective) with bark inclusion. Condition 65%.

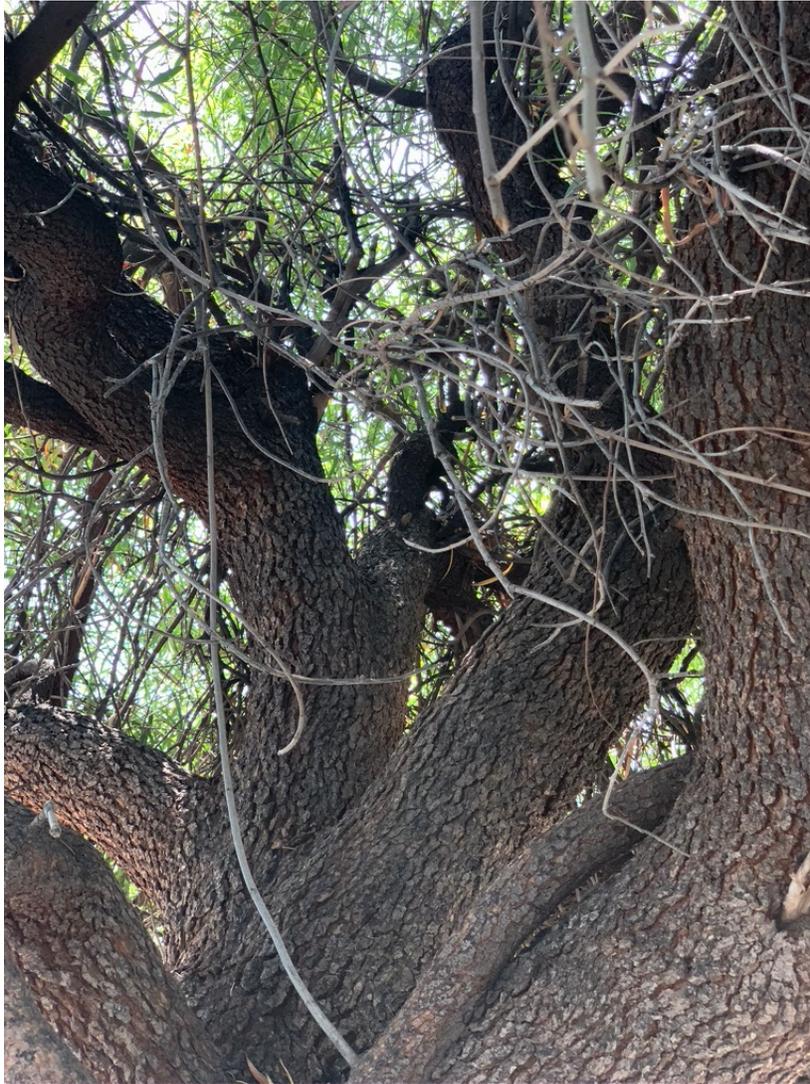
Tree 24 Australian Willow

Poor branch structure development, root damage potential low, drought tolerant. Tolerates moist to wet soil Resistant to Armillaria. Good species for area. Branch strength rated as moderate (UFEI). Condition 70%,

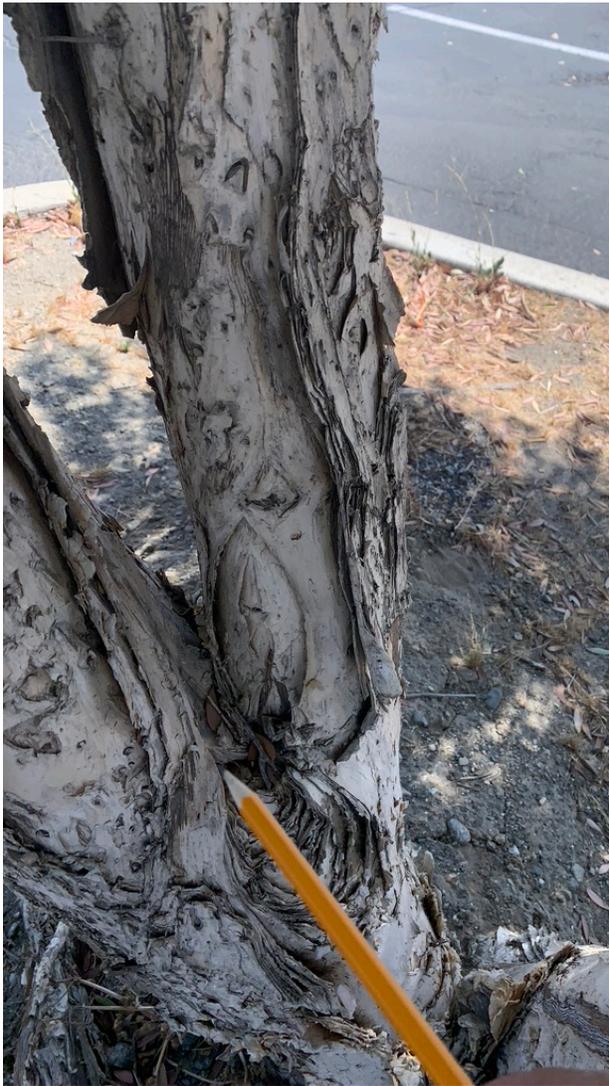
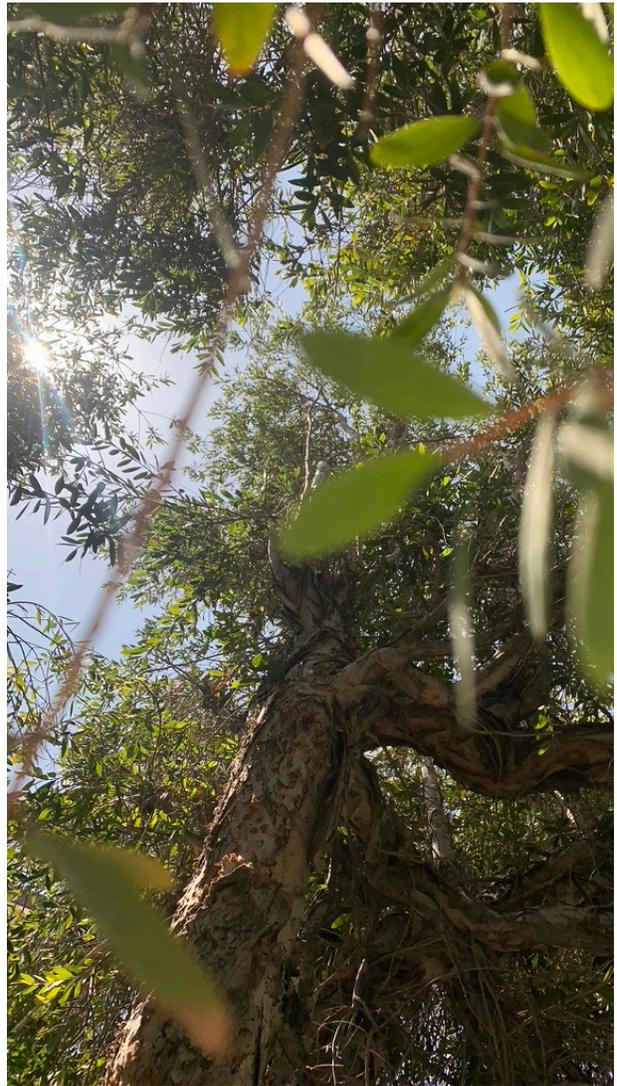
Tree 25 Flaxleaf Paperbark

Structurally defective (*codominant stem with included bark). Improper topping. Structure is substandard. Condition 65%

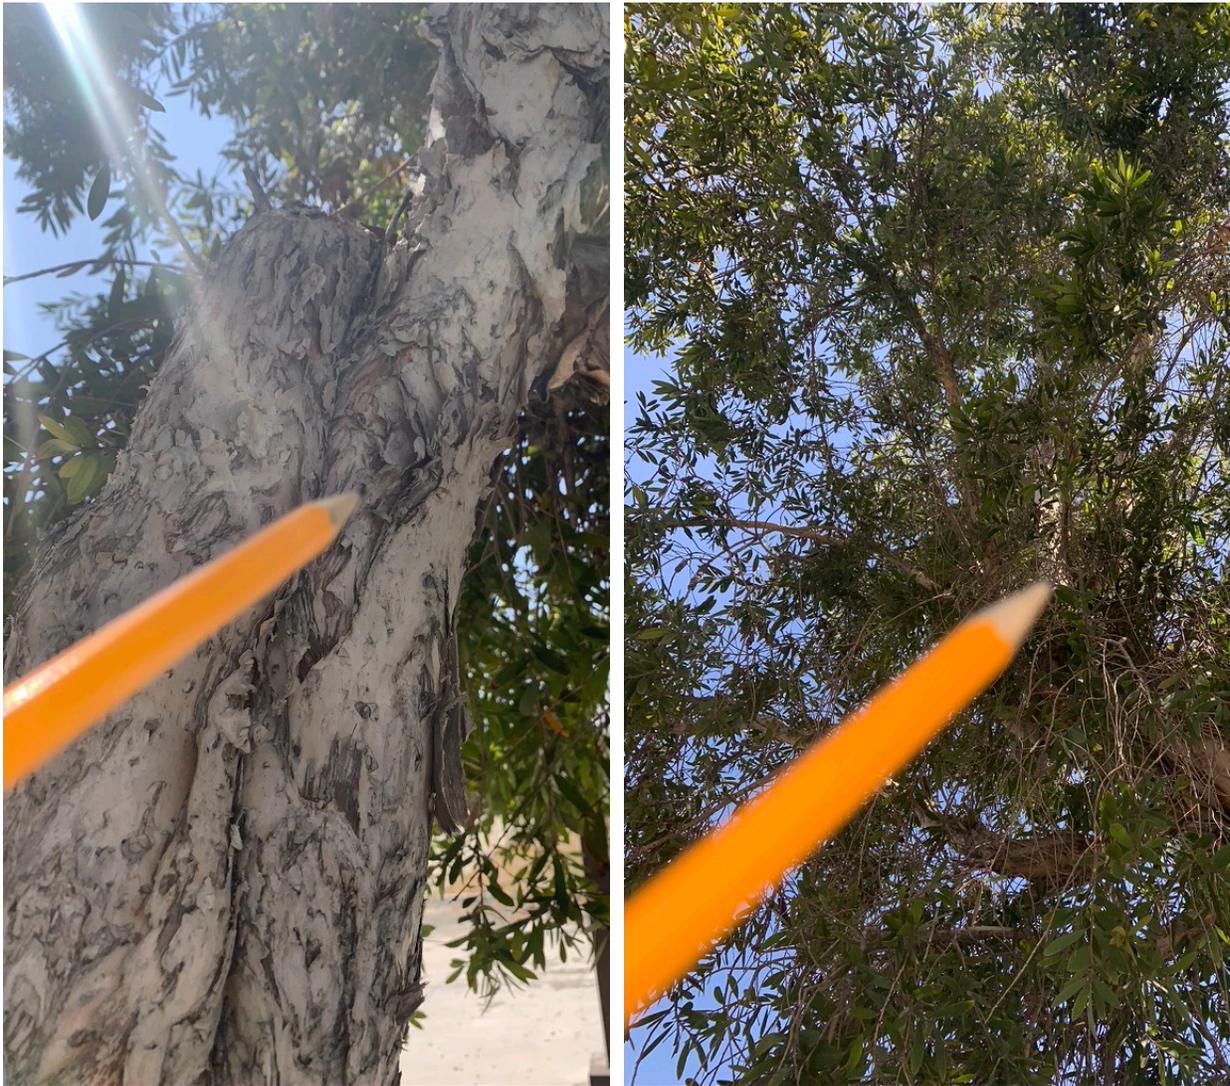
Tree 26 Flaxleaf Paperbark

Structurally defective (*codominant stem with included bark). Improper topping. Structure is substandard. Condition 65%
