APPENDIX H
ARBORIST STUDY

Mark Porter, California Arbor Care

**Inventory and Tree Condition Report Sierra Gate Center as per
Fontana Tree Preservation Ord 1126, § 1, 8-16-94**

Northgate Market Project Fontana, CA

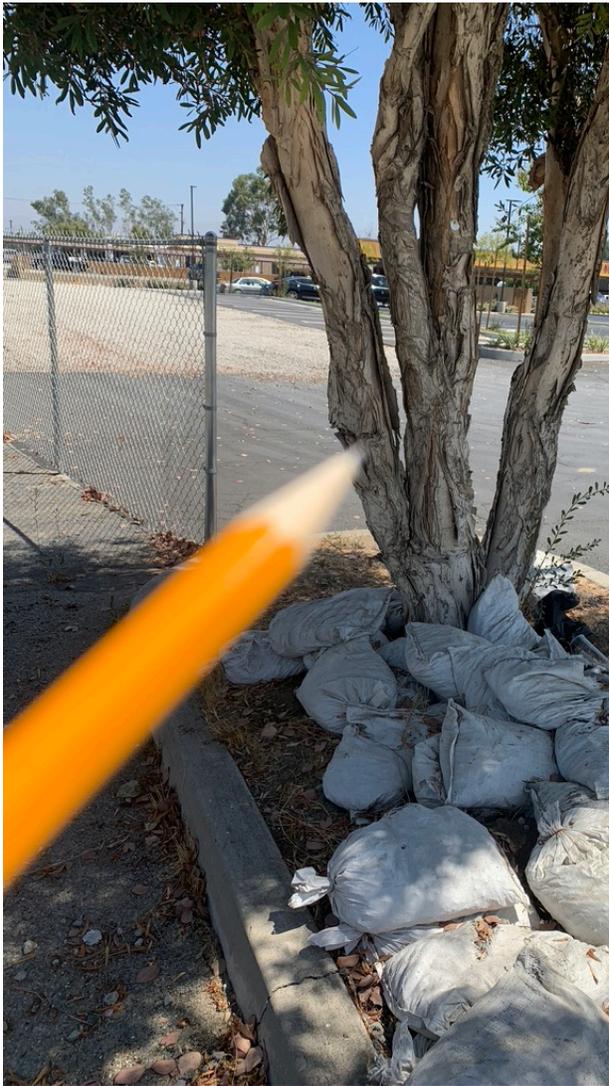
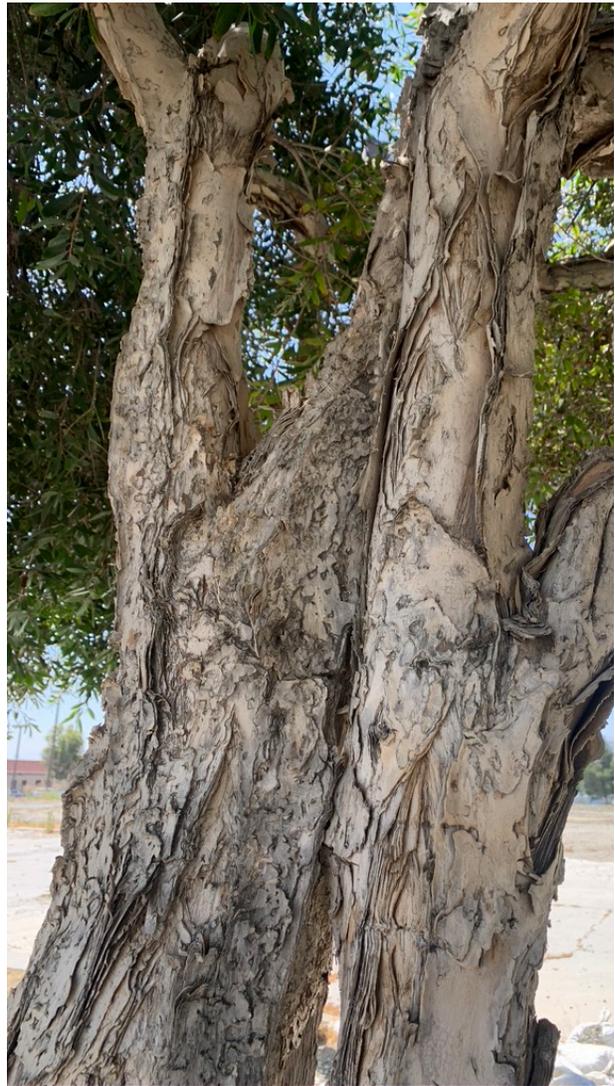
Tree 27 Flaxleaf Paperbark

Structurally defective (*codominant stem with included bark). Aesthetically pleasing, yet the structure is substandard. Branch strength rated as medium; root damage potential rated as low; drought tolerate). Soil conditions poor. Condition 65%.

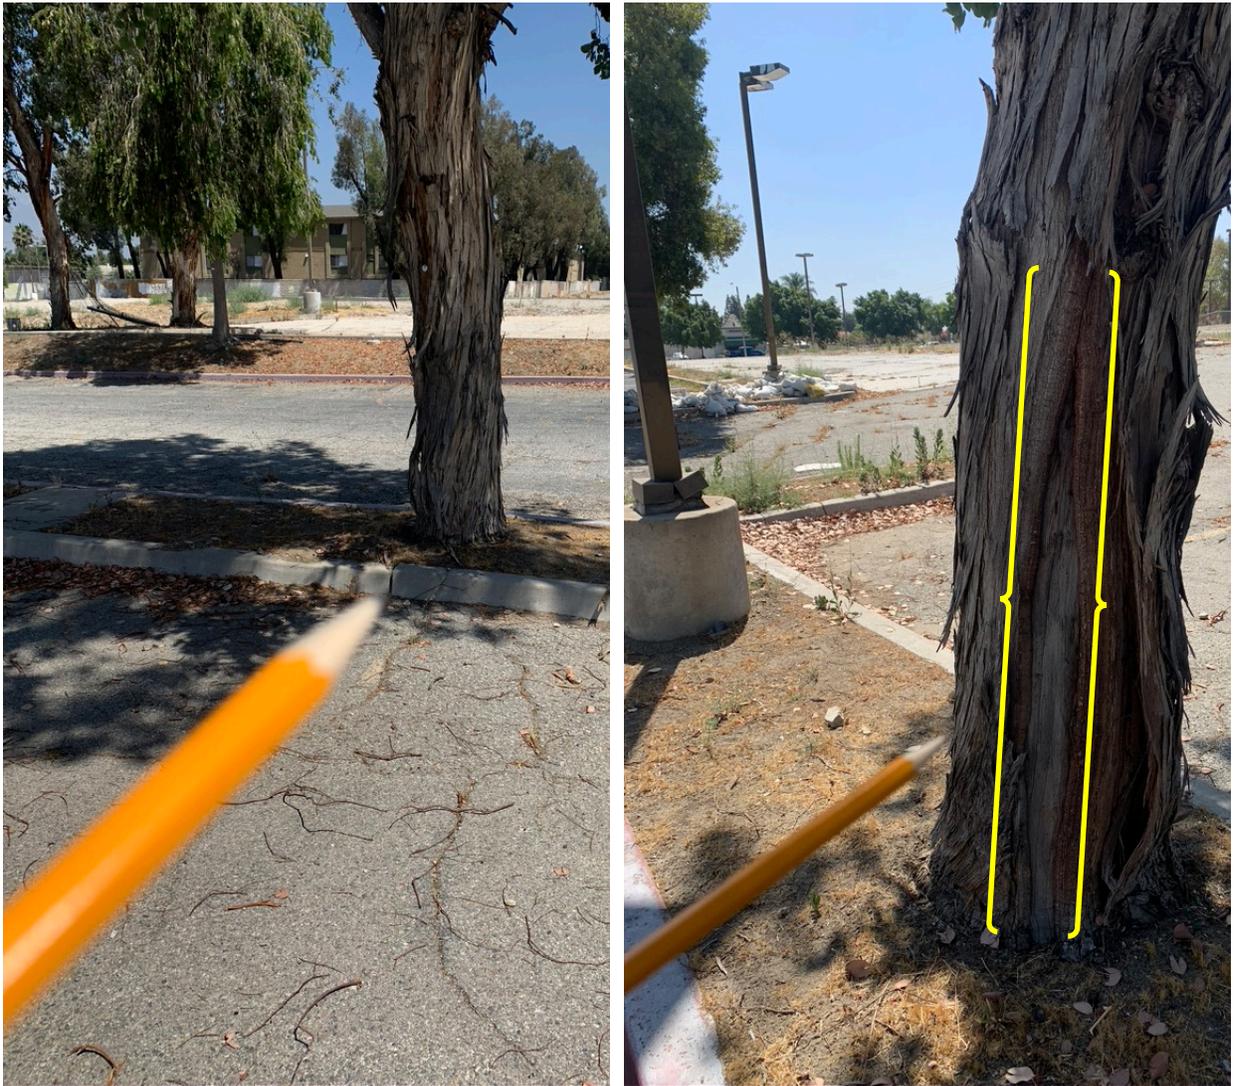
Tree 28 Silver Dollar Gum

Curb damage, restricted soil volume, vertical trunk wound on the west side of trunk, tree has been improperly topped. Condition 65%.

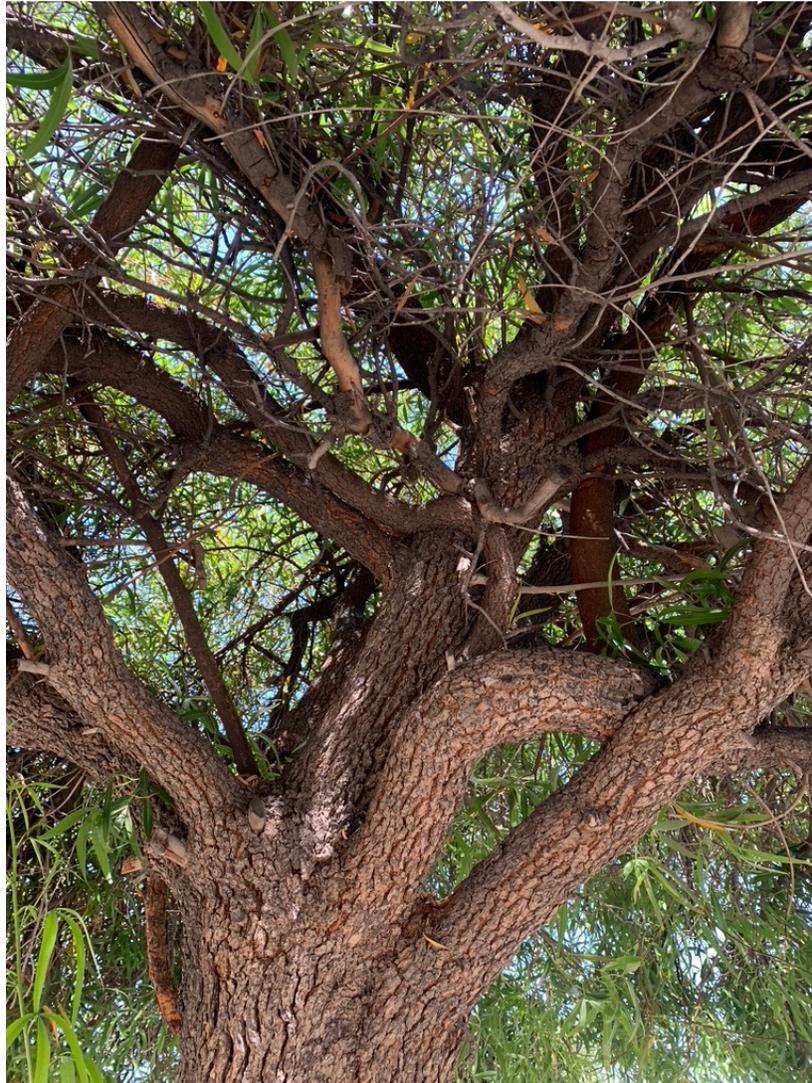
Tree 30
Australian Willow

Poor branch structure development, root damage potential low, drought tolerant. Tolerates moist to wet soil. Resistant to Armillaria. Good species for area. Branch strength rated as moderate (UFEI). Condition 65%,

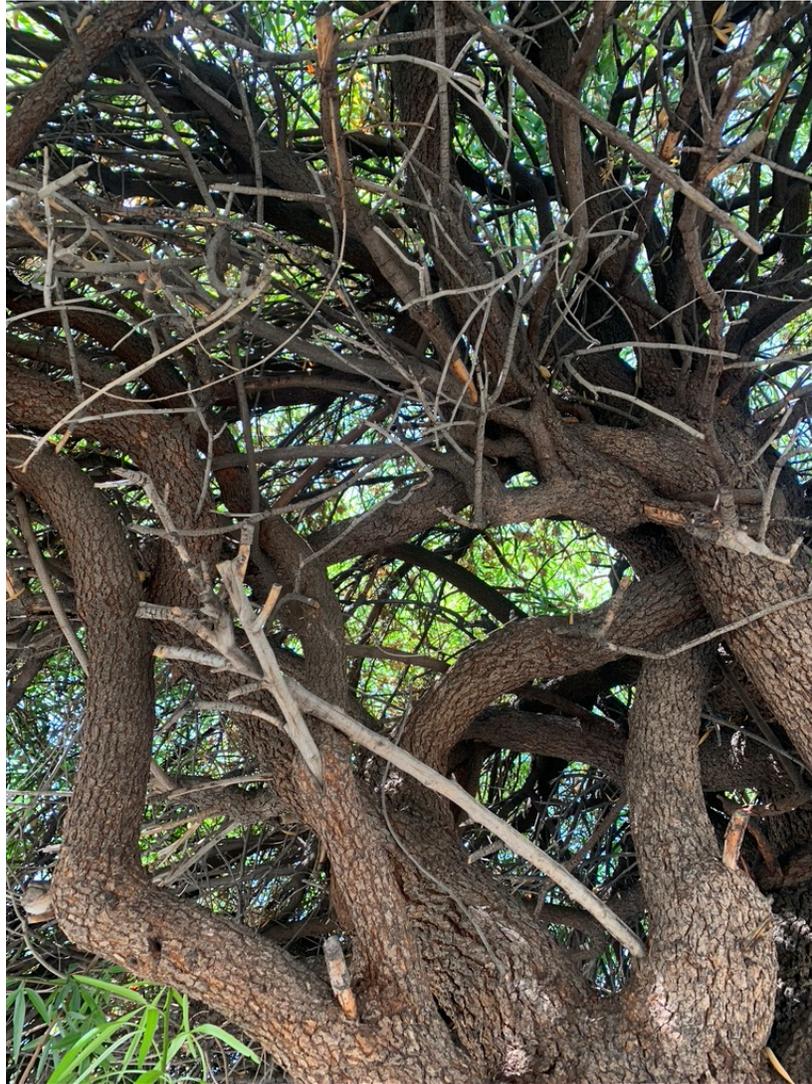
Tree 31 Australian Willow

Poor branch structure development, root damage potential low, drought tolerant. Tolerates moist to wet soil. Resistant to Armillaria. Good species for area. Branch strength rated as moderate (UFEI). Condition 65%.

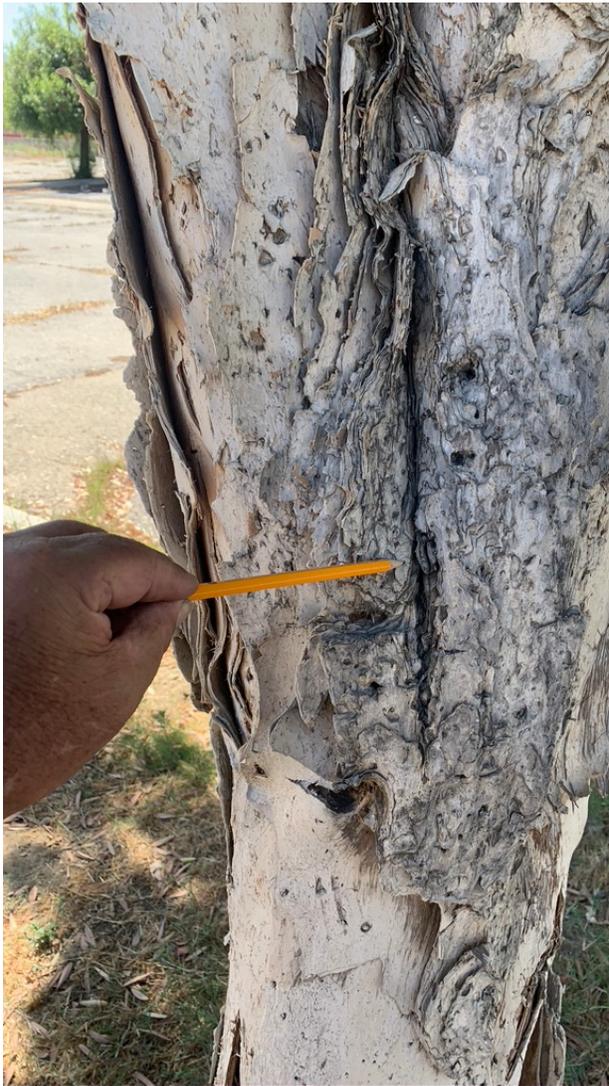
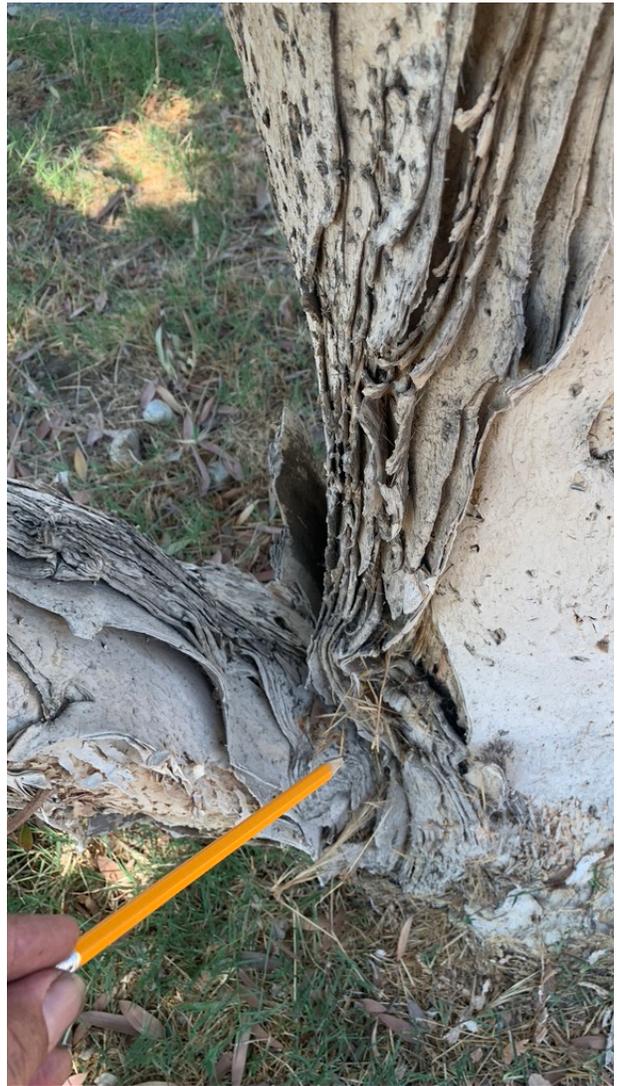
Tree 32 Flaxleaf Paperbark

**Poor form, codominant stems (weak connection). Structurally defective.
Condition 65%**

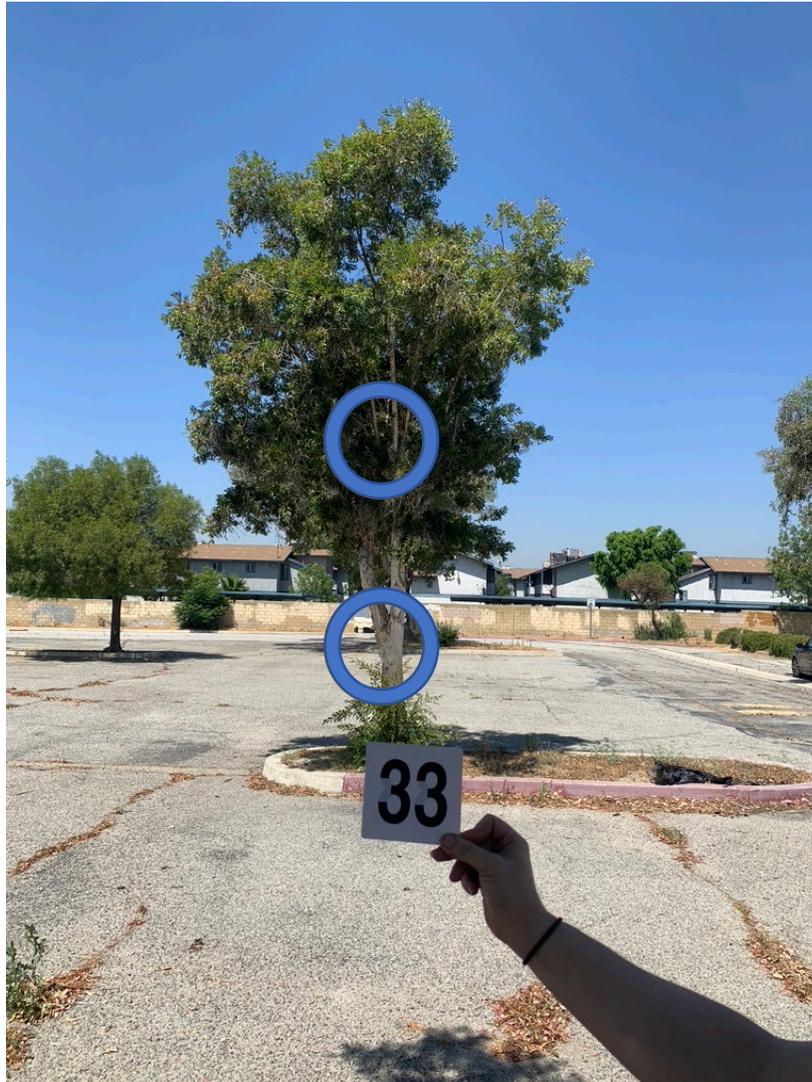
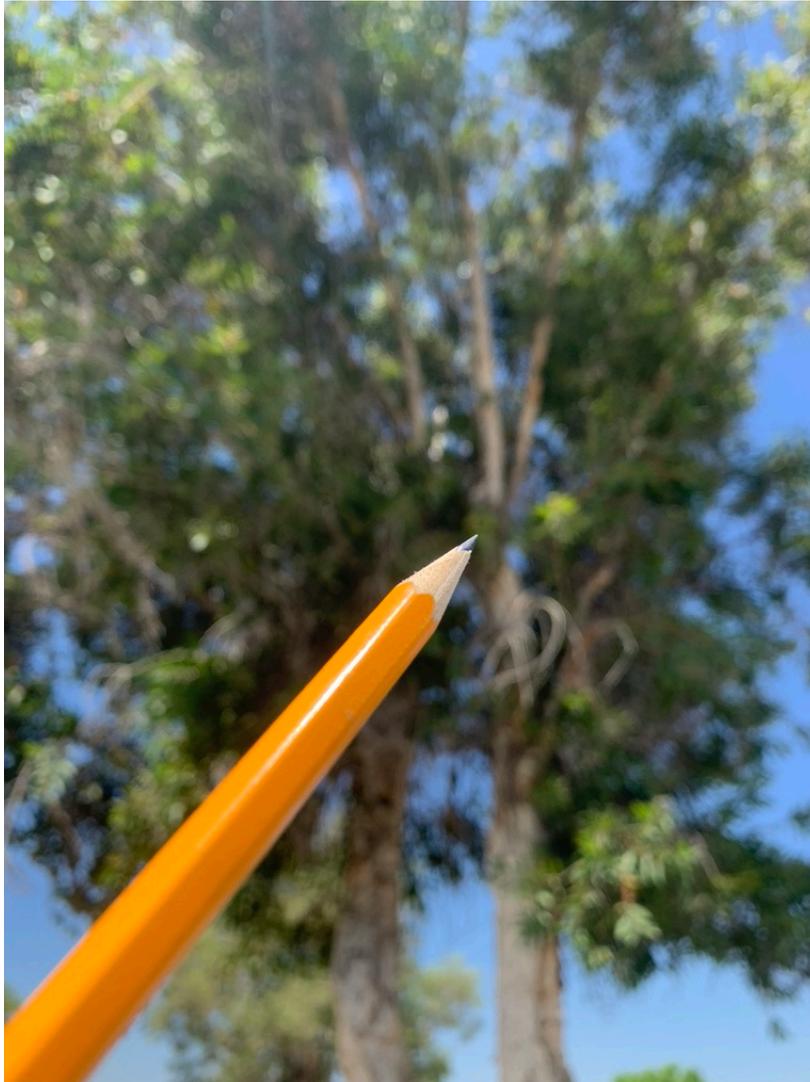
Tree 33 Flaxleaf Paperbark

Codominant stem bark inclusion (weak connection). Structurally problems. Improper topping (multiple epicormic shoots weakly attached). Structurally defective. Condition 65%.

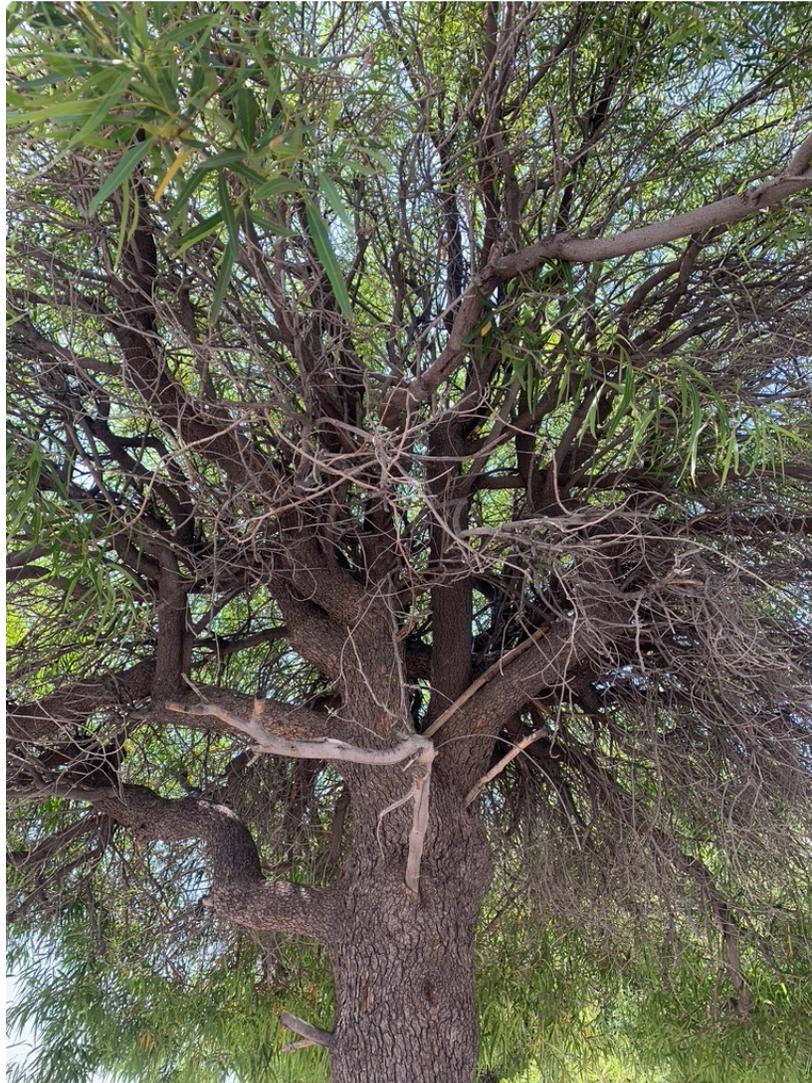
Tree 34 Australian Willow

Crowded branch structure, root damage potential low, drought tolerant. Tolerates moist to wet soil. Resistant to Armillaria. Good species for area. Branch strength rated as moderate (UFEI). Condition 70%.

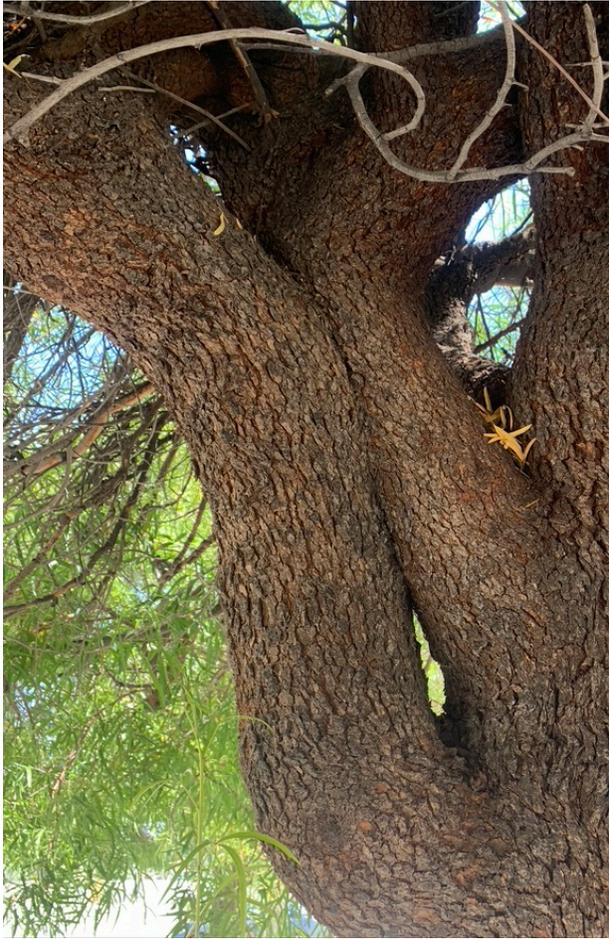
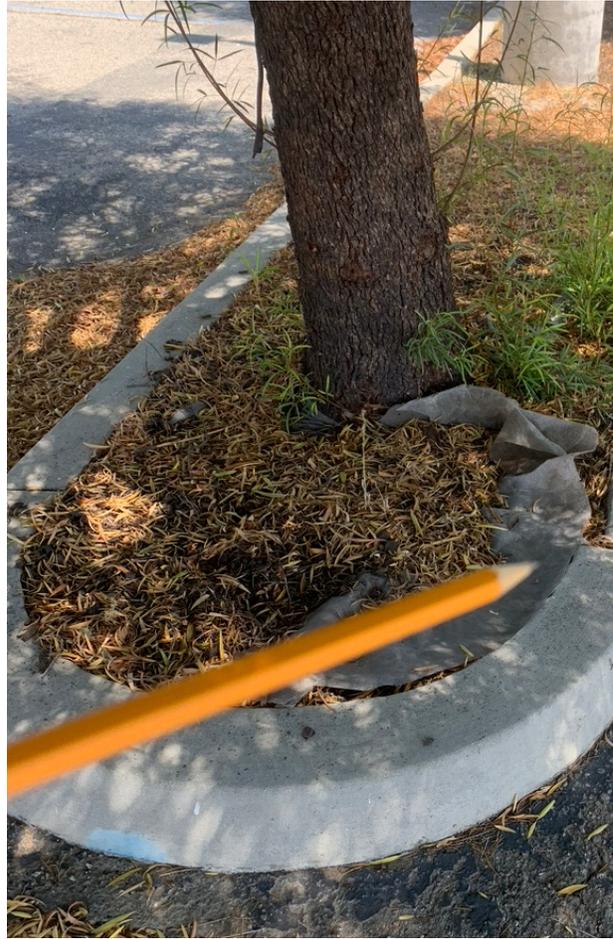
Tree 35 Australian Willow

Substandard structural development (scaffold branches crowded with poor connection). Restricted soil volume, curb damage. Good species for area, aesthetically OK, but poor-quality tree due to misunderstanding of proper structural development (those responsible for maintenance lack proper training and skills to manage trees correctly). Condition 60%

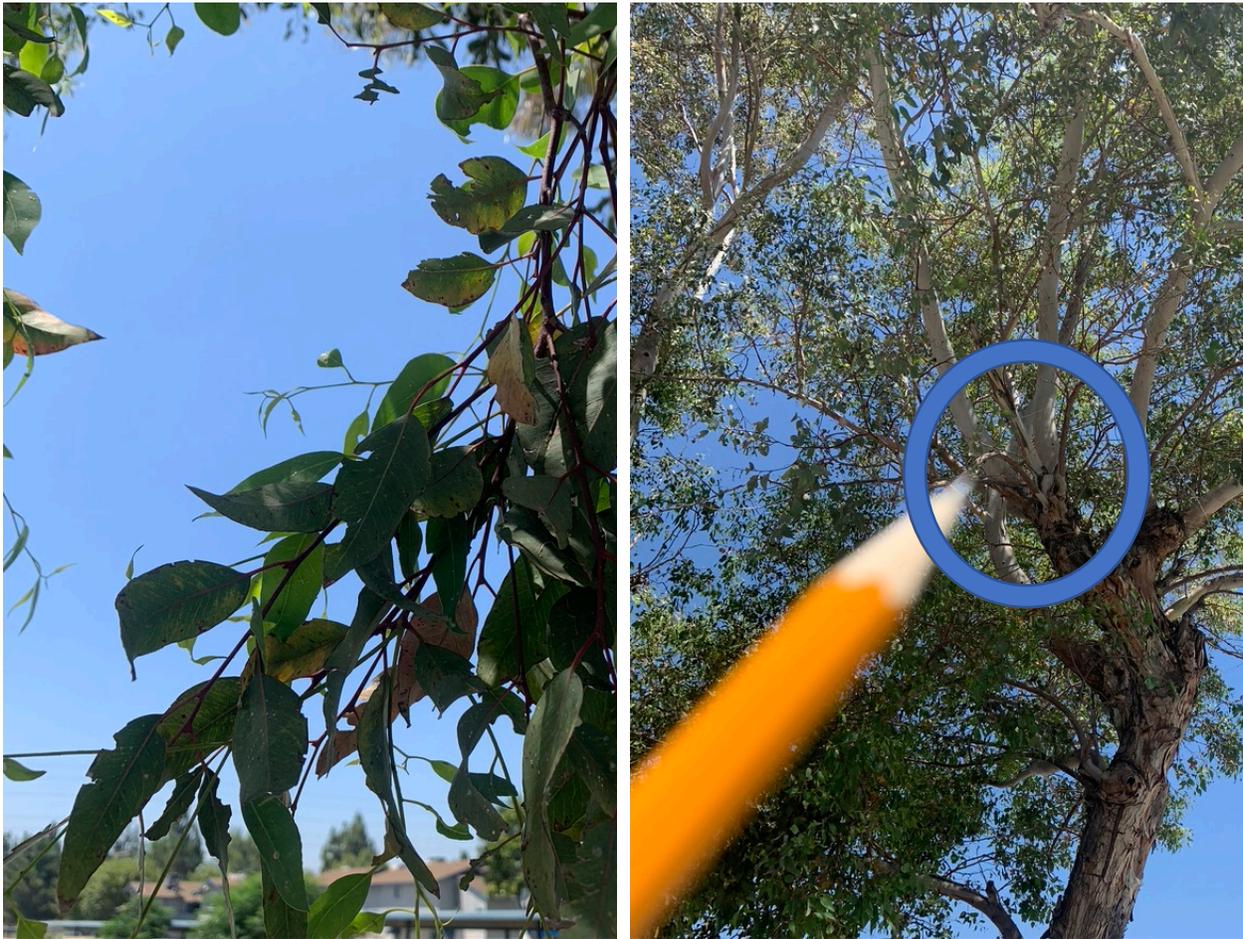
Tree 36 Silver Dollar Gum

Lerp psyllid, tortoise beetle (pests), improper topping (as seen at the transition of rough bark and smooth bark. Epicormic shoots from improper topping are weakly attached and pose a threat of failure to targets (pedestrians and vehicles). Condition 55%.

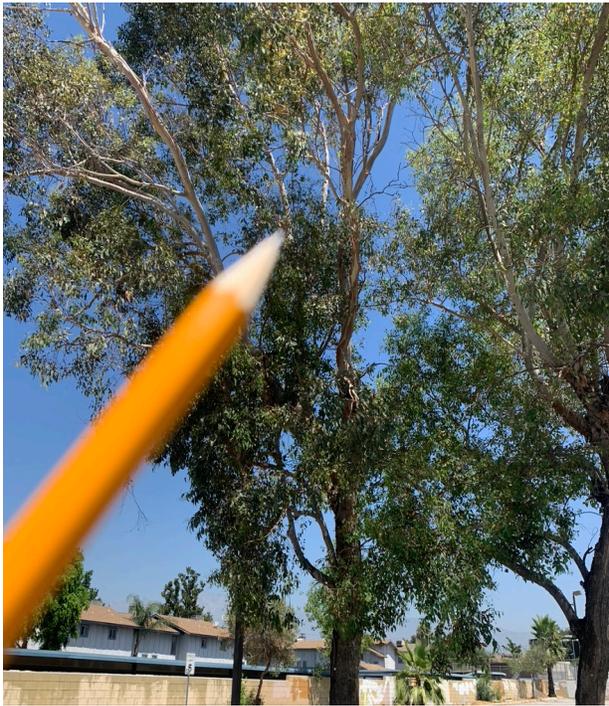
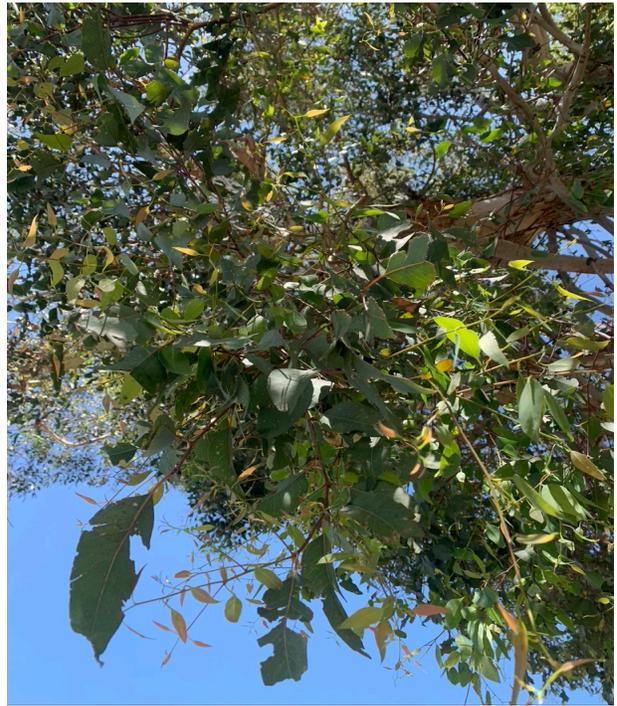
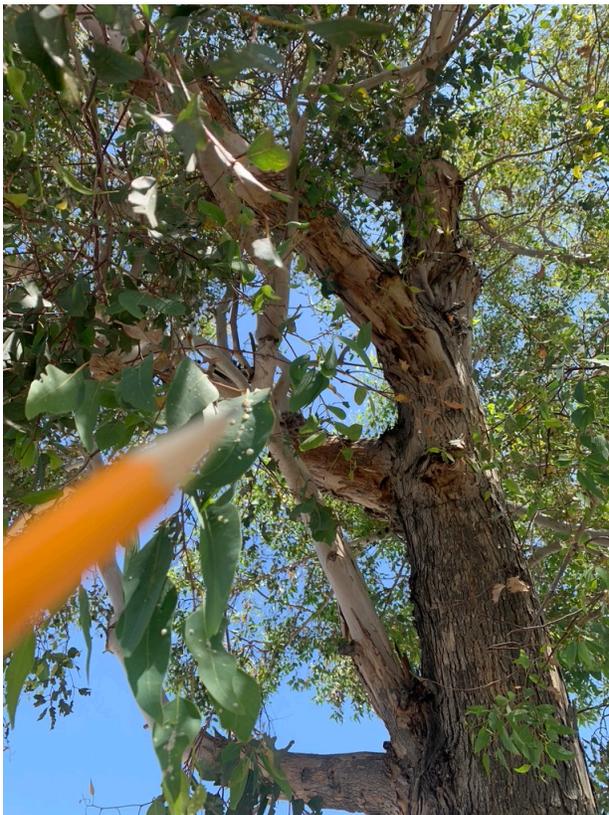
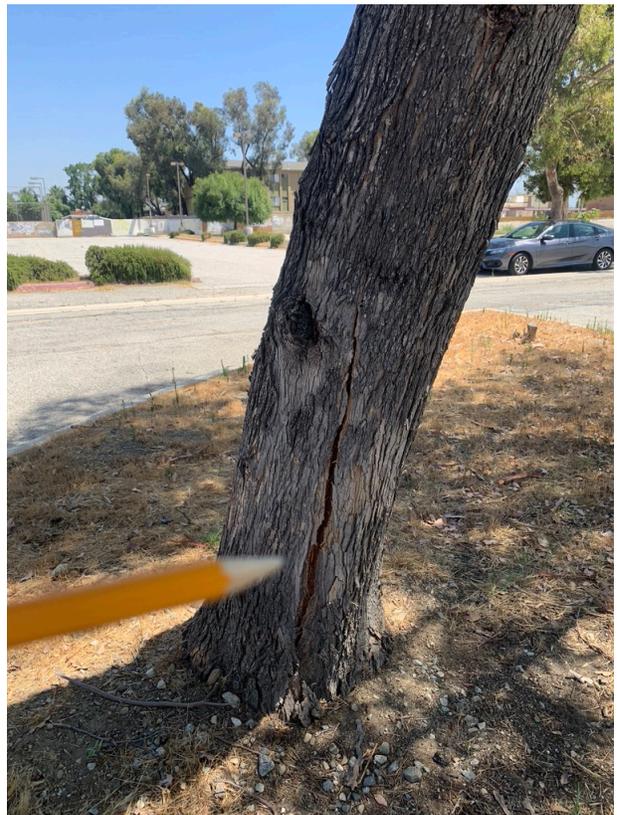
Tree 37 Silver Dollar Gum

Improper topping, tortoise beetle, lerp psyllid, trunk crack. Condition 50%

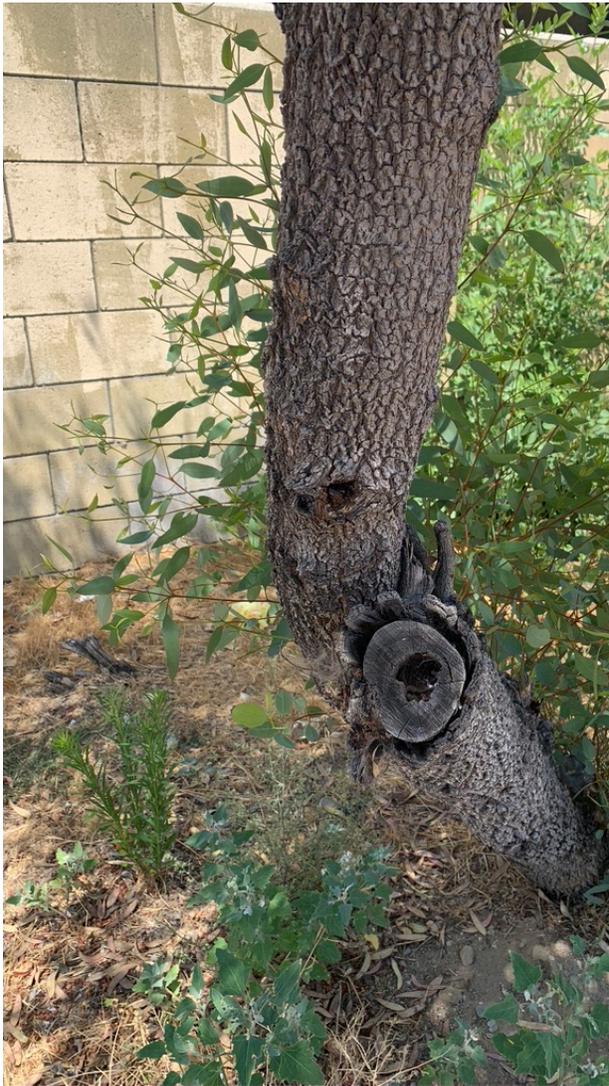
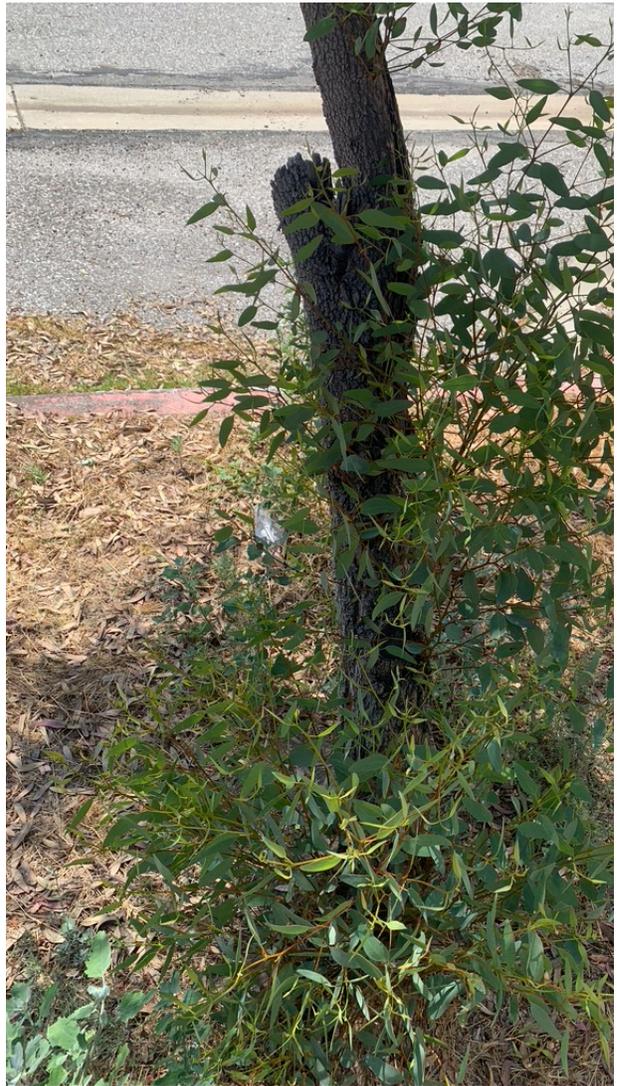
Tree 38 Nichol's Willowleaf Peppermint

Lack of woundwood formation, decay, epicormic growth at base of tree. Condition 65%.

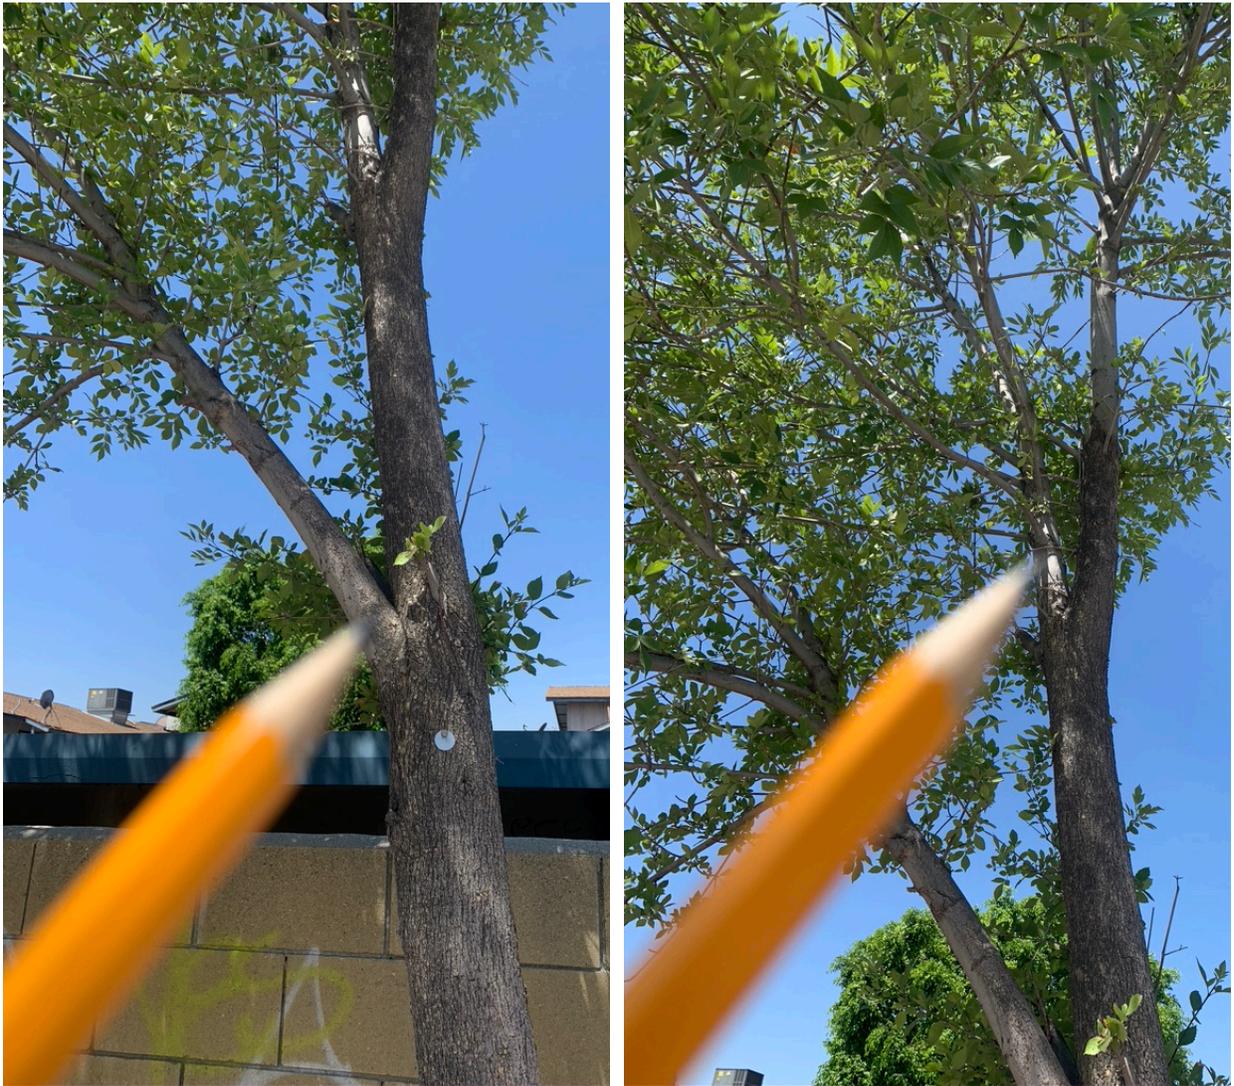
Tree 39 Evergreen Ash

Scaffold branch connections are weakly attached, bark inclusion, , string trimmer damage at root buttress, multiple tight branches congested at one spot. Condition 50%.

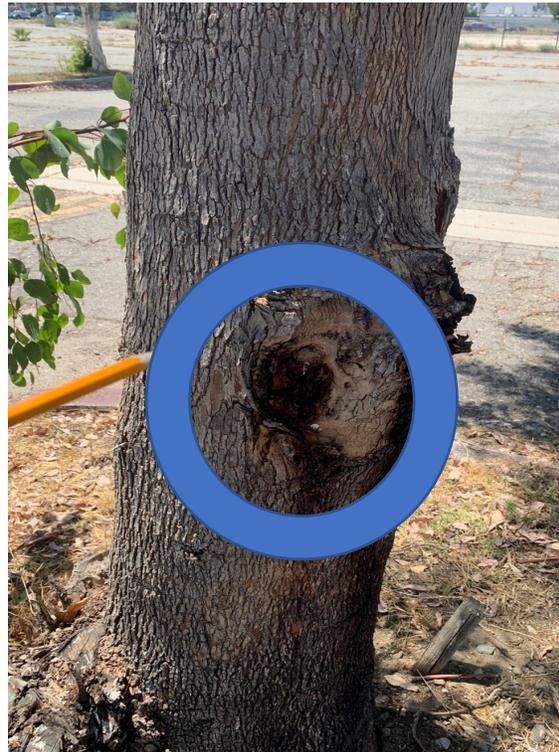
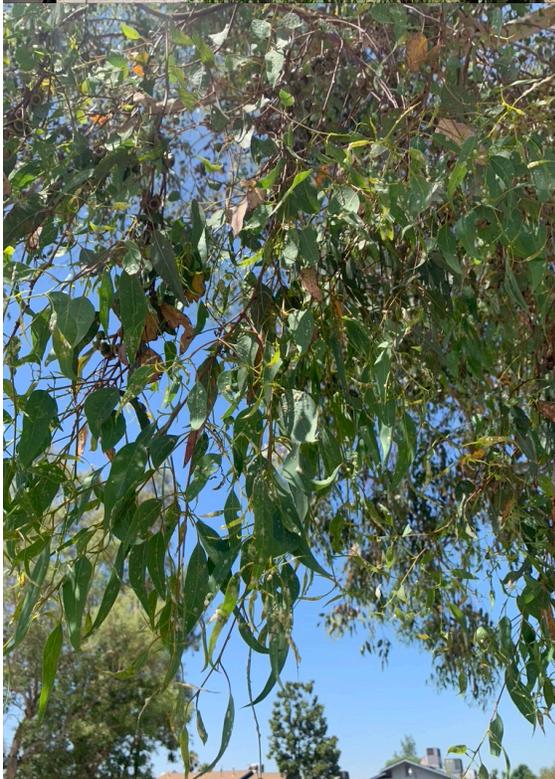
Tree 40 Silver Dollar Gum

Slime flux bacteria, tortoise beetle, lerp psyllid, improper topping. Condition 60%

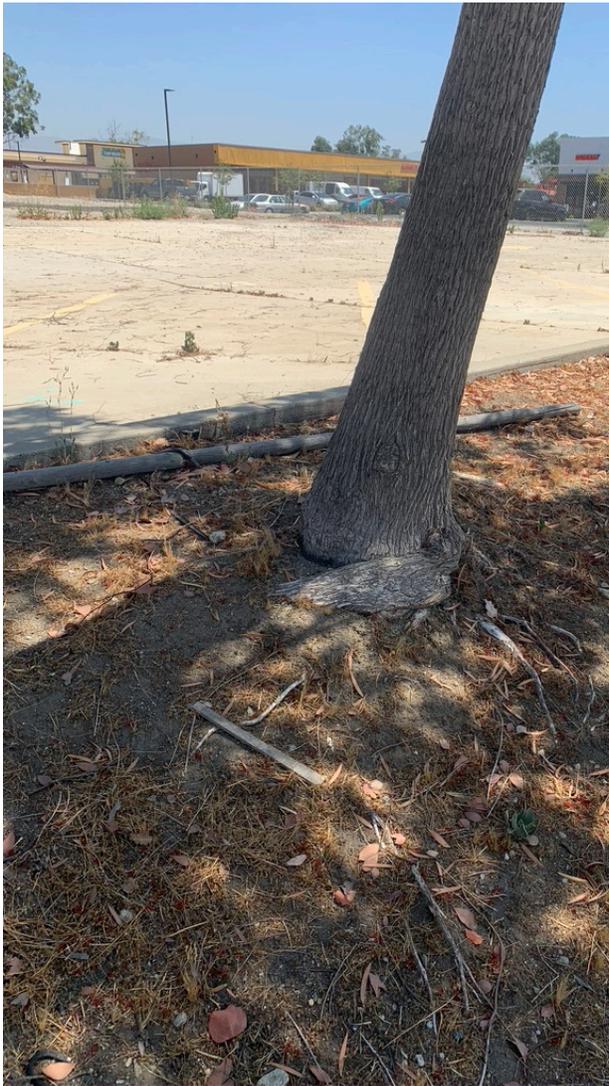
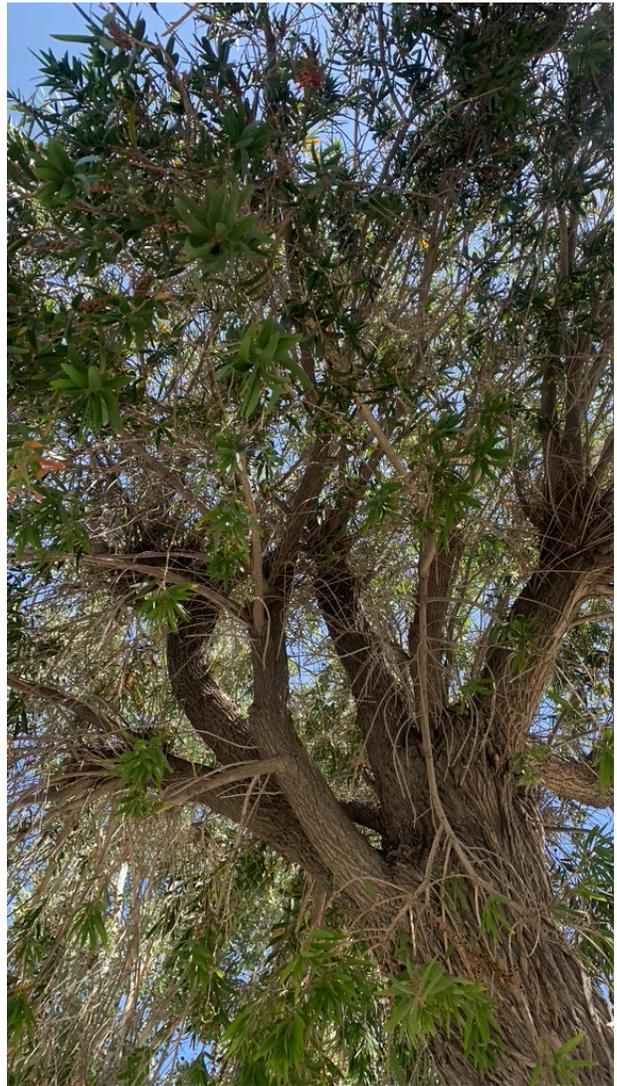
Tree 41 Bottlebrush

Stem growing root, topping damage, structurally defective. Condition 60%

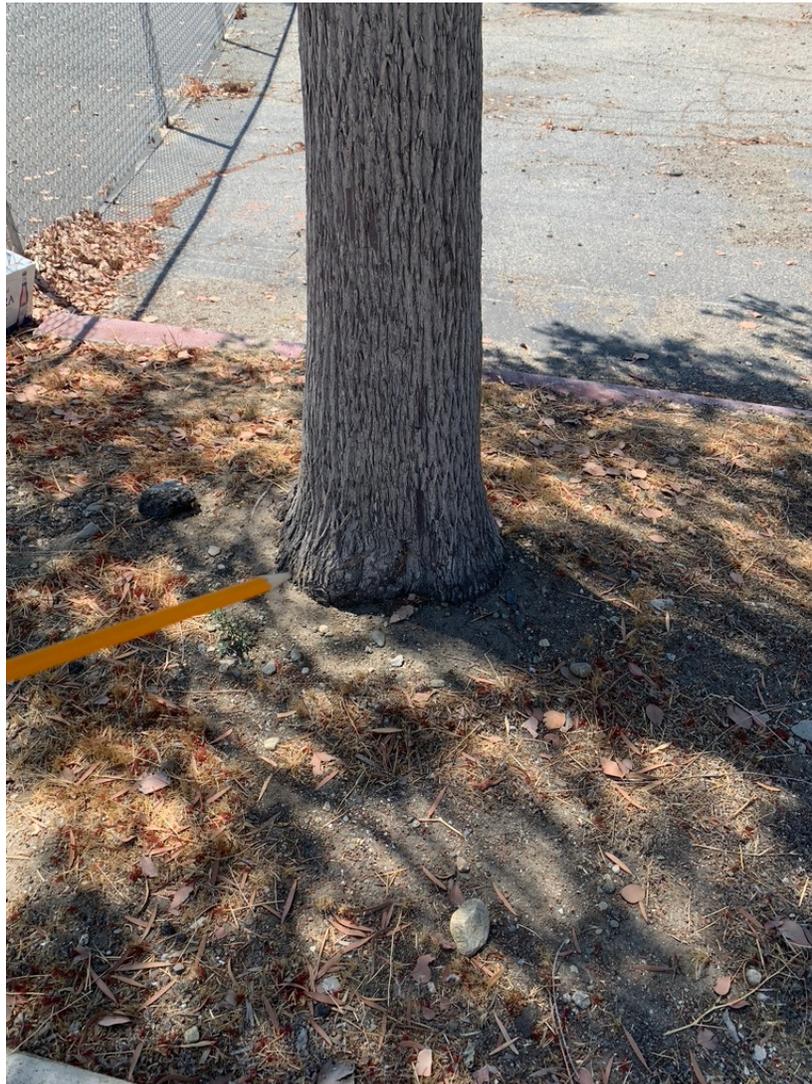
Tree 42 Bottlebrush

Flat depression on lower trunk. Probable stem girdling root, tree was improperly topped. Structurally defective. Condition 65%.

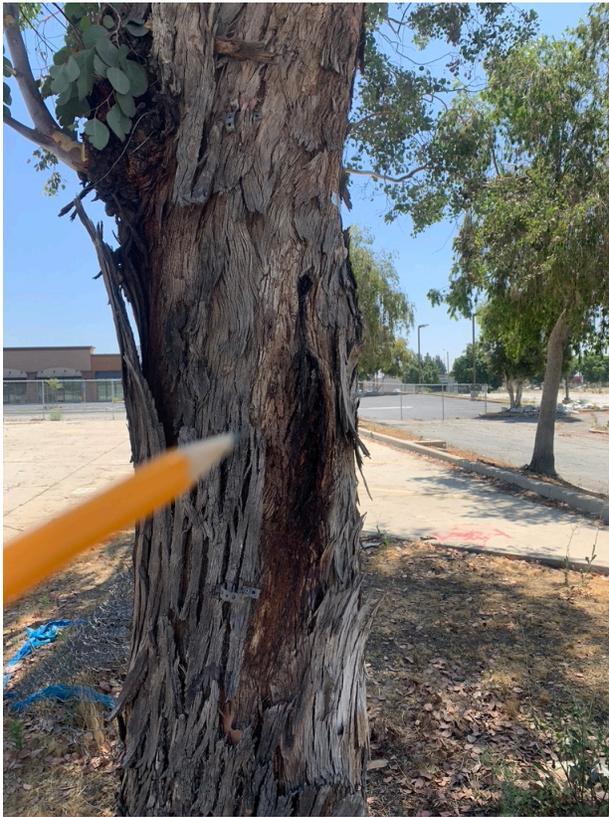
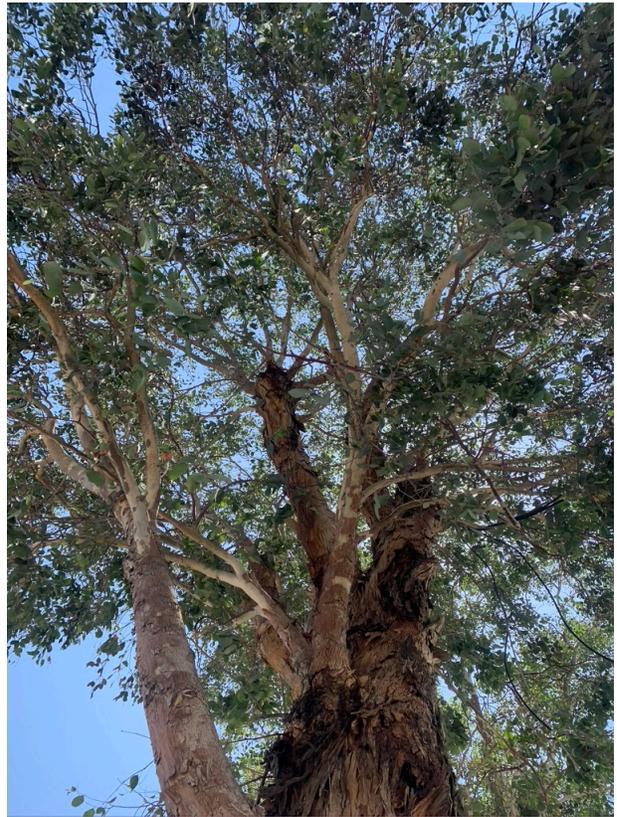
Tree 43 Silver Dollar Gum

Kino bleeding, topping damage (structure defective), electrical wires and chain linked fence embedded in tree. Condition 60%.

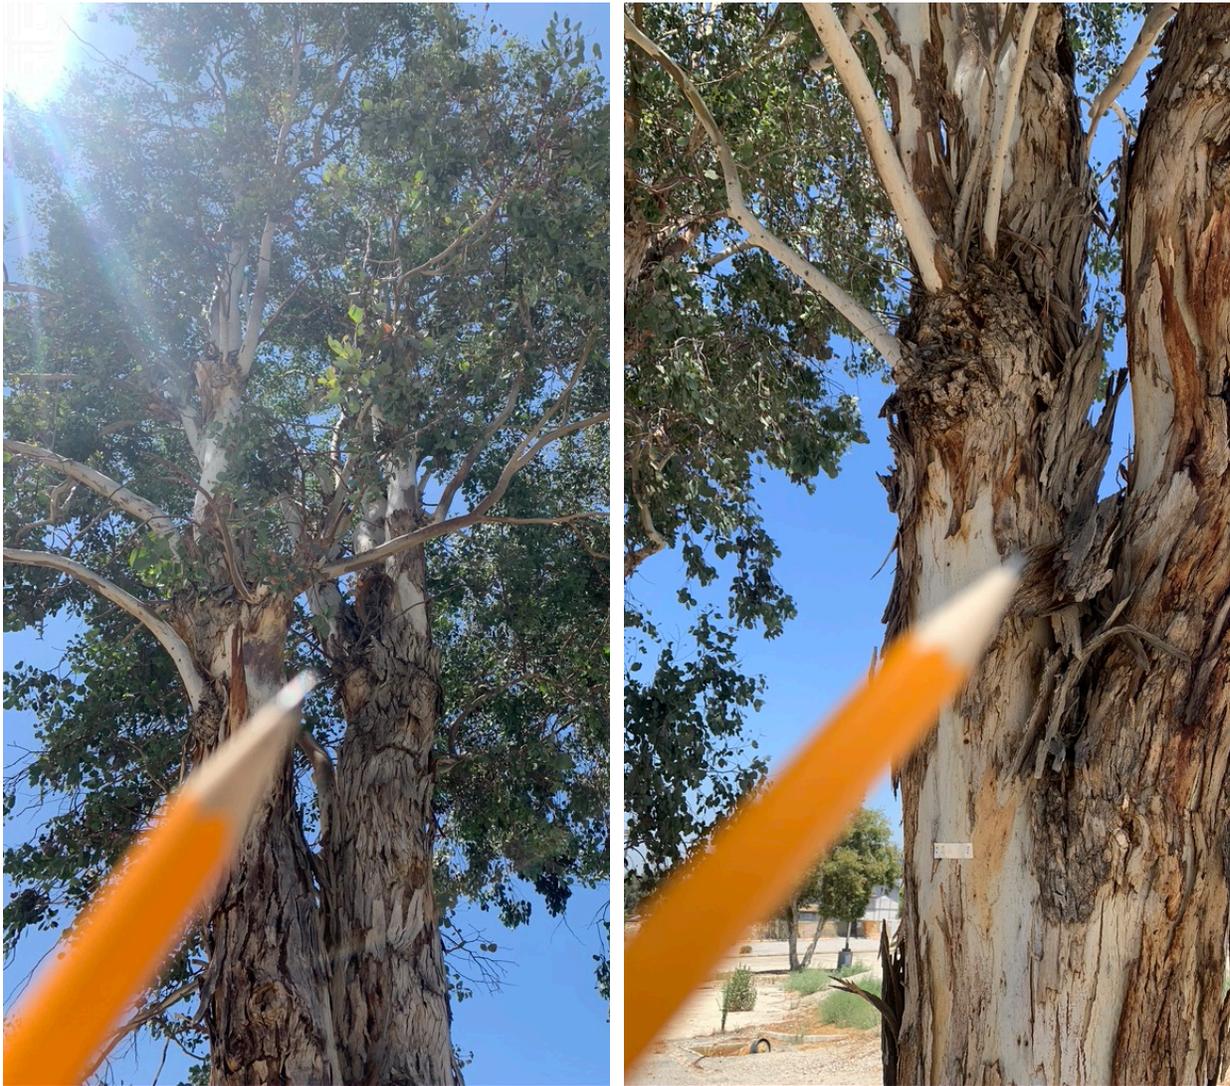
Tree 44 Silver Dollar Gum

Topping damage, poorly attached leaders, bark inclusion. Condition 65.

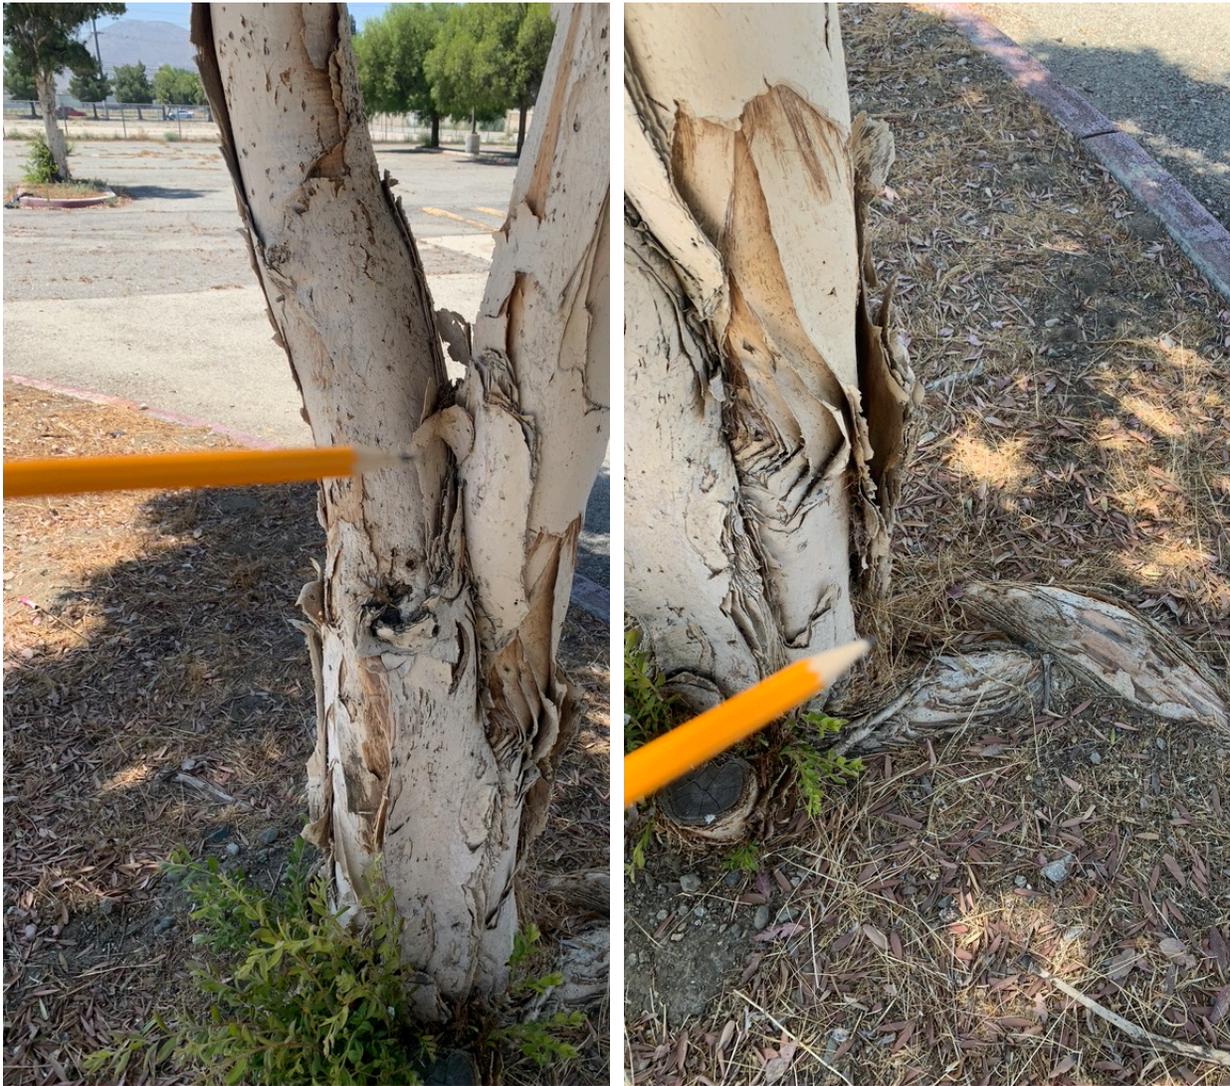
Tree 45

Codominant trunk, bark included, root compression, surface roots. Condition 65%.
