APPENDIX H
ARBORIST STUDY

Mark Porter, California Arbor Care

**Inventory and Tree Condition Report Sierra Gate Center as per
Fontana Tree Preservation Ord 1126, § 1, 8-16-94**

Northgate Market Project Fontana, CA

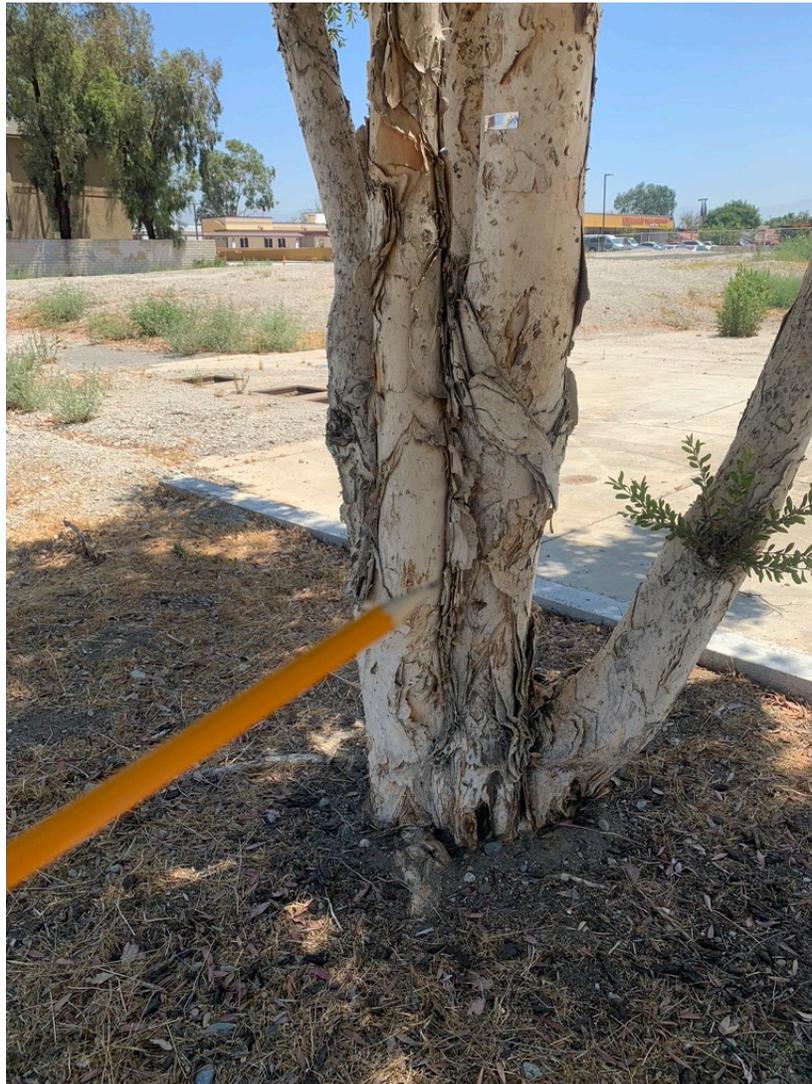
Tree 46 Flaxleaf Paperbark

Five codominant stems with bark inclusion, surface and kinked roots. Aesthetically pleasing, yet structurally defective. Condition 65%.

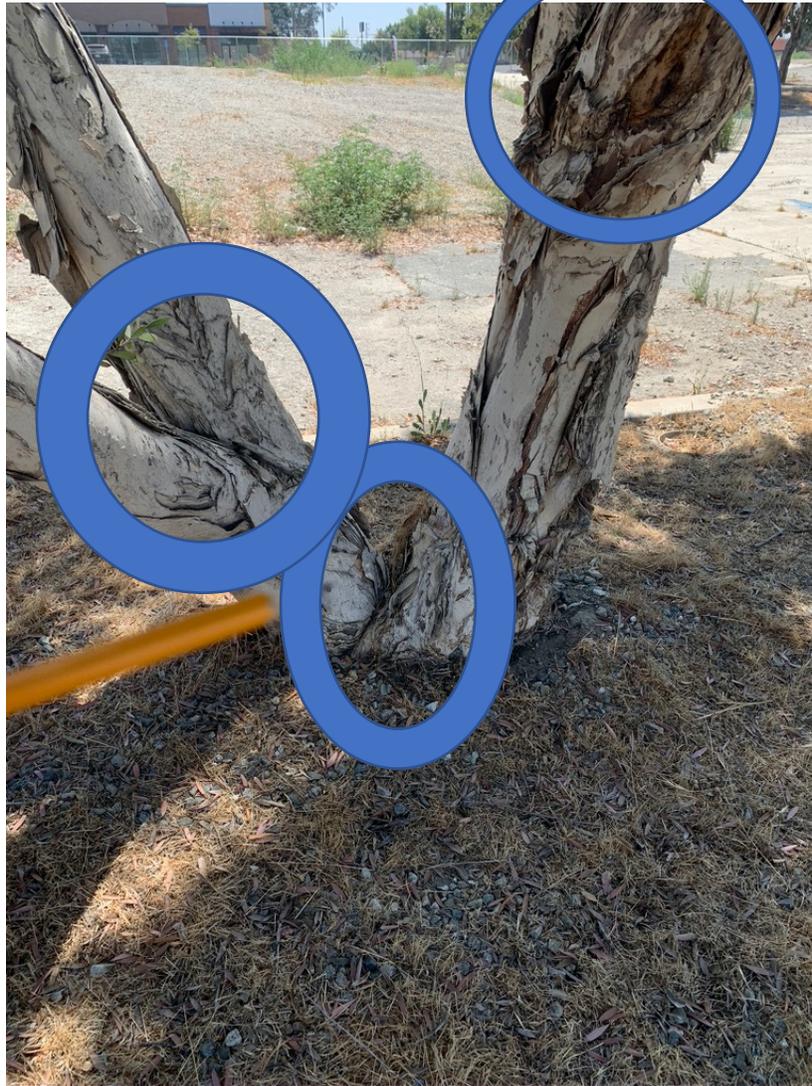
Tree 47 Flaxleaf Paperbark

Multiple failure points as tree matures. Defective structure (weal attachments, codominant stems with bark inclusion). Structural condition poor. Condition 65%

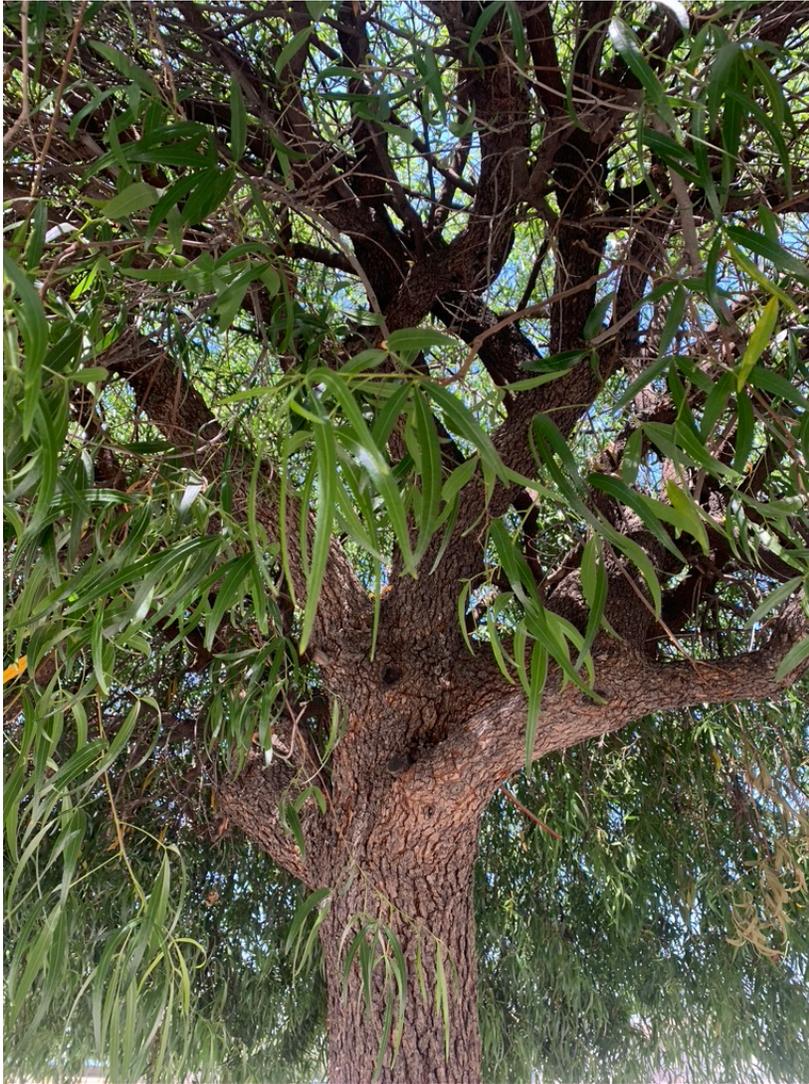
Tree 48 Australian Willow

Scaffold branch development not optimal, yet workable. root damage potential low, drought tolerant. Tolerates moist to wet soil. Resistant to Armillaria. Good species for area. Branch strength rated as moderate (UFEI). Condition 80%,

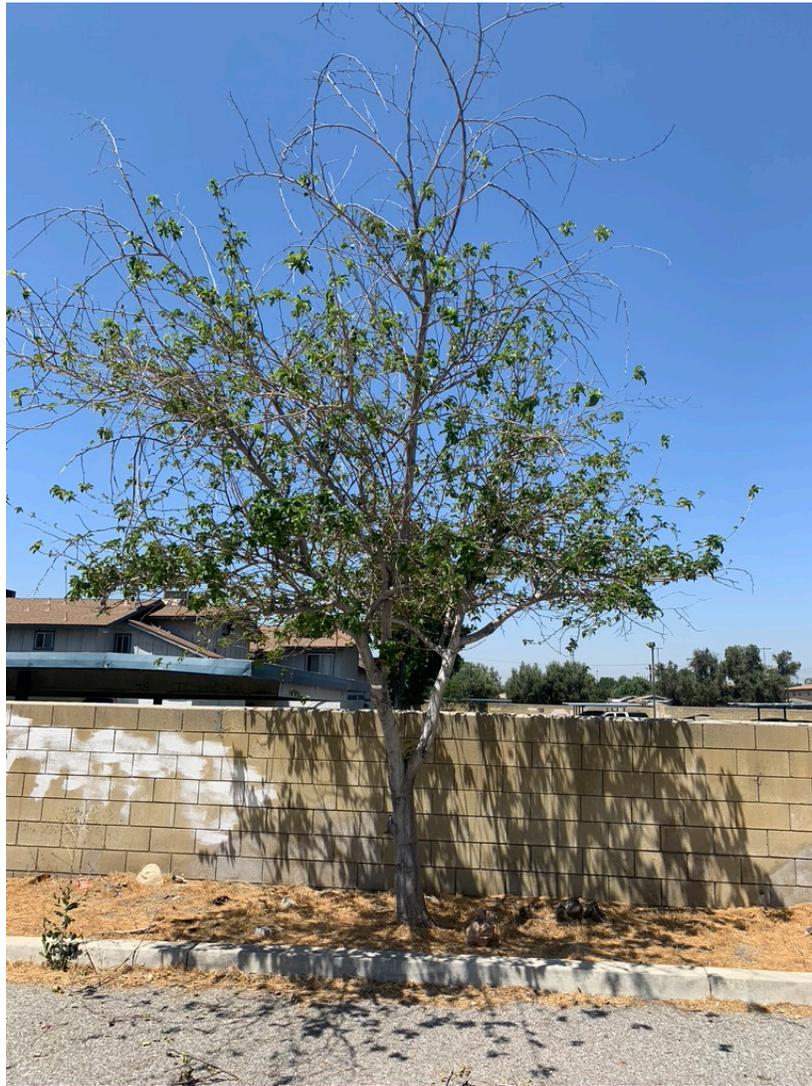
Tree 49 Fruitless Mulberry

Poor structure, foliage dwarfed, woundwood development poor, crown dieback.
Condition 50%.
