APPENDIX H
ARBORIST STUDY

Mark Porter, California Arbor Care

**Inventory and Tree Condition Report Sierra Gate Center as per
Fontana Tree Preservation Ord 1126, § 1, 8-16-94**

Northgate Market Project Fontana, CA

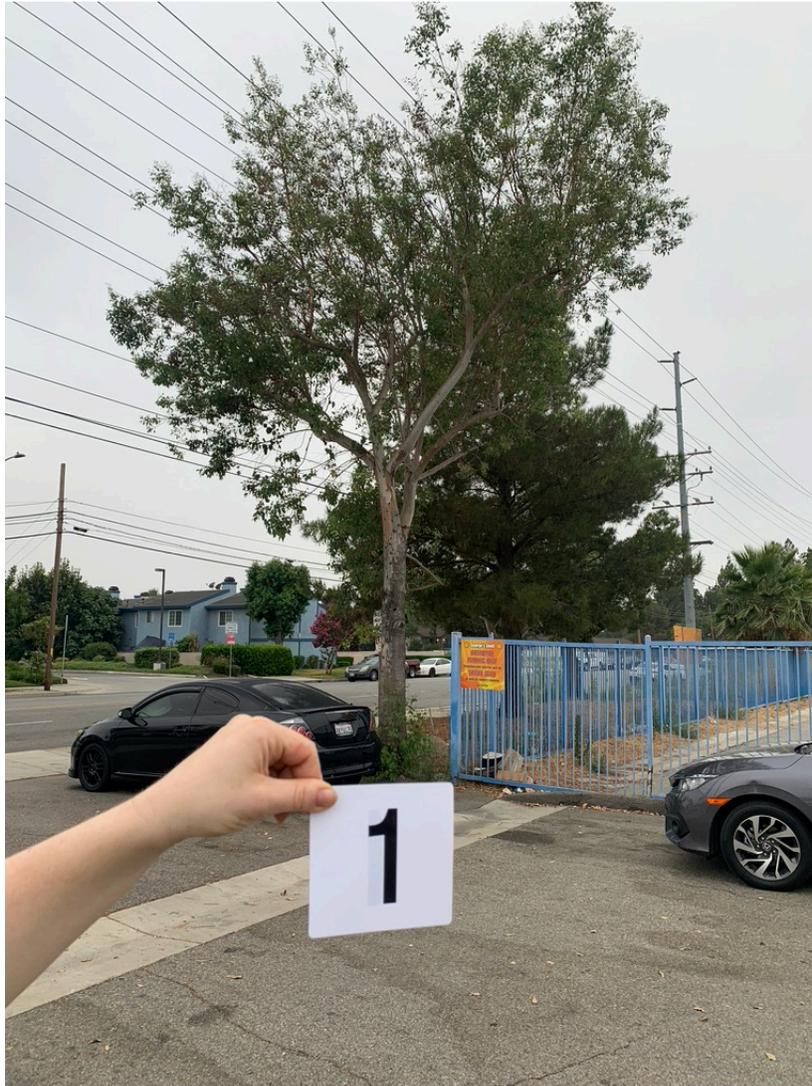
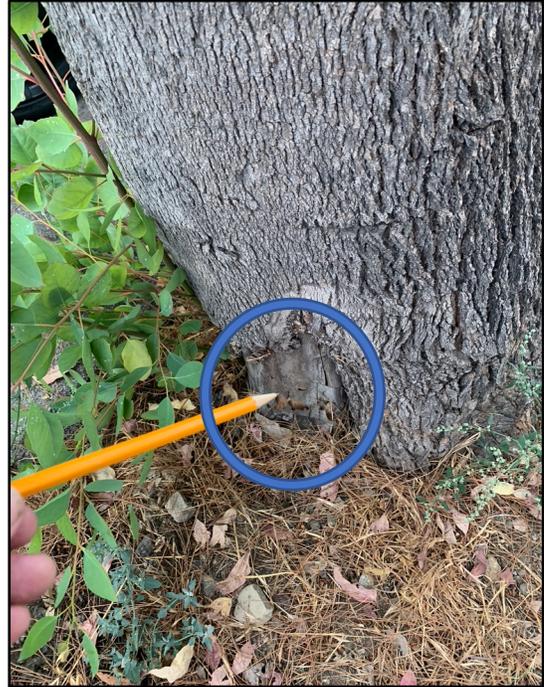
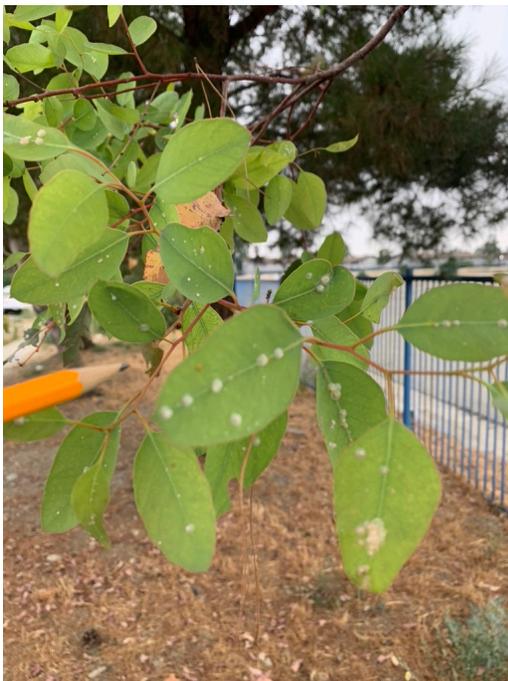
Tree 1 -Flooded Gum

Emerging population of lerp psyllid pest. Chlorotic foliage. Water stress x 5 years.
kinked root, restricted soil volume, root buttress injury.
Codes: Cod, Cr, Dk, Inc, Binj, RF Sh, Xing. Condition 60%.

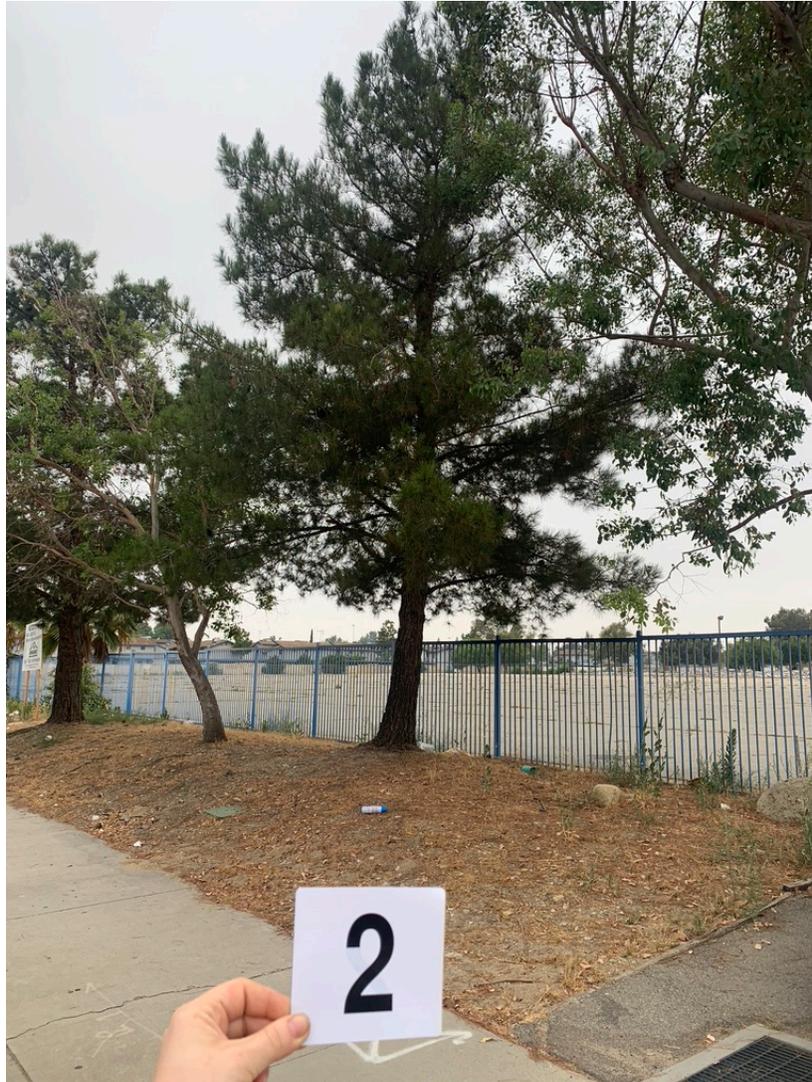
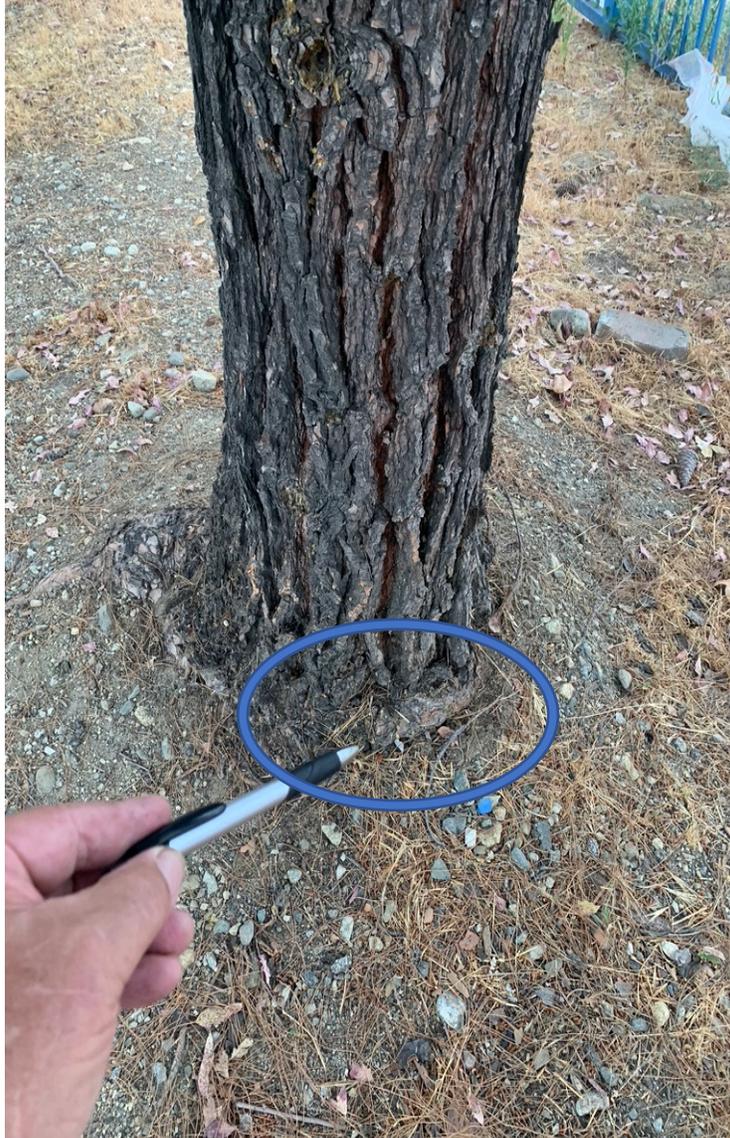
Tree 2 Mondell Pine

Stem Girdling Root (SGR), water stress x 5 years, soil compaction. 70%

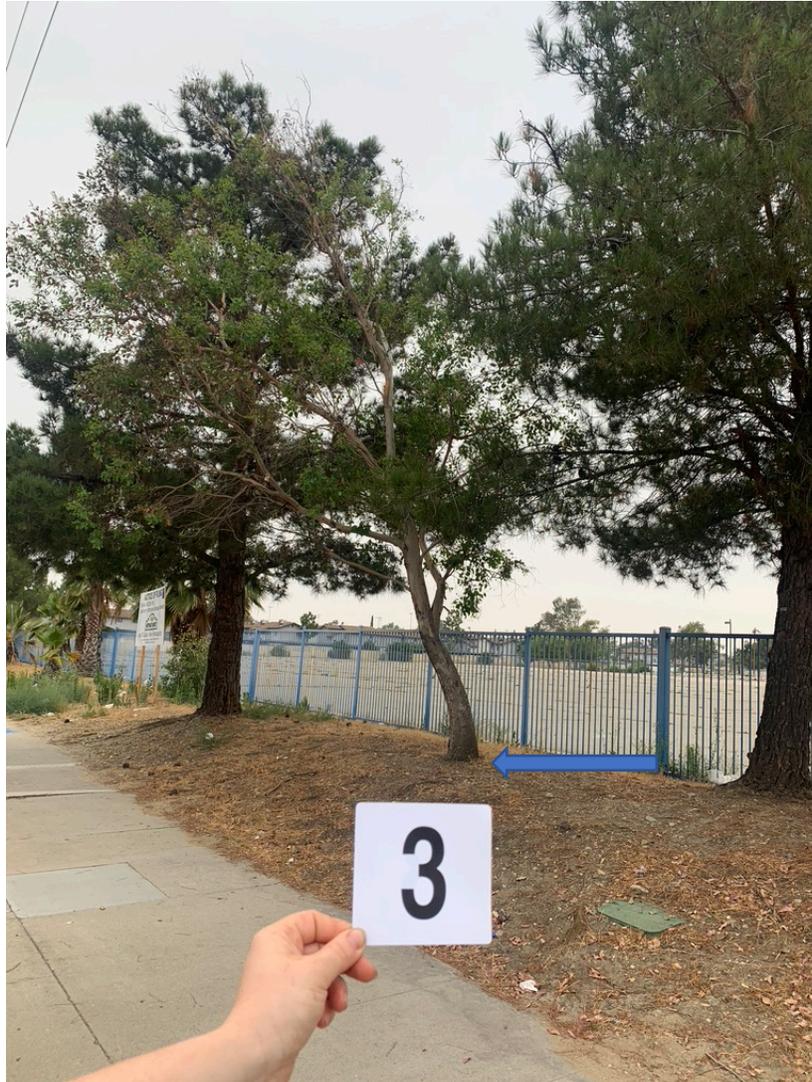
TREE 3 Flooded Gum

Sidewalk damage, surface roots, lerp psyllid, soil compaction, tortoise beetle. poor health, poor structure. Water stress x 5 years. Codes: 1s, Health D, Structure D. Condition 60%.

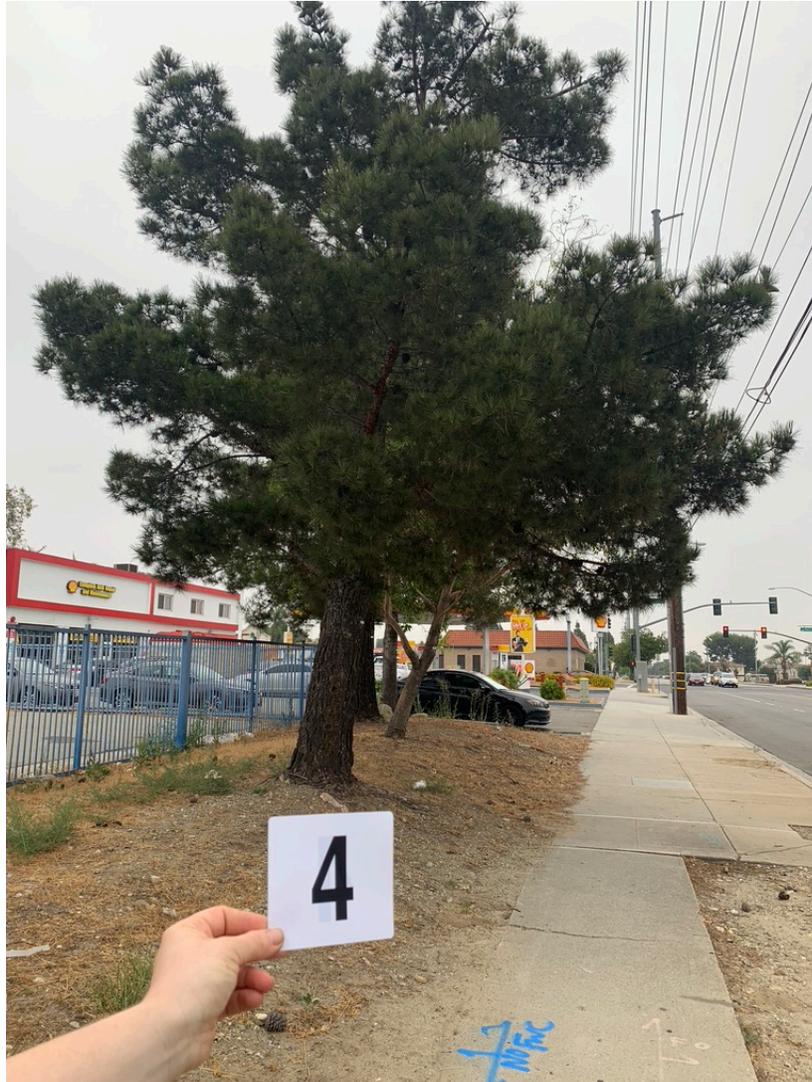
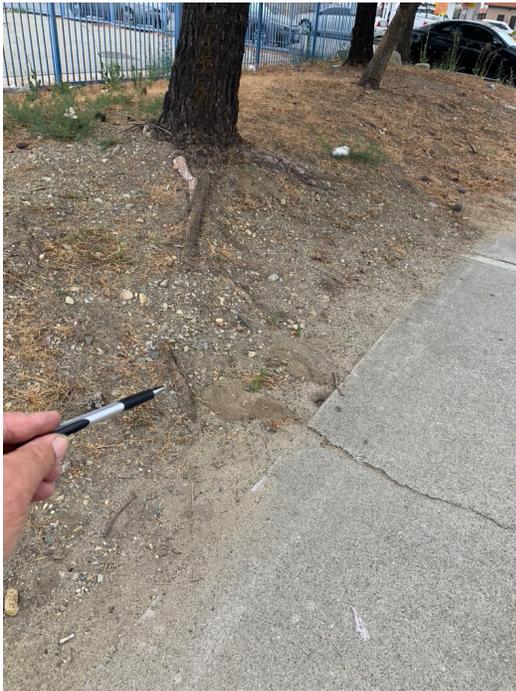
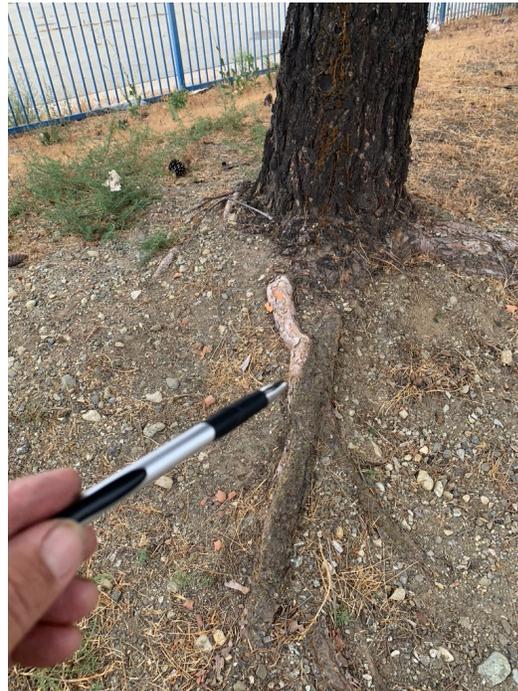
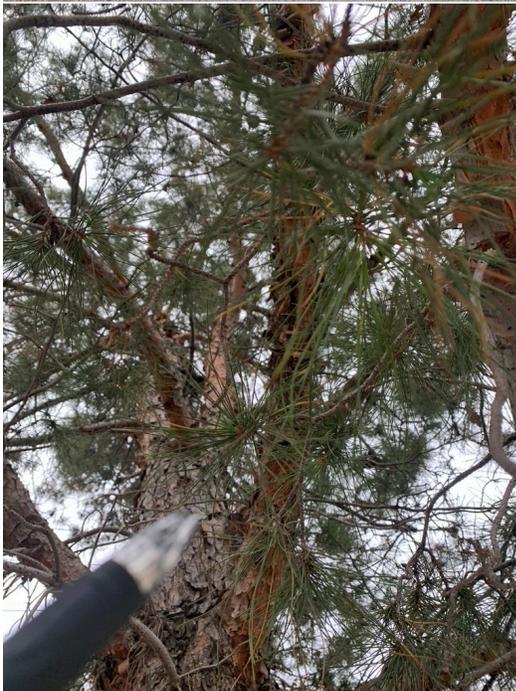
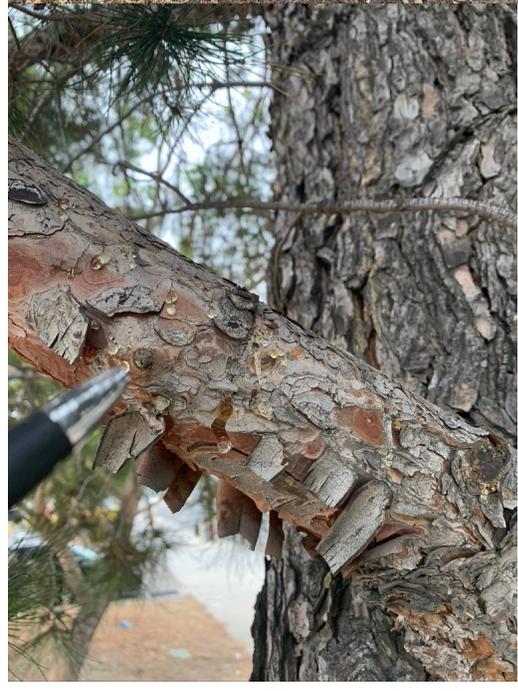
Tree 4 Mondell Pine

Stem girdling root, sidewalk conflict, poor branch structure (rating codes: cod Cr, Xing) water stress, sap dripping. Health D, structure D. Condition 60%

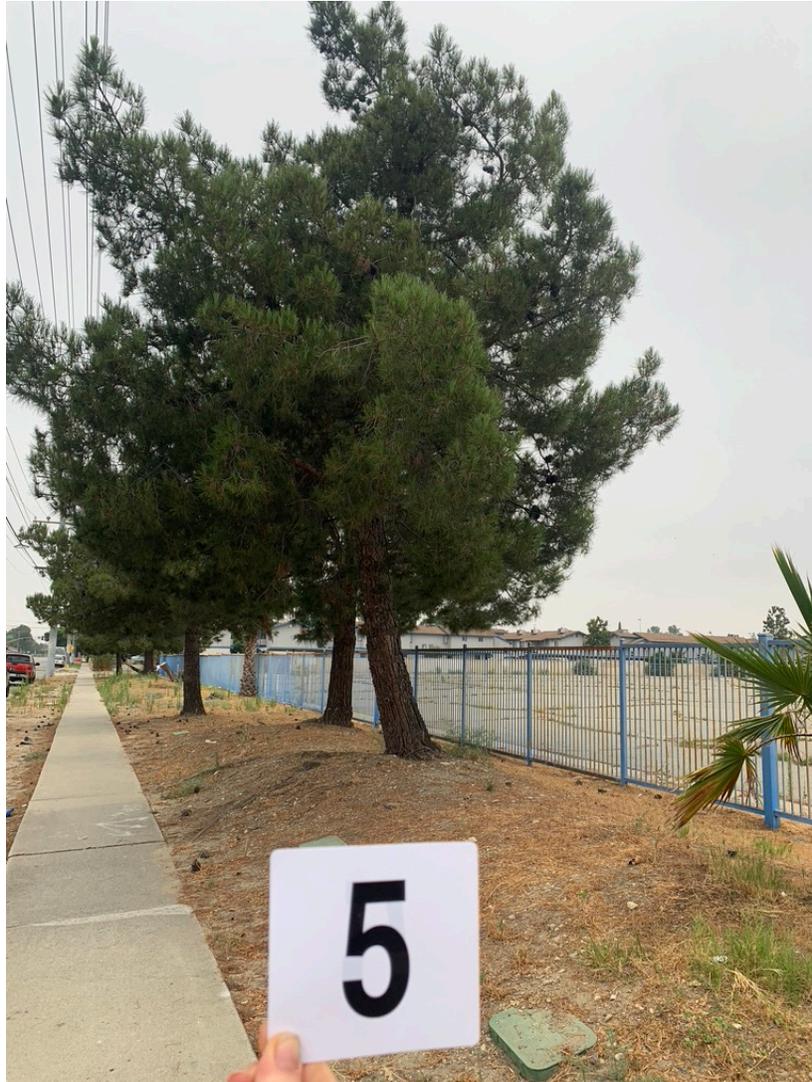
Tree 5 Mondell Pine

Multiple surface roots, **soil compaction**, water stress, dripping sap. Health C. Structure C. Condition 70%

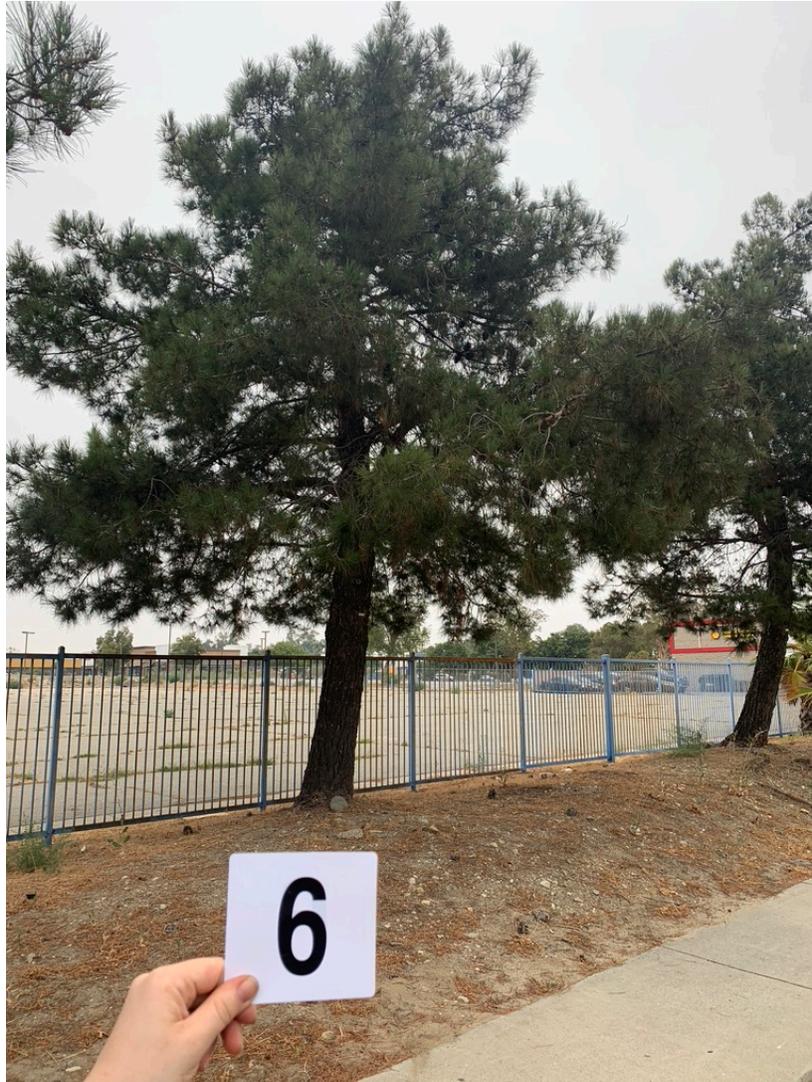
Tree 6 Mondell Pine

Water stress x 5 years, compacted soil, (Sh) sap dripping, wound closure slow. Surface roots and water meter conflict. Condition 70%

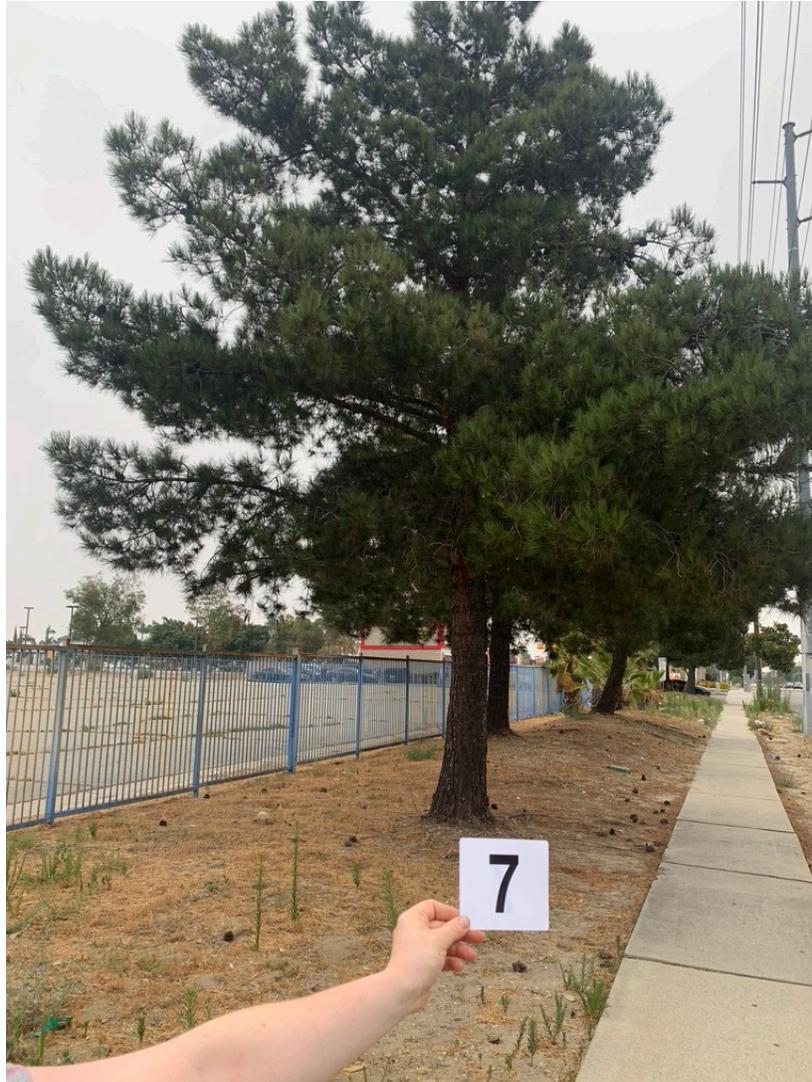
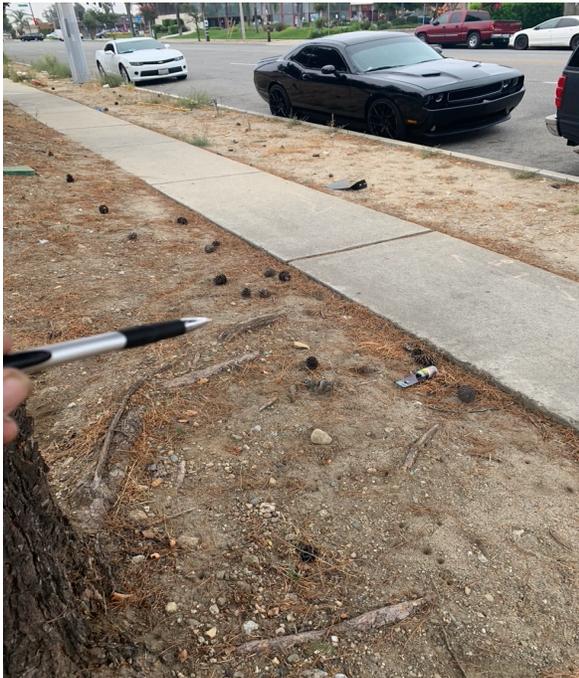
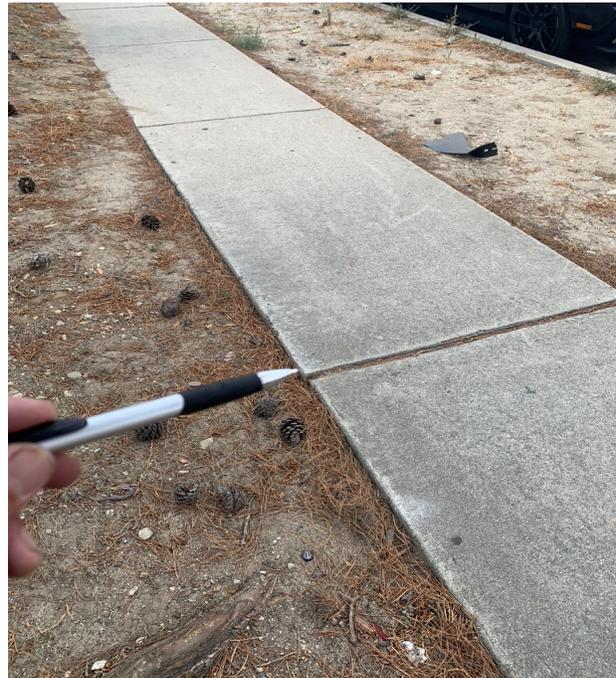
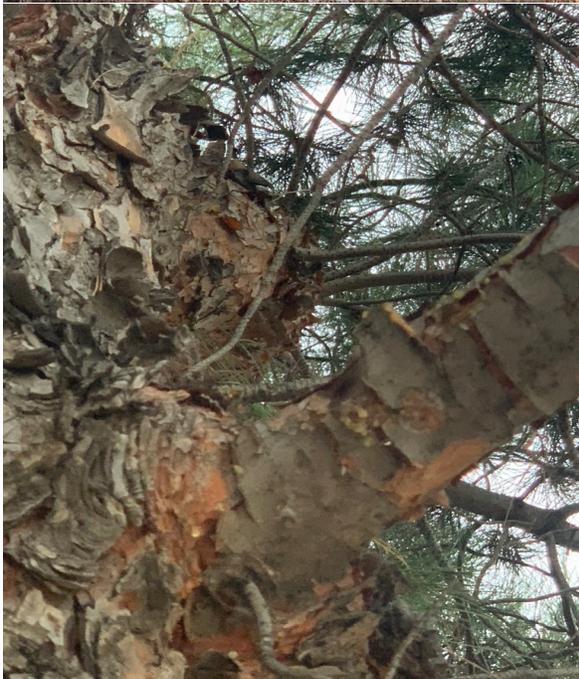
Tree 7 Mondell Pine

Surface roots, sidewalk conflict, sap dripping, water stressed. Form and structure fair, health poor. Condition 65%.

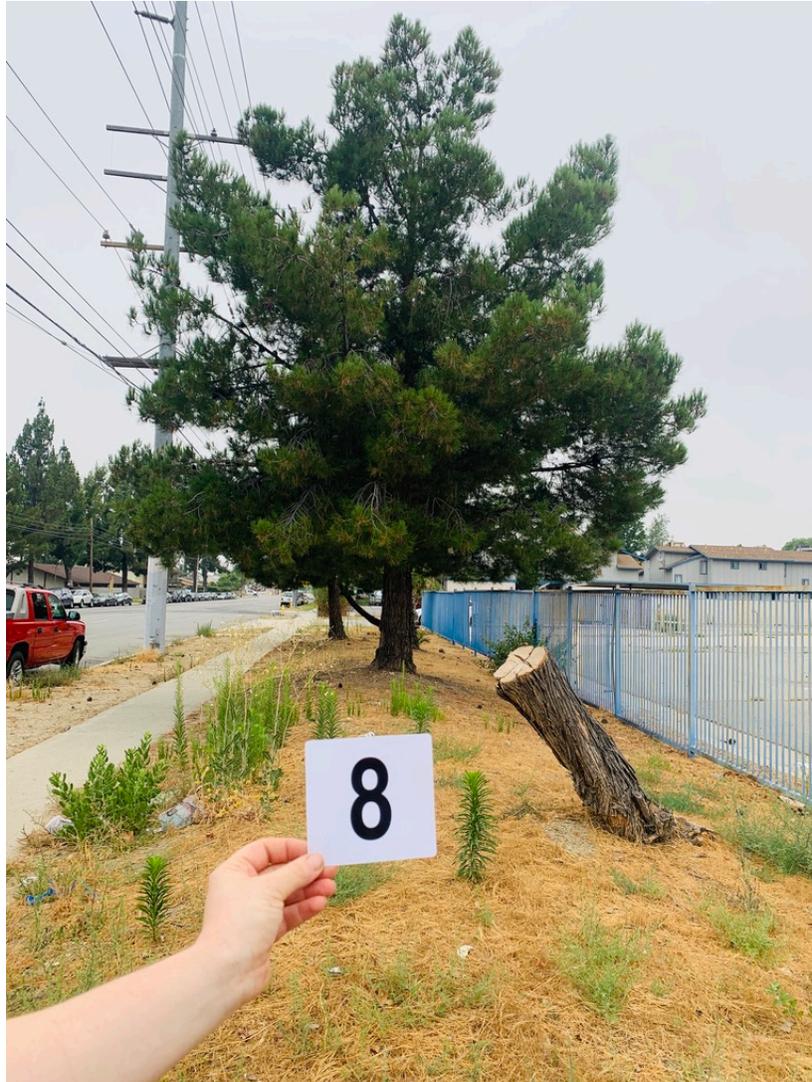
Tree 8 Mondell Pine

Stem girdling root, surface roots, compacted soil, sap dripping, water stress x 5 yrs.
Form fair, health poor. Condition 65%

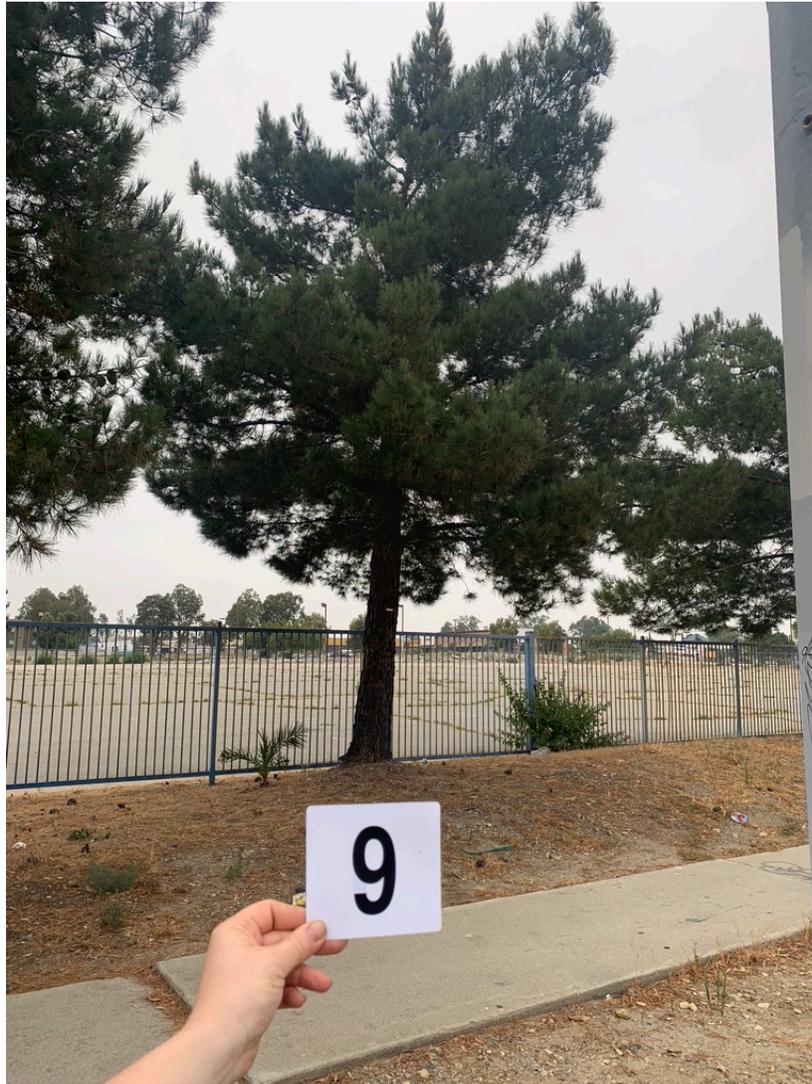
Tree 9 Mondell Pine

Surface roots, water stress x 5 years, low vigor, soil compacted.
Condition 70%

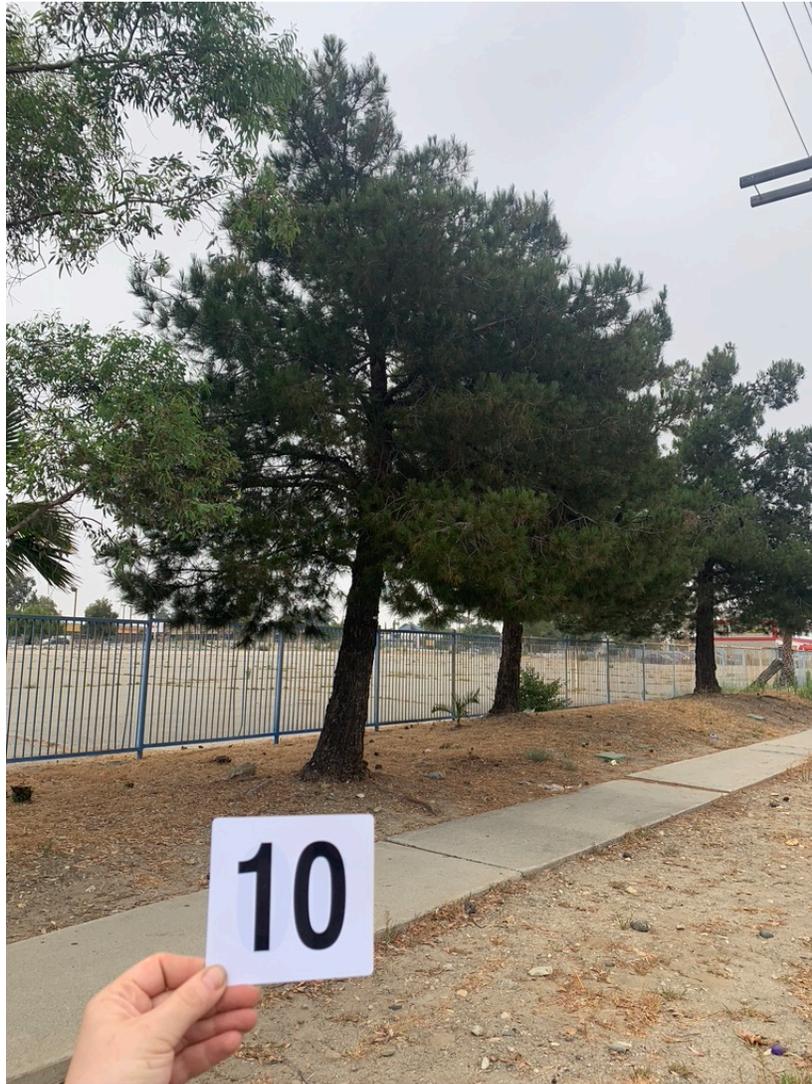
Tree 10 Mondell Pine

Surface roots, water stress x 5 years, low vigor, soil compacted. Stem girdling root formation. Form poor, structure fair, health poor. Condition 65%.

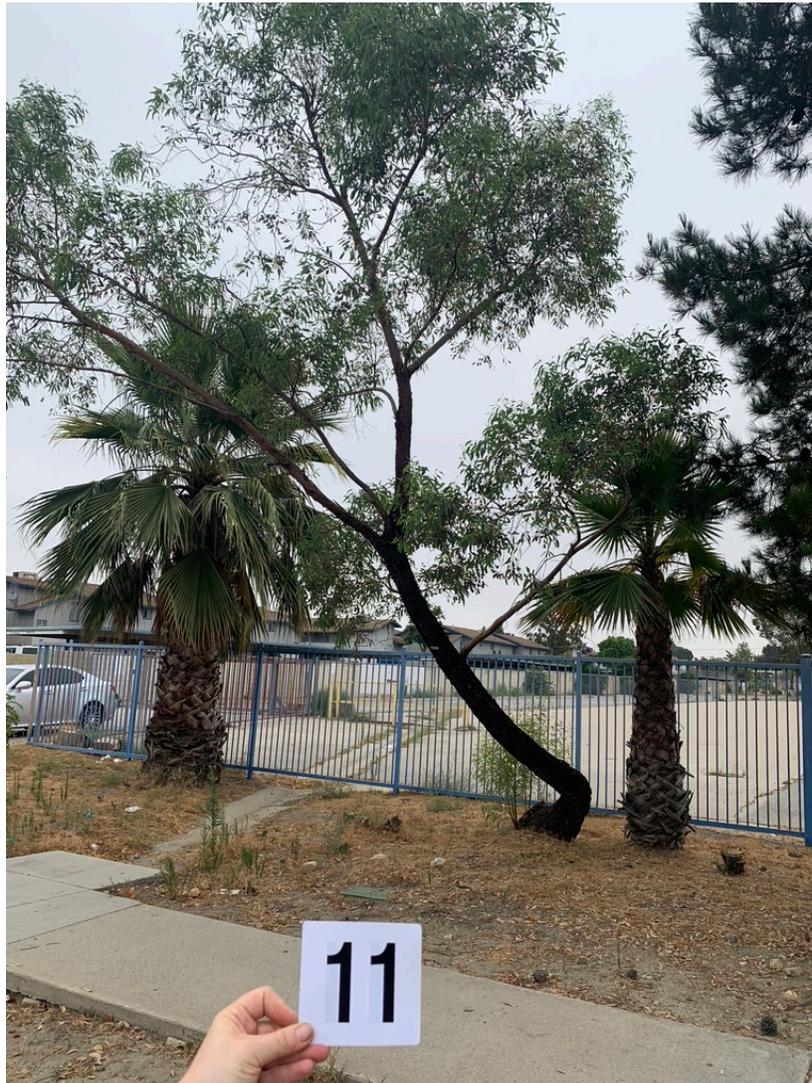
Tree 11 Red Iron Bark

Tortoise beetle, scaffold branch aspect ratio near 60% (weak attachment), water stress, chlorotic foliage, trunk lean (DI), epicormic shoots. Condition 60%

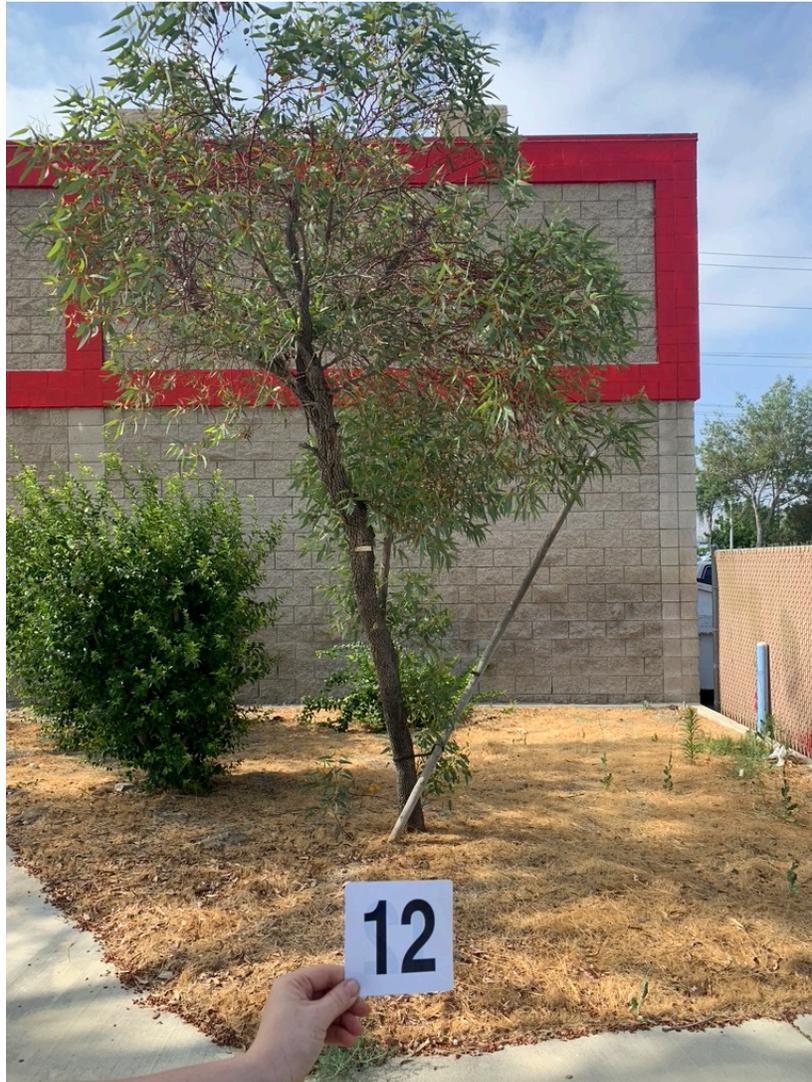
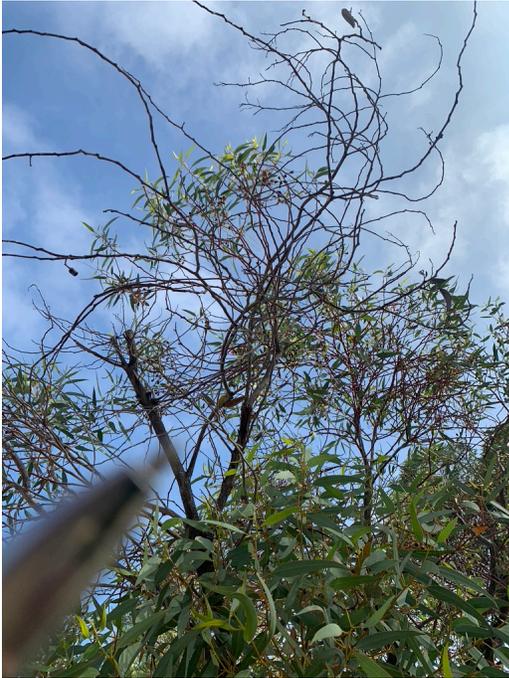
Tree 12 Nichol's Willowleaf Peppermint

Dieback in crown, sections of dead bark, trunk wound at buttress. Condition 55%

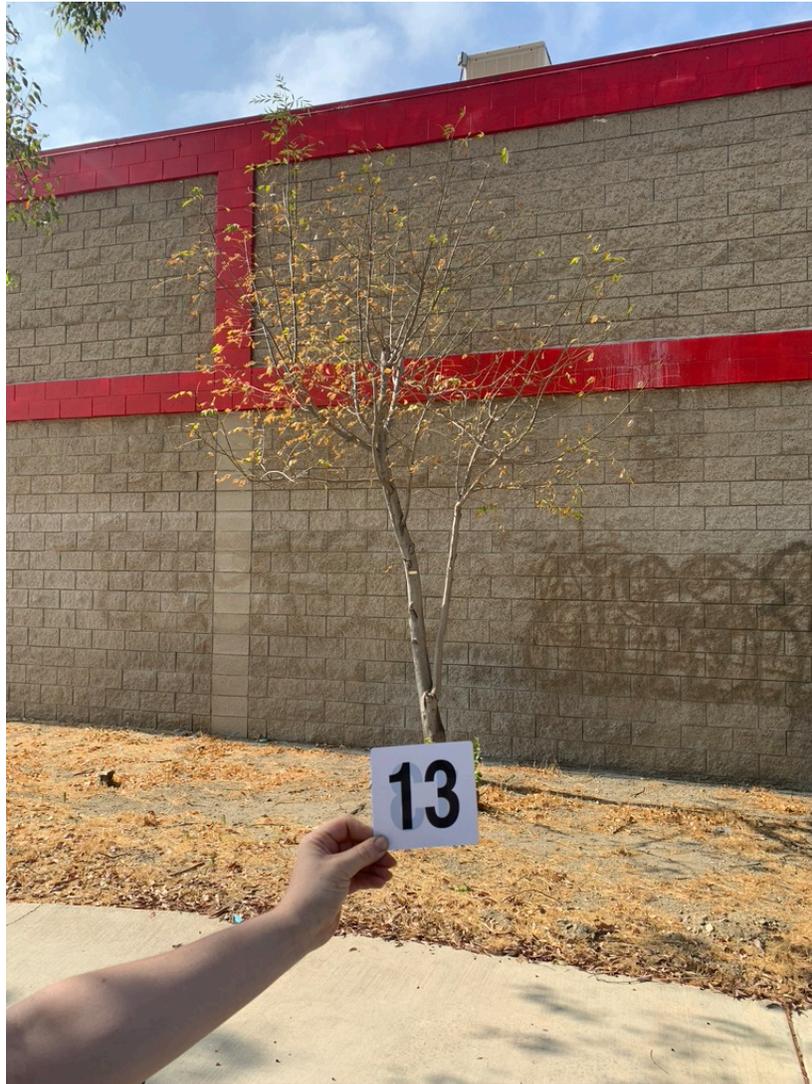
Tree 13 Evergreen Ash

Water stress and soil compaction leading to surface rooting. Upper crown showing leaf scorch, dieback and overall poor vigor. Rating code: Cod, Cl, Db. Condition 50%

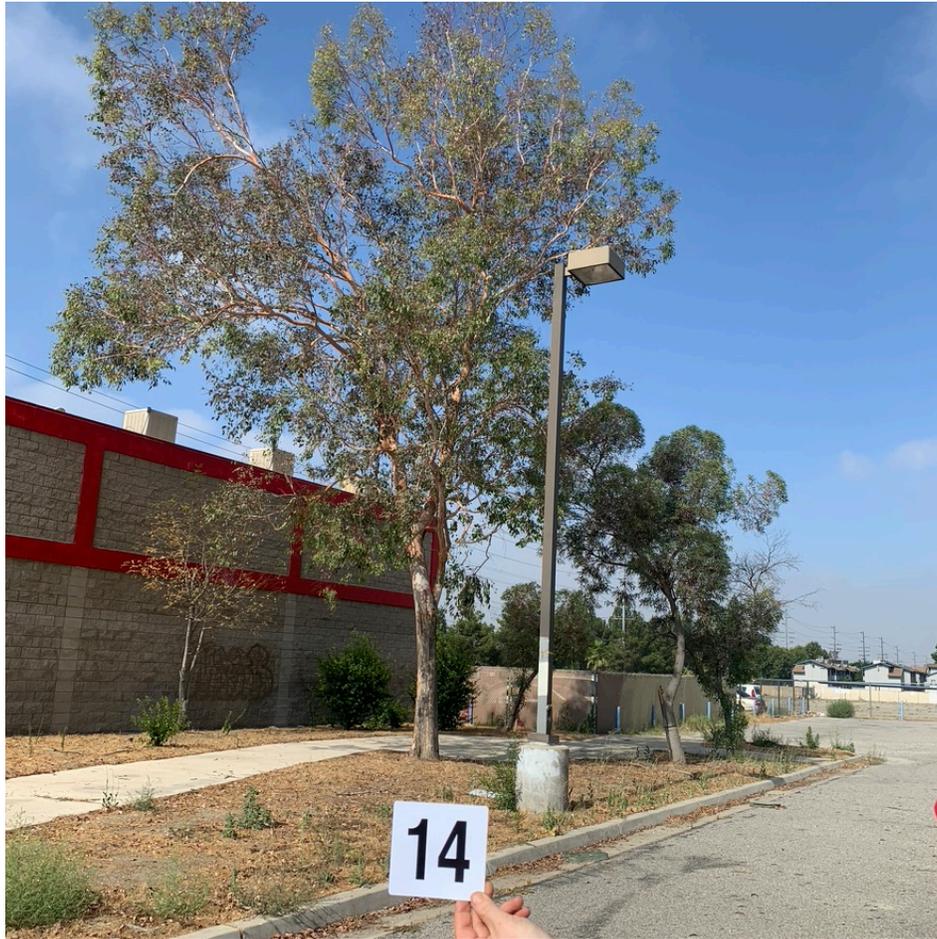
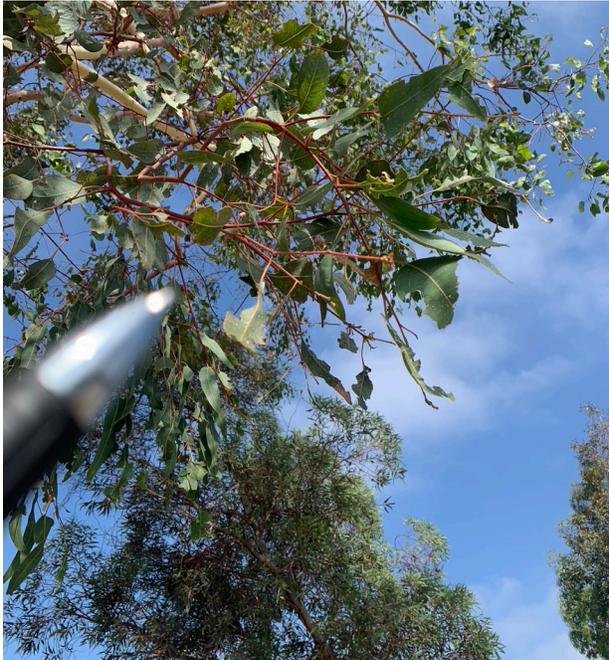
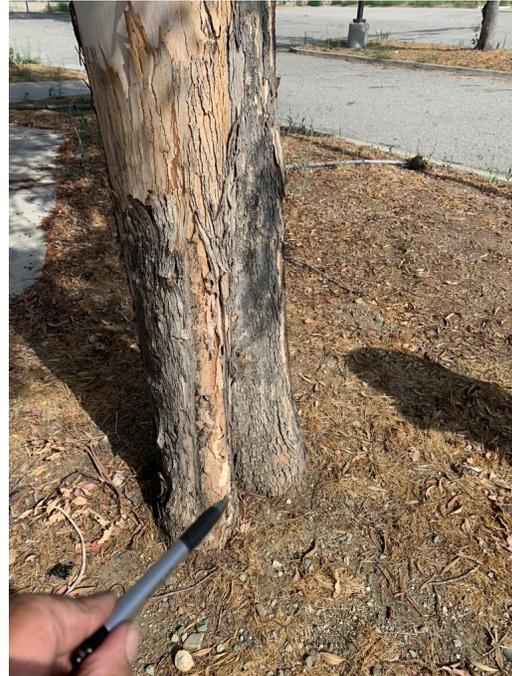
Tree14 Silver Dollar Gum

Lerp Psyllid, tortoise beetle, helical growth lower trunk abnormality (torsional loading and twisting). Multiple stems of the same diameter (codominant). Condition 65%

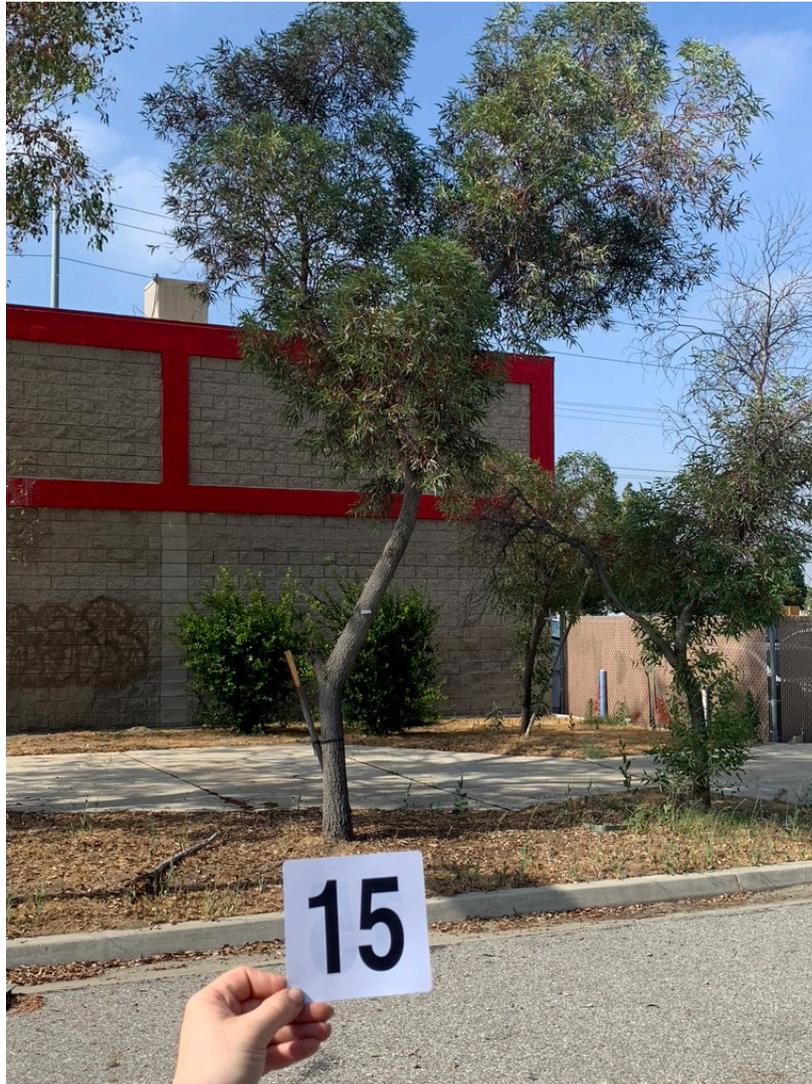
Tree 15 Nichol's Willowleaf Peppermint

Water stress x 5 years sections of dead bark, structural defects. Condition 60%.

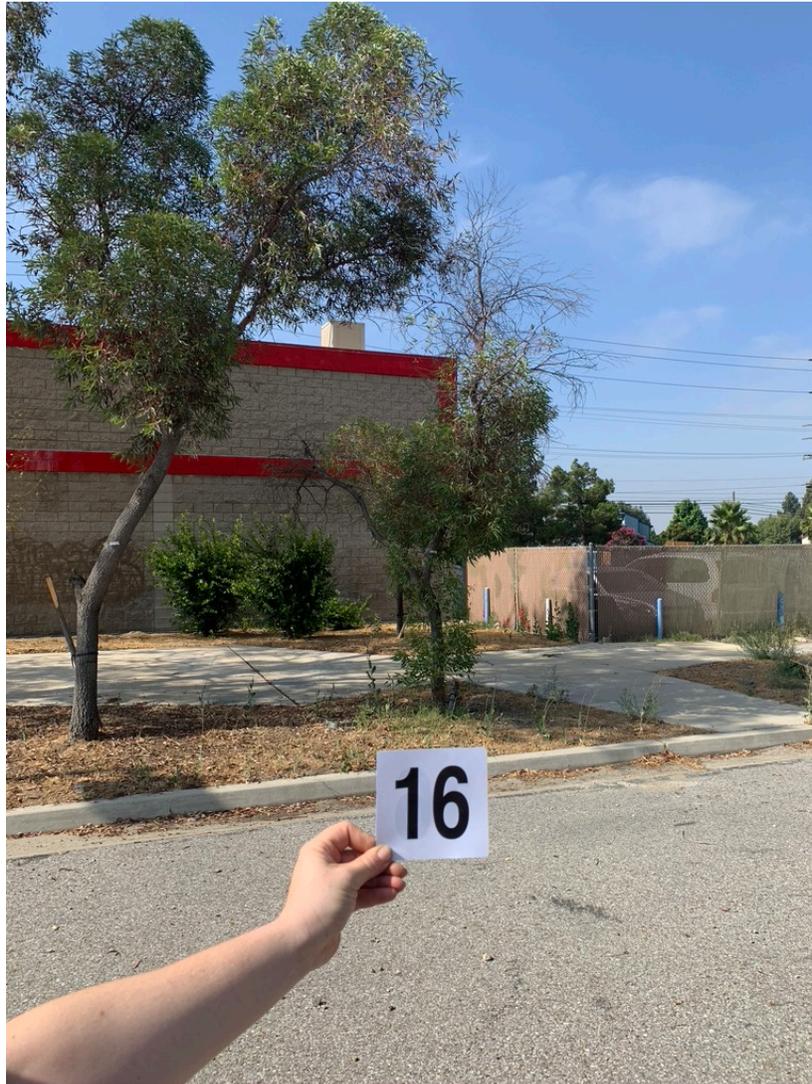
Tree 16 Nichol's Willowleaf Peppermint

Poor vigor, poor health. Condition 55%.

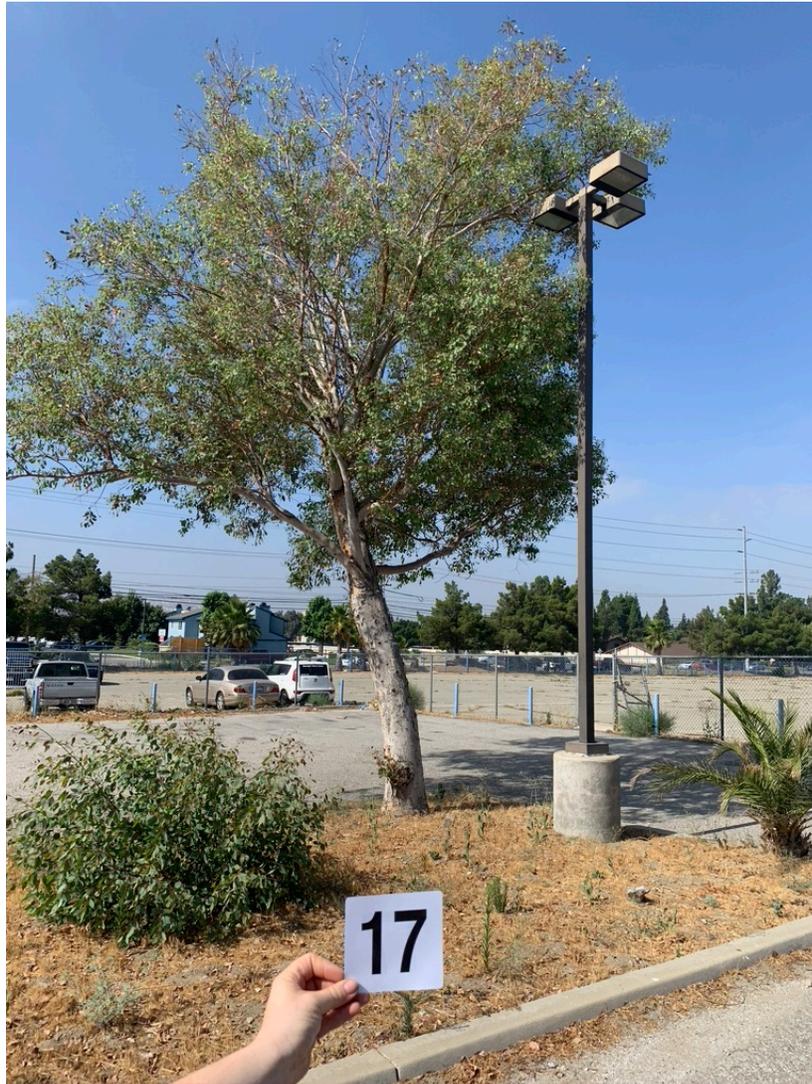
Tree 17 Silver Dollar Gum

Multiple leaders tightly spaced (poor structural development of branch structure, lerp psyllid, tortoise beetle, water stress. Condition 65%

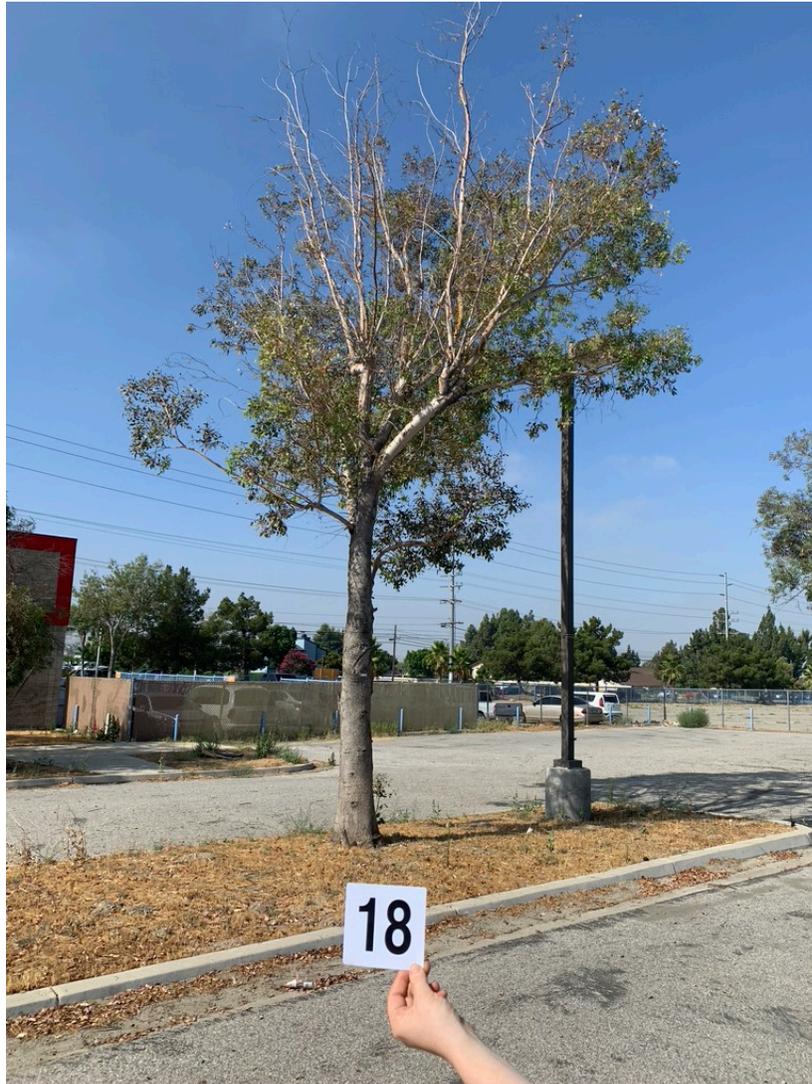
Tree 18 Silver Dollar Gum

Crown diebank, kinked root, tortoise beetle. Condition 60%

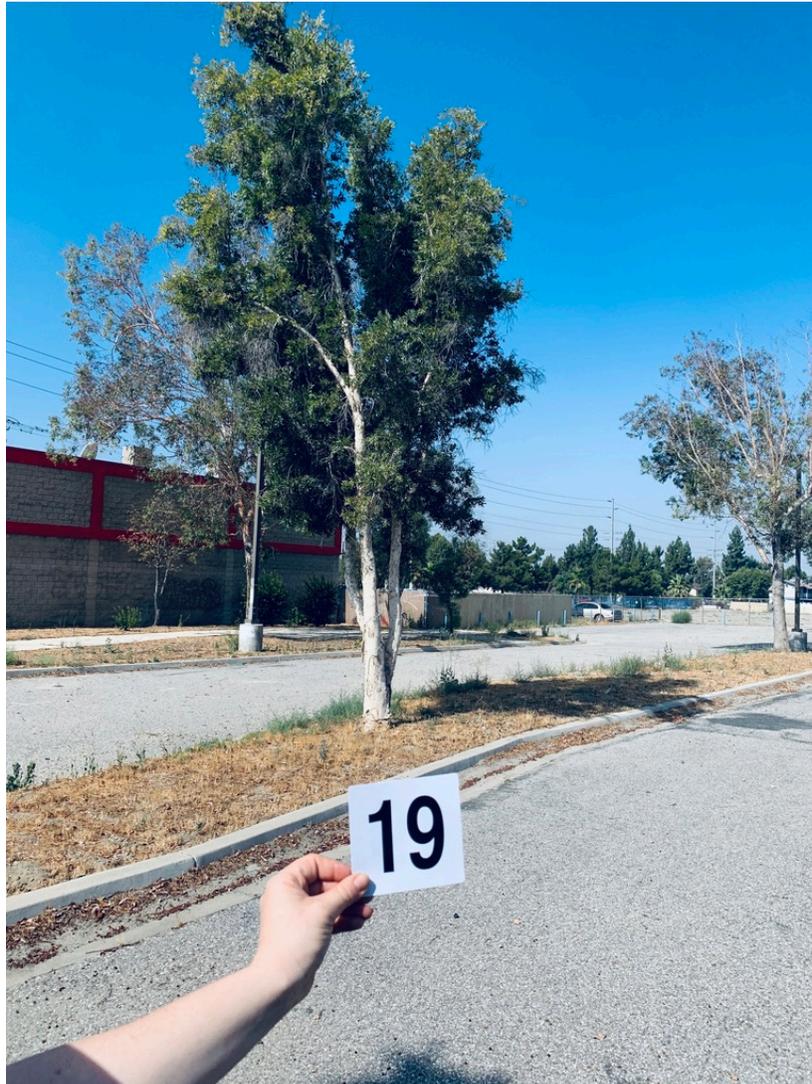
TREE 19 Flaxleaf Paperbark

Surface roots, water stress, branch aspect ratio 1:1. Codominant stems bark inclusion (defective structure. Condition 65%.
