APPENDIX H
ARBORIST STUDY

Mark Porter, California Arbor Care

**Inventory and Tree Condition Report Sierra Gate Center as per
Fontana Tree Preservation Ord 1126, § 1, 8-16-94**

Northgate Market Project Fontana, CA

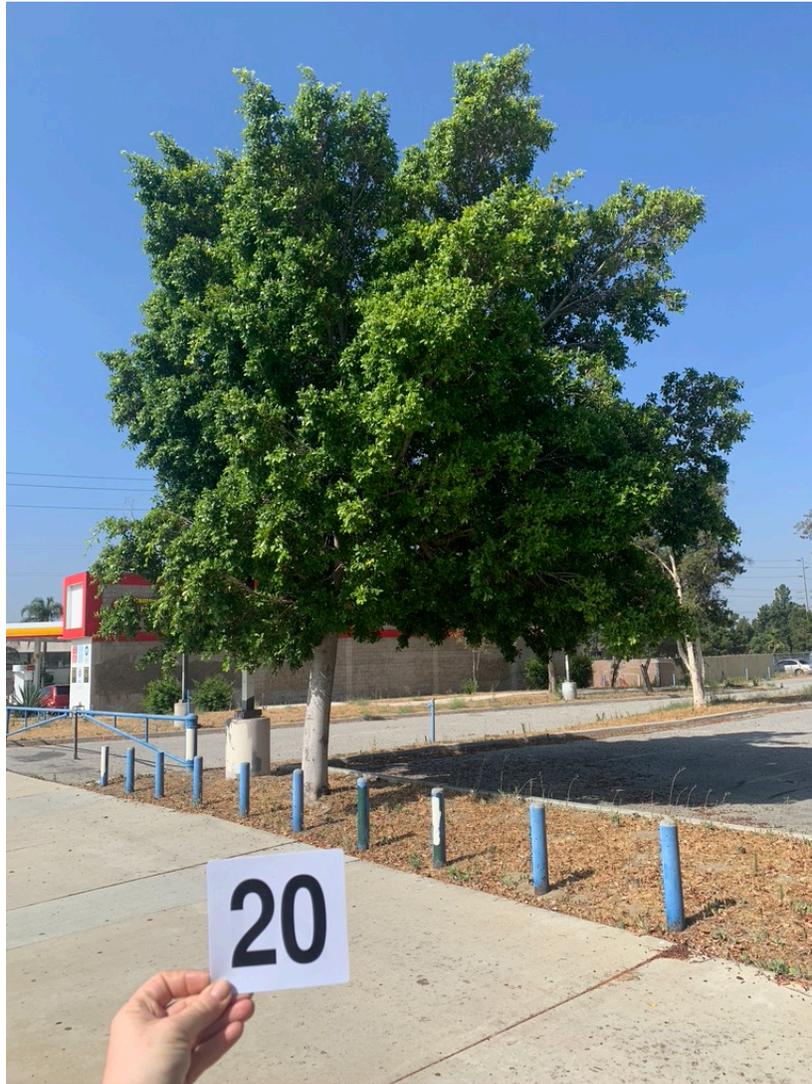
Tree 20 Indian Laurel Fig

Surface roots, Sidewalk displacement, multiple branches growing from same point (aspect ratio 1:1 = weak structure). Foliage Healthy Structure problems correctable. Condition 70%

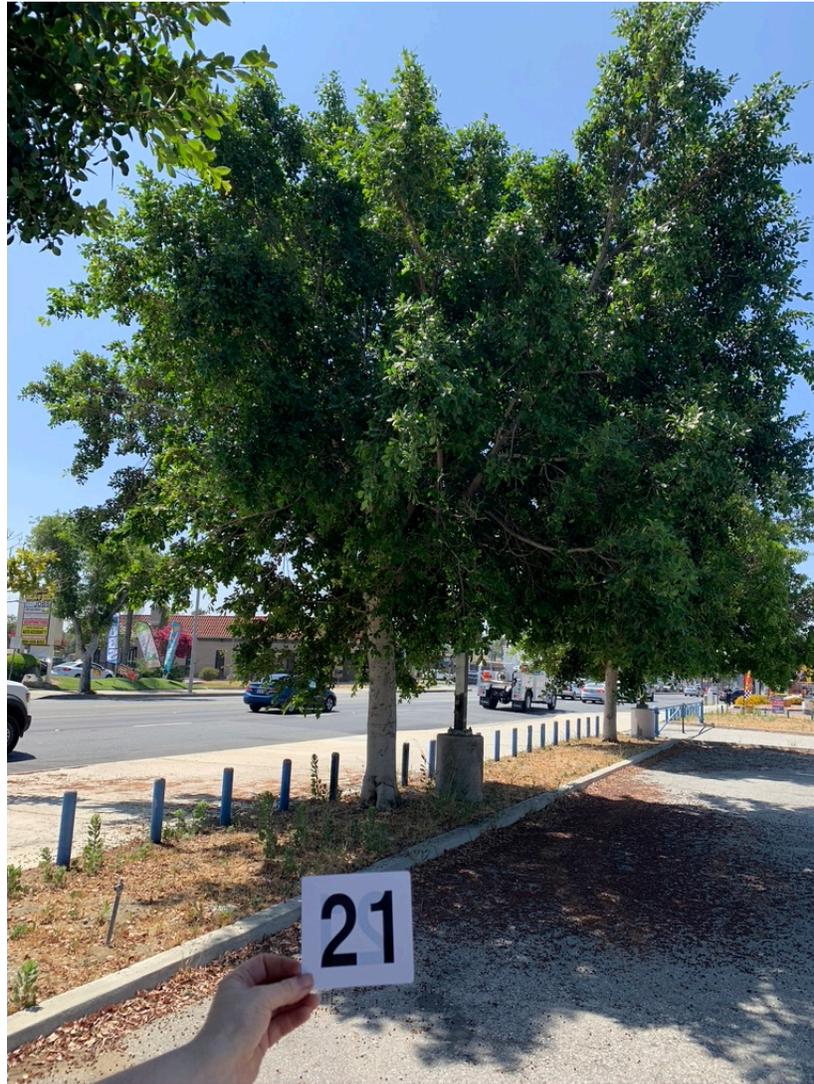
Tree 21 Indian Laurel Fig

Surface roots may invite sidewalk displacement. Water stress. Multiple scaffold branches growing from one spot. Defective branch structure (branch aspect ratio 1:1), Infrastructure damage expected soon (sidewalk displacement). Leaf health good Structural issues and root issues. Kinked root. Condition 65%.

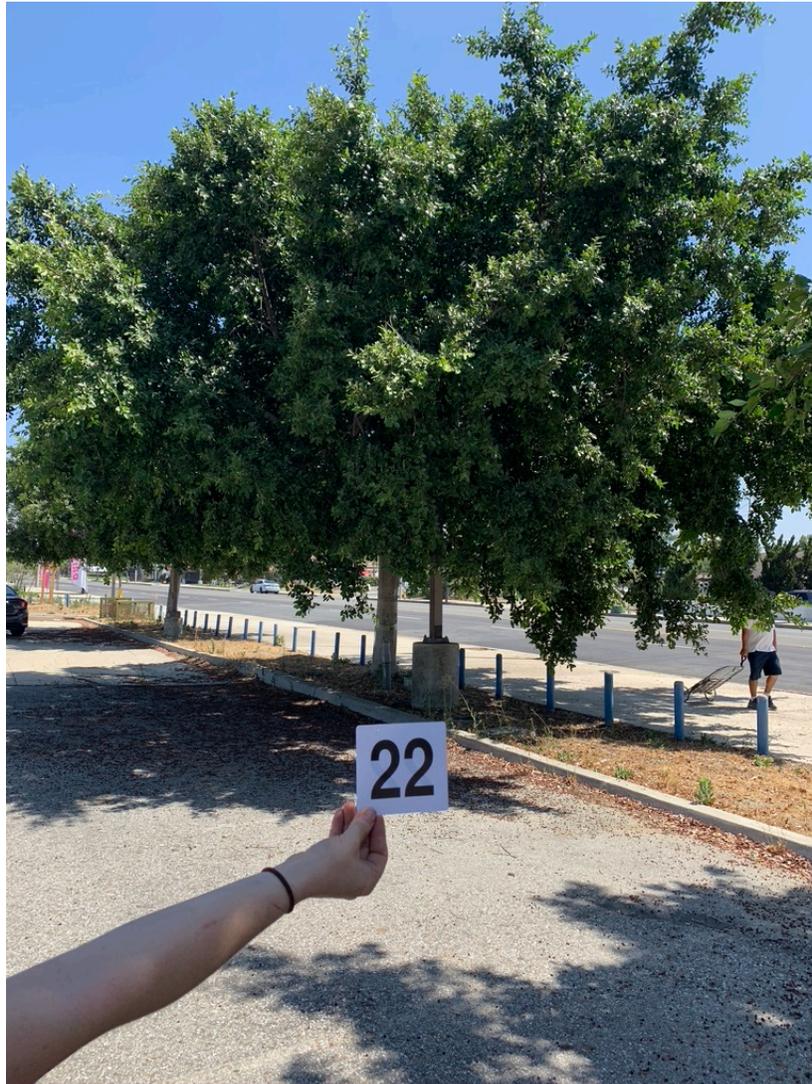
Tree 22 Indian Laurel Fig

Aggressive surface roots, probable sidewalk conflicts, multiple codominant stems arising at one point, scaffold branch aspect ratio 1:1 (weak connections).). Leaf health good Structural issues and root issues. Condition 65%.

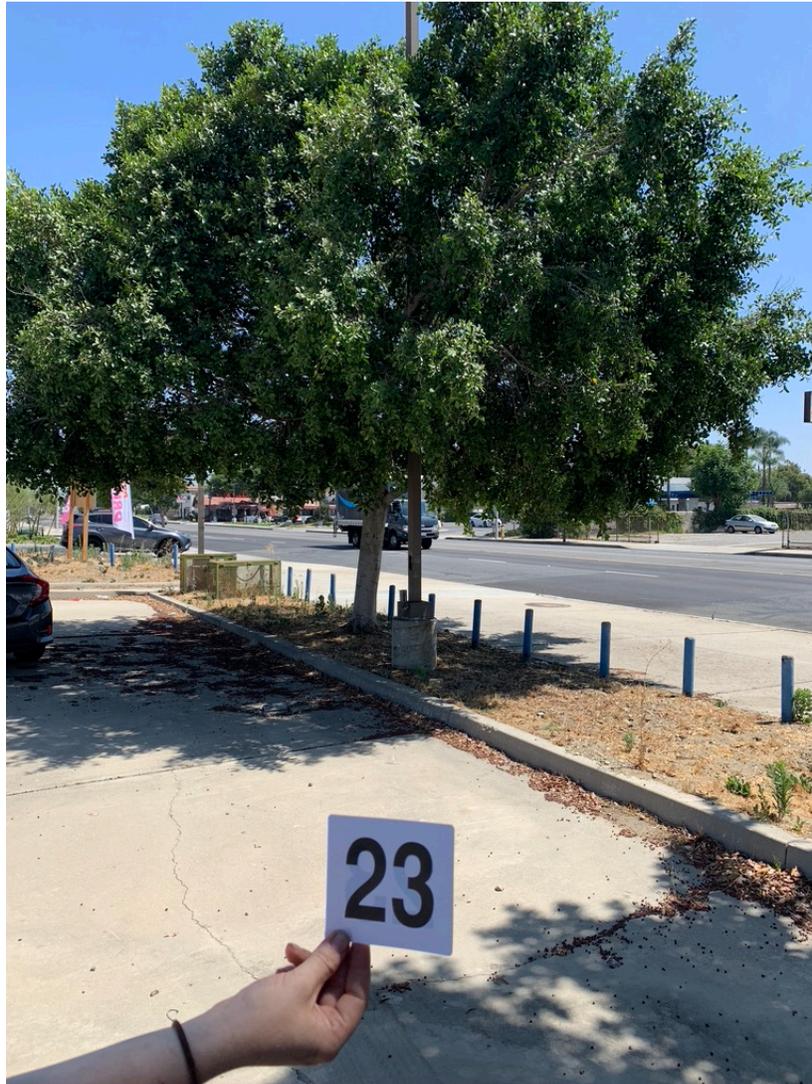
Tree 23 Indian Laurel Fig

Structural defects, multiple codominant stems, bark inclusion, scaffold branch aspect ratio 1:1 (weak connections). Leaf health good Structural problem (defective) with bark inclusion. Condition 65%.

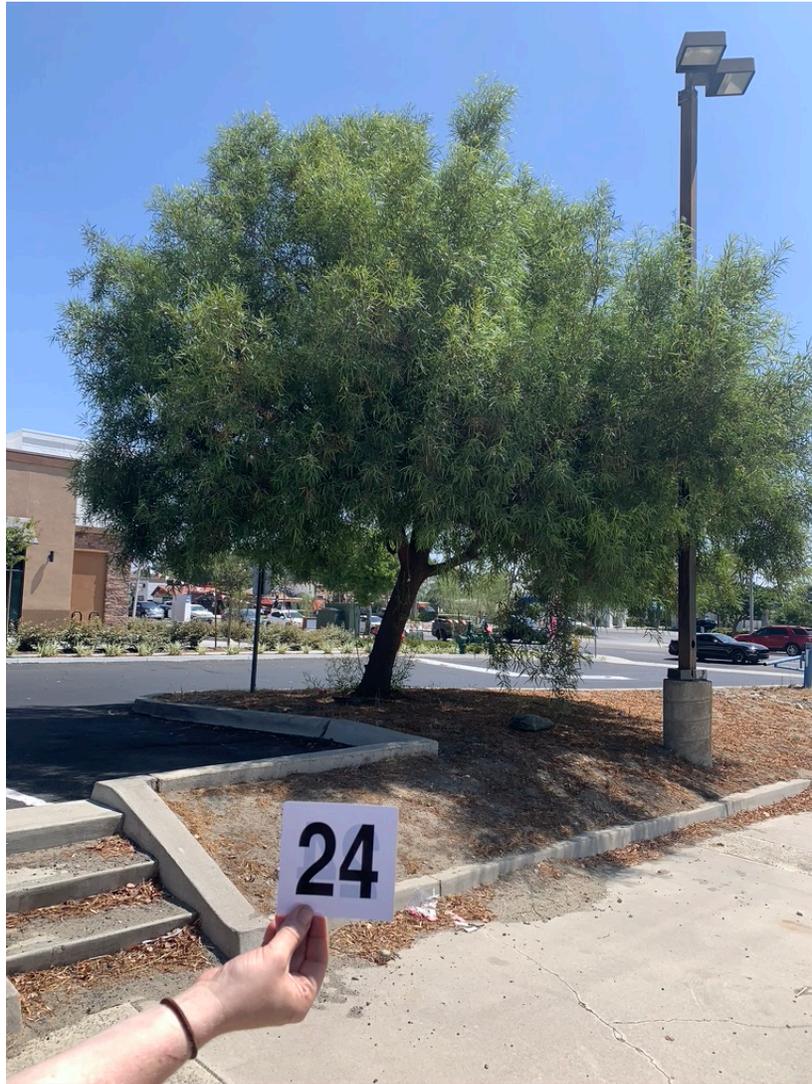
Tree 24 Australian Willow

Poor branch structure development, root damage potential low, drought tolerant. Tolerates moist to wet soil Resistant to Armillaria. Good species for area. Branch strength rated as moderate (UFEI). Condition 70%,

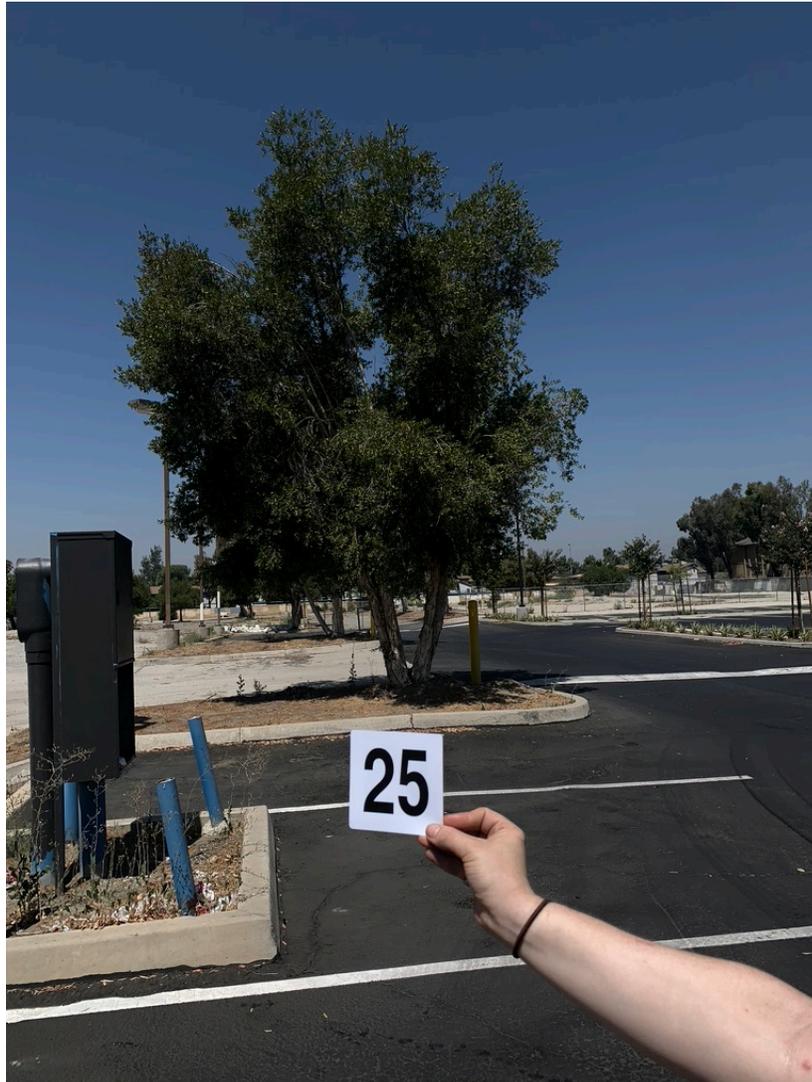
Tree 25 Flaxleaf Paperbark

Structurally defective (*codominant stem with included bark). Improper topping. Structure is substandard. Condition 65%

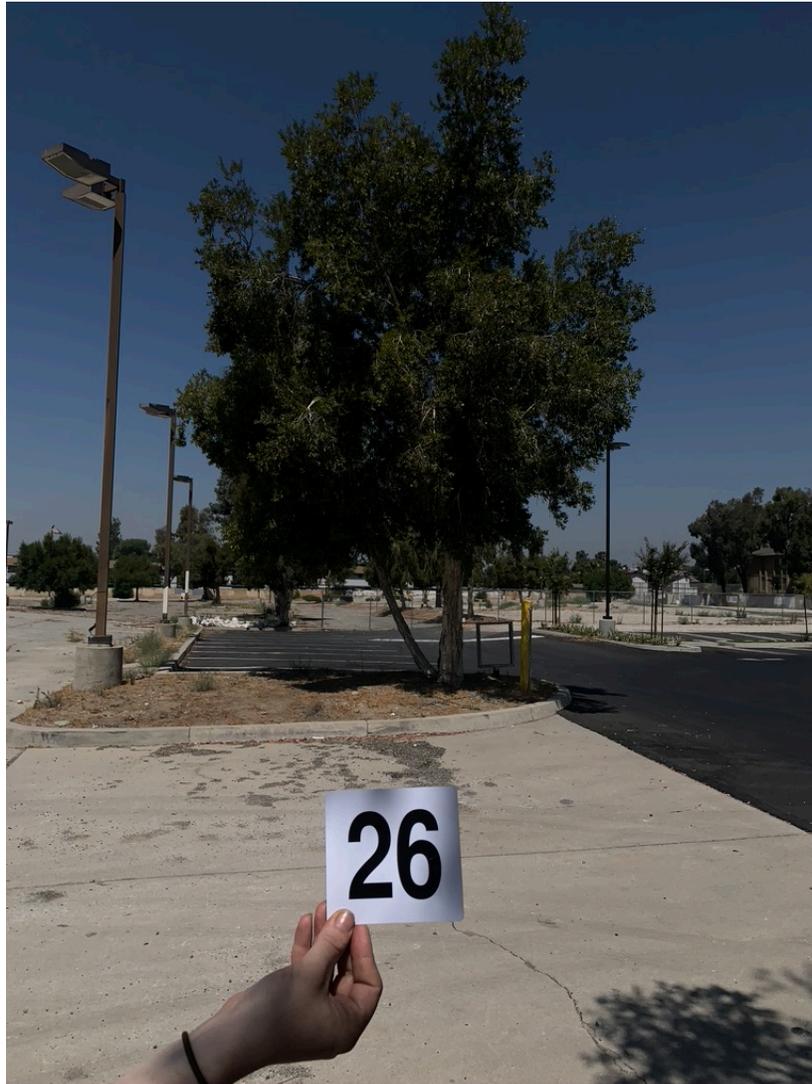
Tree 26 Flaxleaf Paperbark

Structurally defective (*codominant stem with included bark). Improper topping. Structure is substandard. Condition 65%

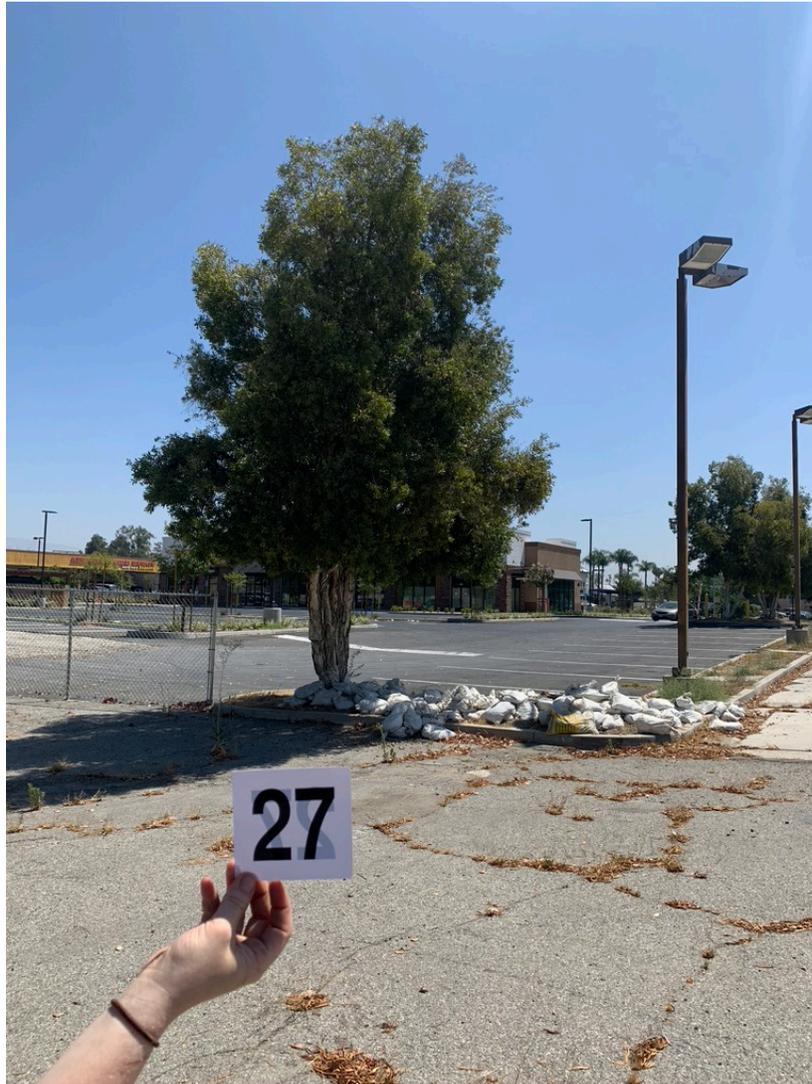
Tree 27 Flaxleaf Paperbark

Structurally defective (*codominant stem with included bark). Aesthetically pleasing, yet the structure is substandard. Branch strength rated as medium; root damage potential rated as low; drought tolerate). Soil conditions poor. Condition 65%.

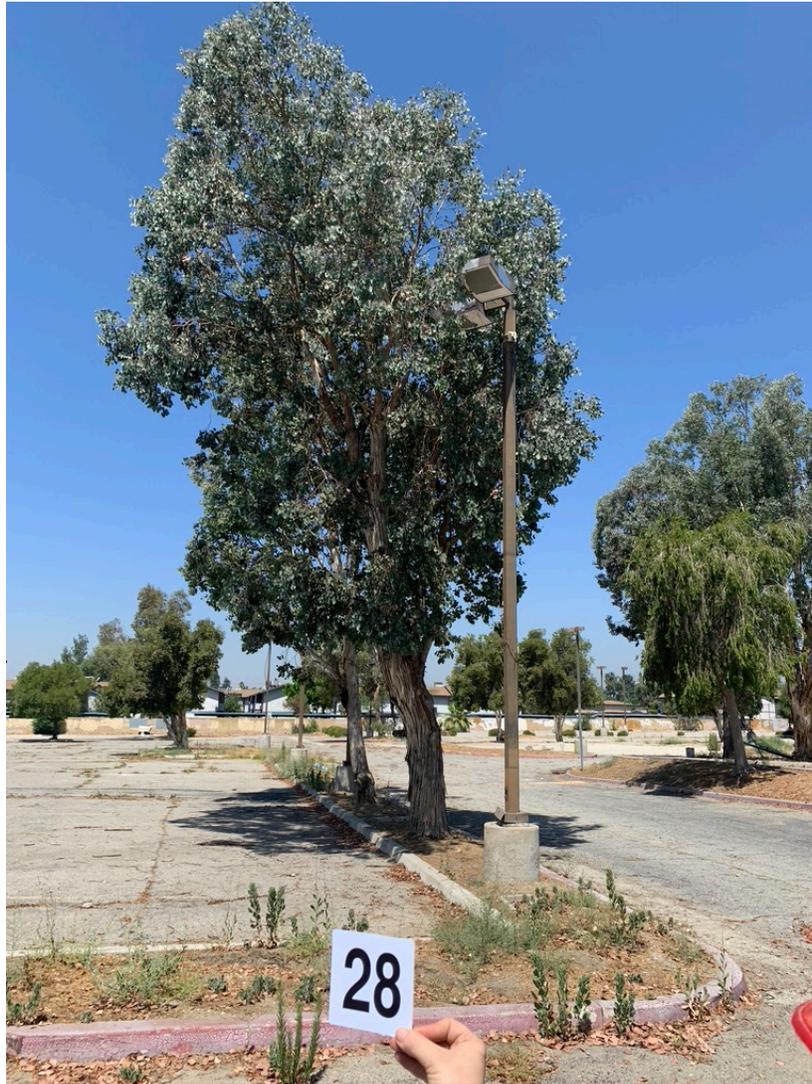
Tree 28 Silver Dollar Gum

Curb damage, restricted soil volume, vertical trunk wound on the west side of trunk, tree has been improperly topped. Condition 65%.

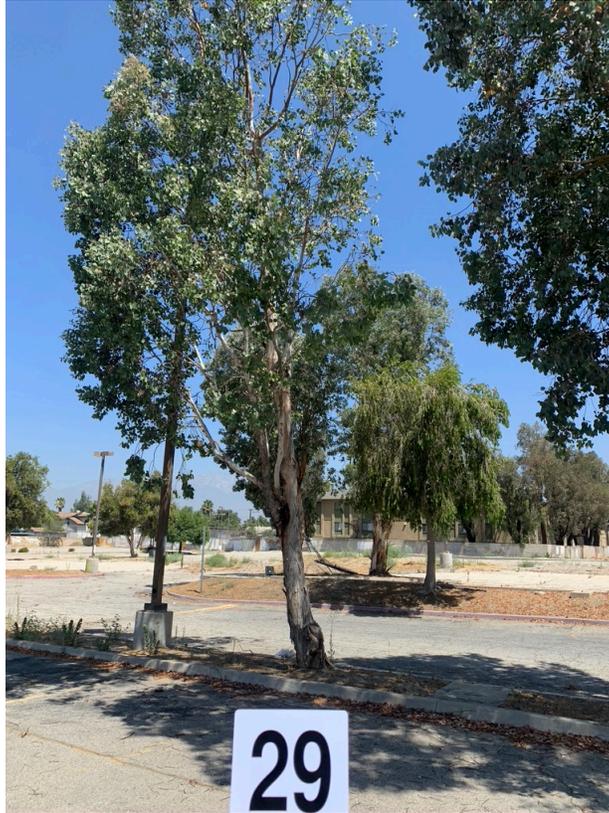
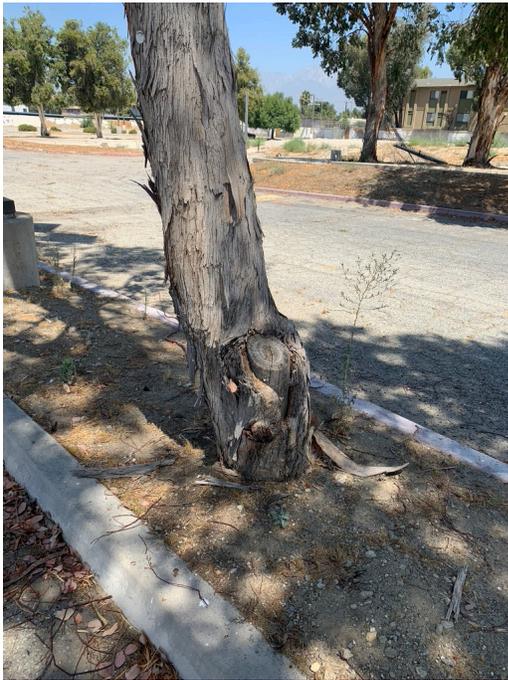
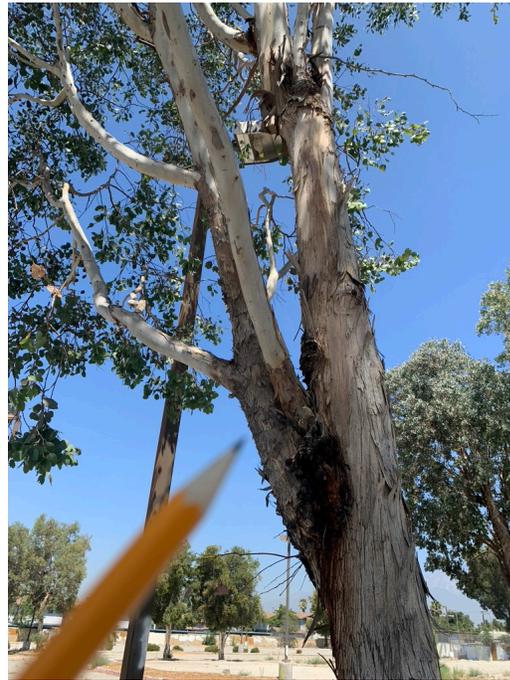
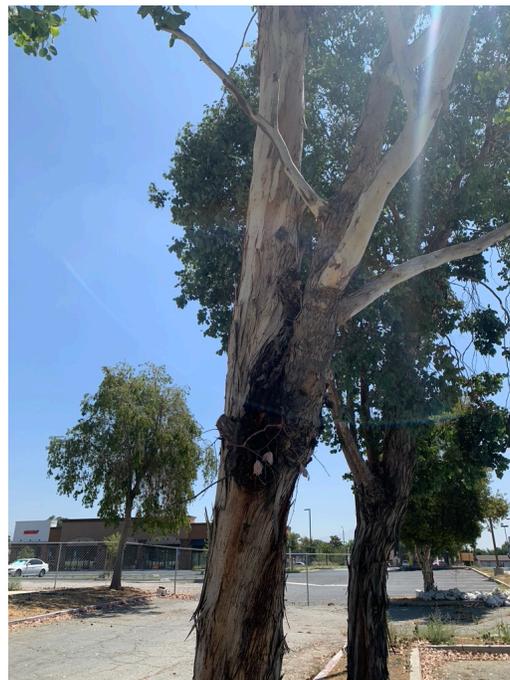
Tree 29 Silver Dollar Gum

Trunk wound to lower trunk, poor branch connections, codominant branch over hangs parking area. Structure defective. Condition 60%.

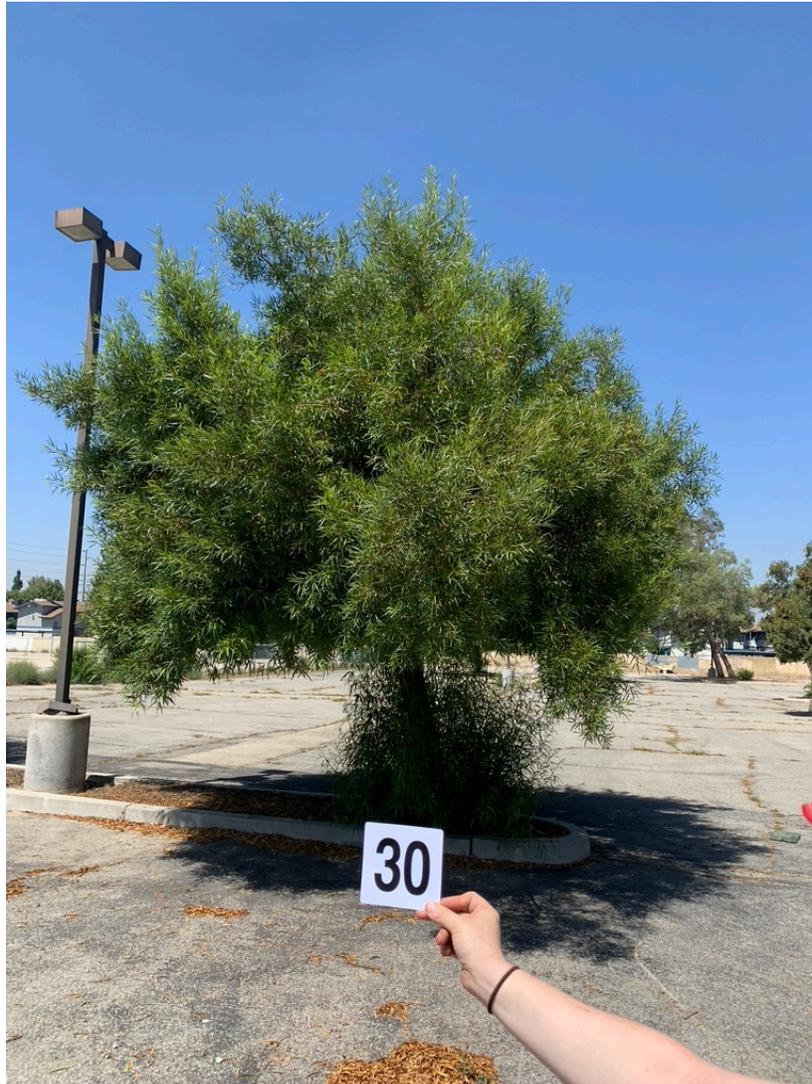
Tree 30
Australian Willow

Poor branch structure development, root damage potential low, drought tolerant. Tolerates moist to wet soil. Resistant to Armillaria. Good species for area. Branch strength rated as moderate (UFEI). Condition 65%,

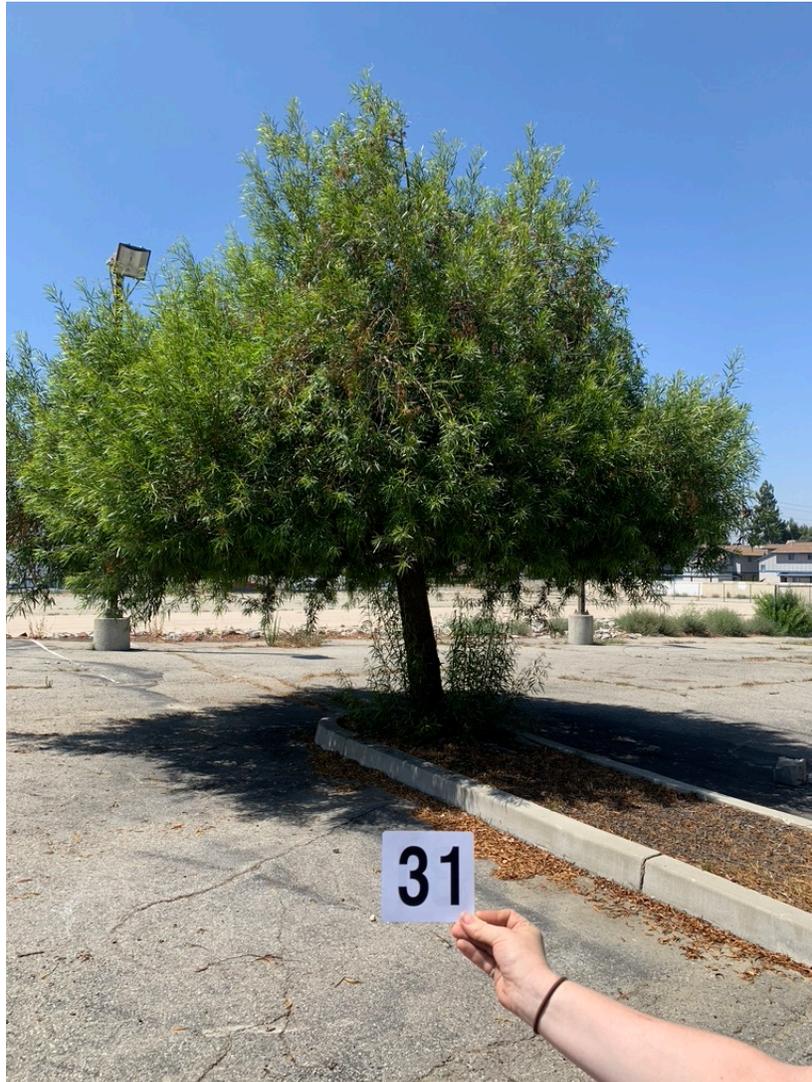
Tree 31 Australian Willow

Poor branch structure development, root damage potential low, drought tolerant. Tolerates moist to wet soil. Resistant to Armillaria. Good species for area. Branch strength rated as moderate (UFEI). Condition 65%.

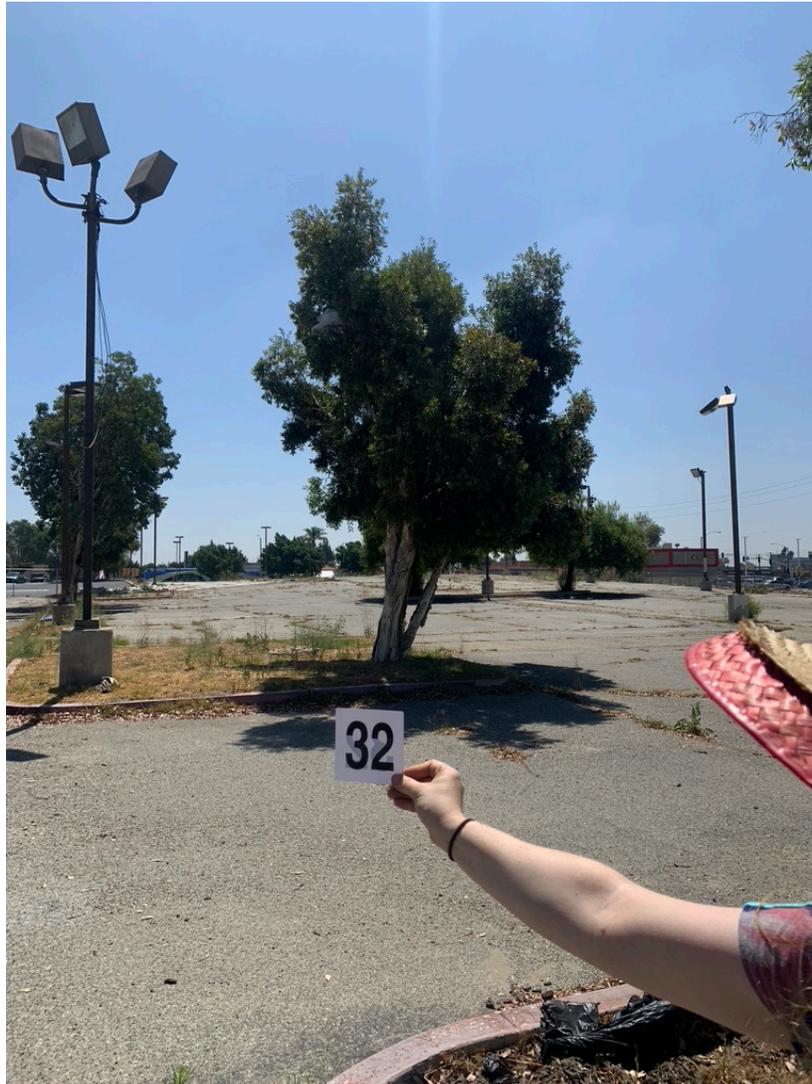
Tree 32 Flaxleaf Paperbark

**Poor form, codominant stems (weak connection). Structurally defective.
Condition 65%**

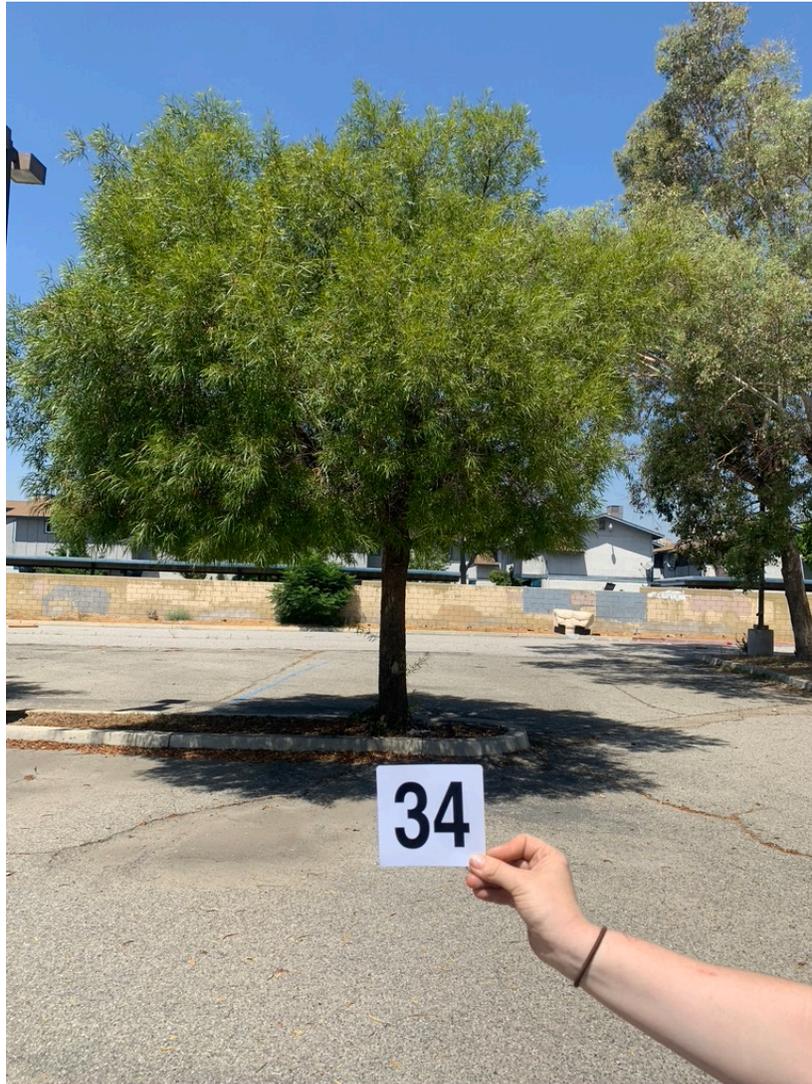
Tree 34 Australian Willow

Crowded branch structure, root damage potential low, drought tolerant. Tolerates moist to wet soil. Resistant to Armillaria. Good species for area. Branch strength rated as moderate (UFEI). Condition 70%.

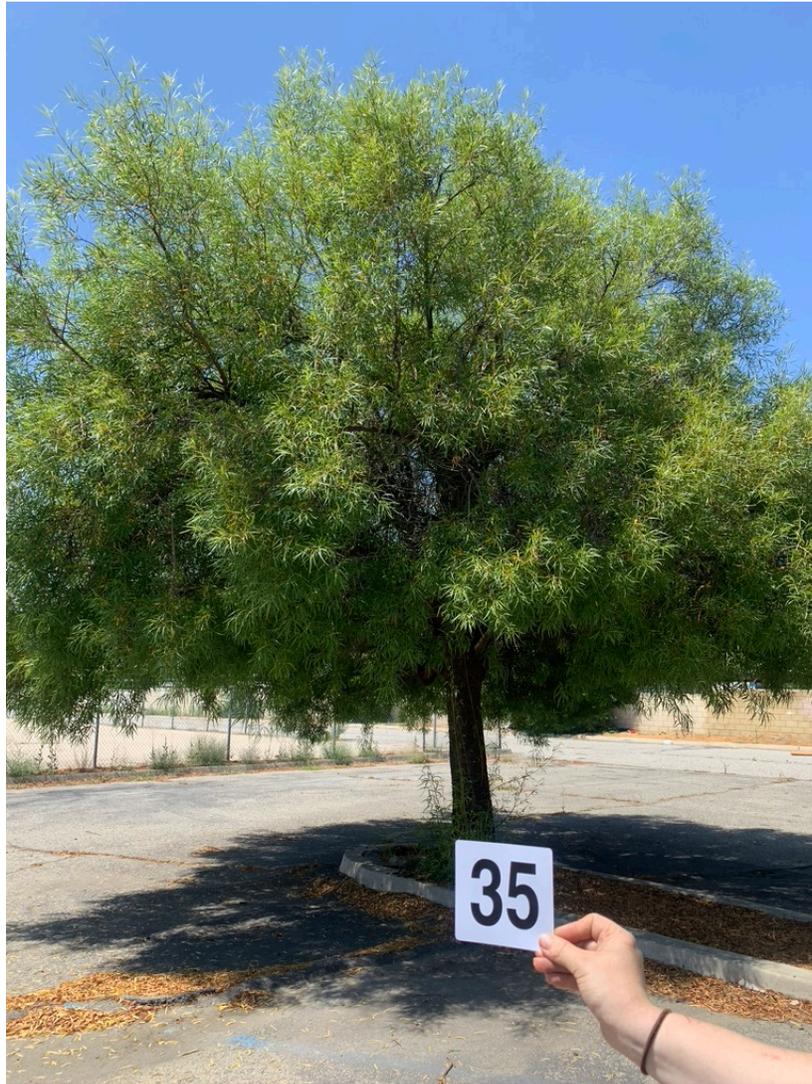
Tree 35 Australian Willow

Substandard structural development (scaffold branches crowded with poor connection). Restricted soil volume, curb damage. Good species for area, aesthetically OK, but poor-quality tree due to misunderstanding of proper structural development (those responsible for maintenance lack proper training and skills to manage trees correctly). Condition 60%

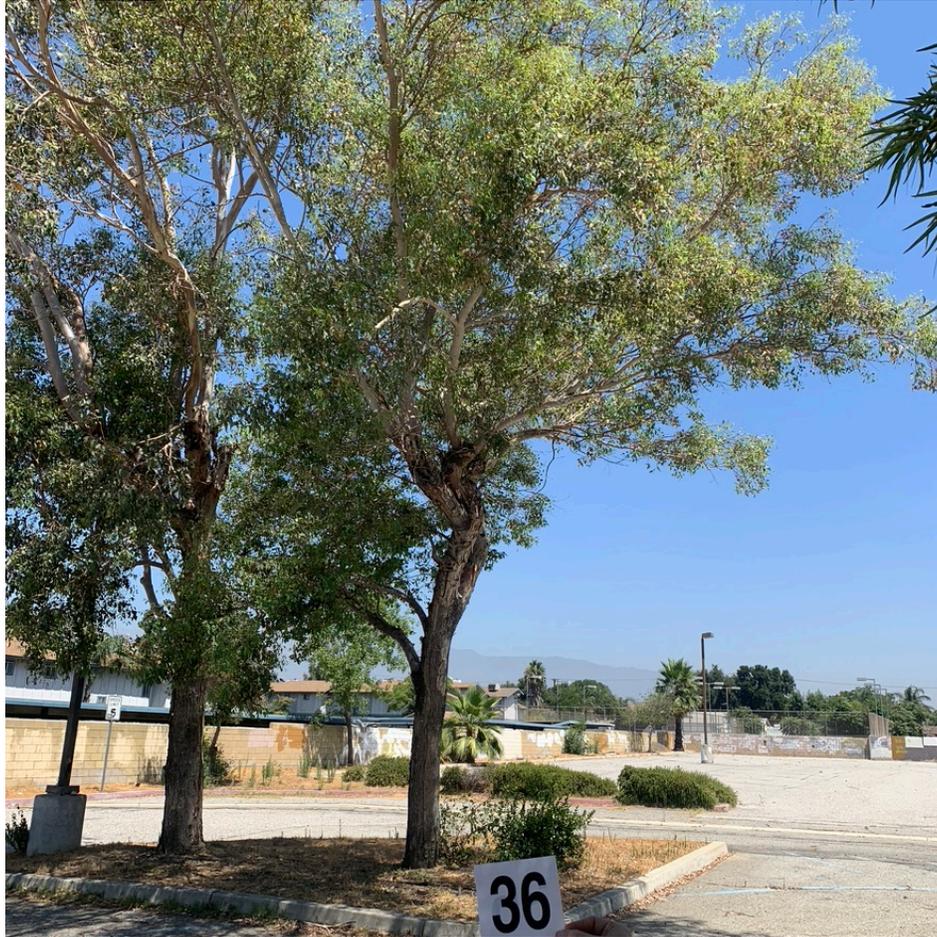
Tree 36 Silver Dollar Gum

Lerp psyllid, tortoise beetle (pests), improper topping (as seen at the transition of rough bark and smooth bark. Epicormic shoots from improper topping are weakly attached and pose a threat of failure to targets (pedestrians and vehicles). Condition 55%.

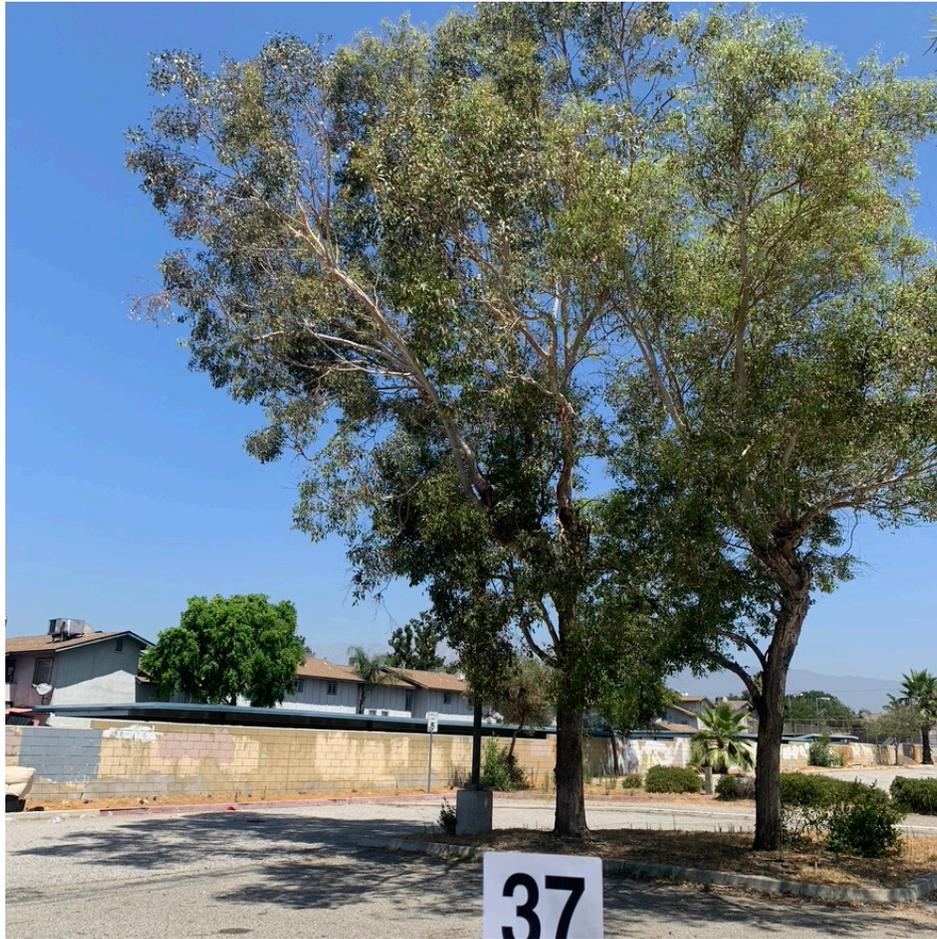
Tree 37 Silver Dollar Gum

Improper topping, tortoise beetle, lerp psyllid, trunk crack. Condition 50%

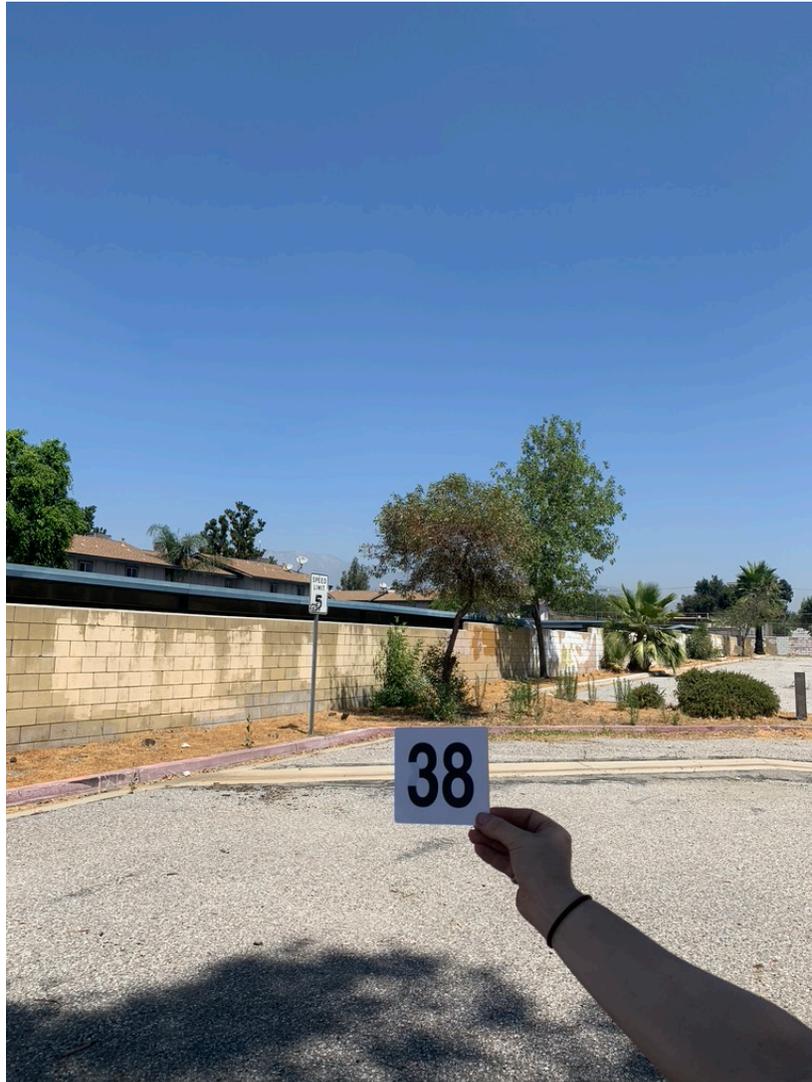
Tree 38 Nichol's Willowleaf Peppermint

Lack of woundwood formation, decay, epicormic growth at base of tree. Condition 65%.

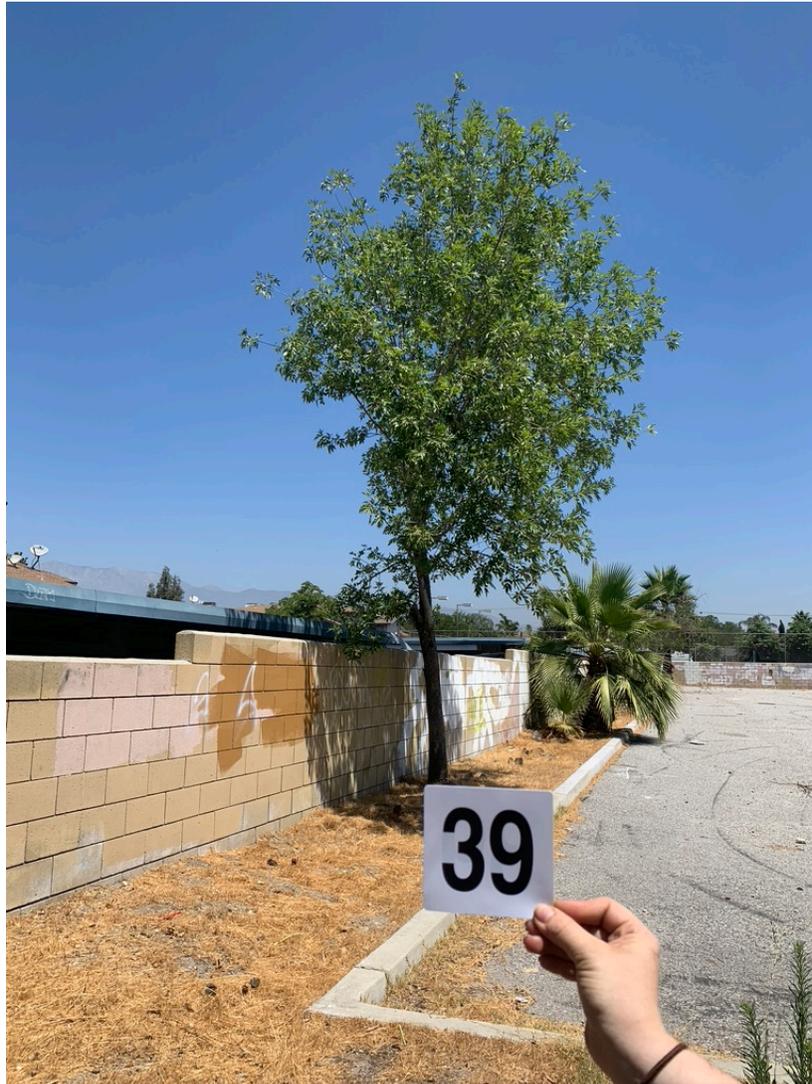
Tree 39 Evergreen Ash

Scaffold branch connections are weakly attached, bark inclusion, , string trimmer damage at root buttress, multiple tight branches congested at one spot. Condition 50%.

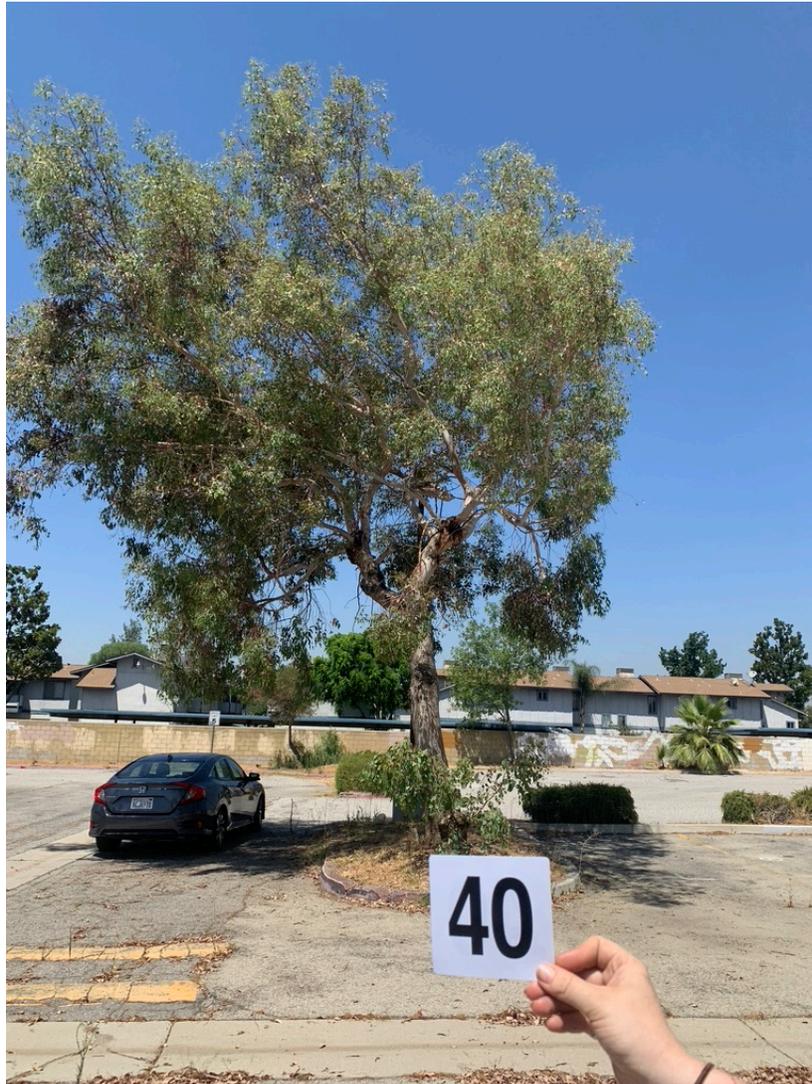
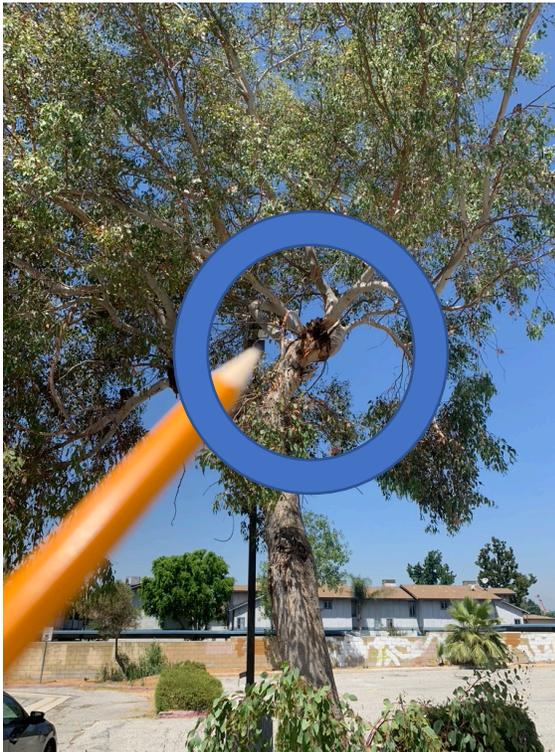
Tree 40 Silver Dollar Gum

Slime flux bacteria, tortoise beetle, lerp psyllid, improper topping. Condition 60%

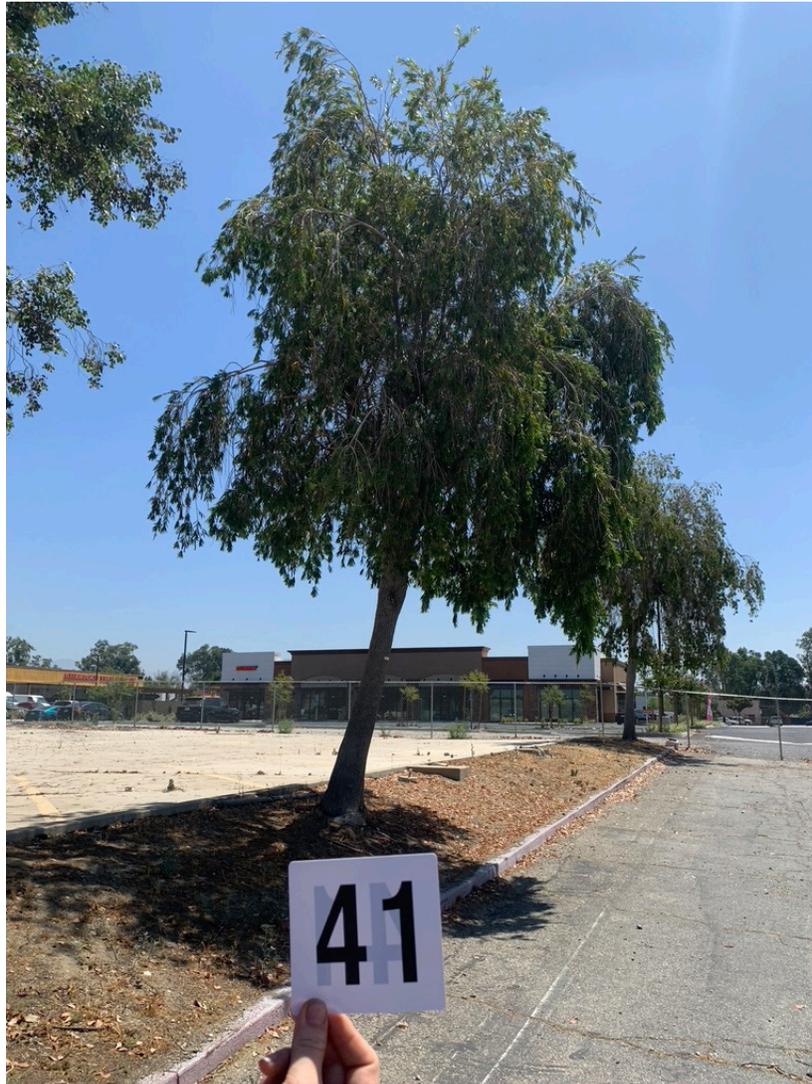
Tree 41 Bottlebrush

Stem growing root, topping damage, structurally defective. Condition 60%

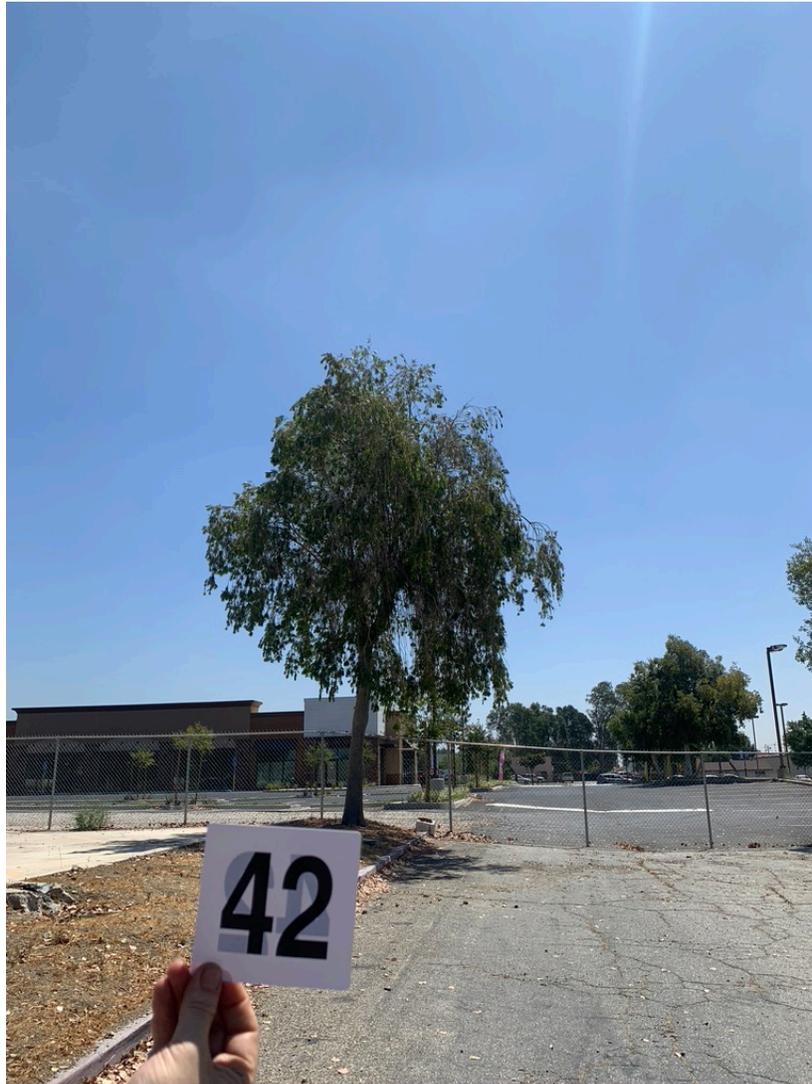
Tree 42 Bottlebrush

Flat depression on lower trunk. Probable stem girdling root, tree was improperly topped. Structurally defective. Condition 65%.

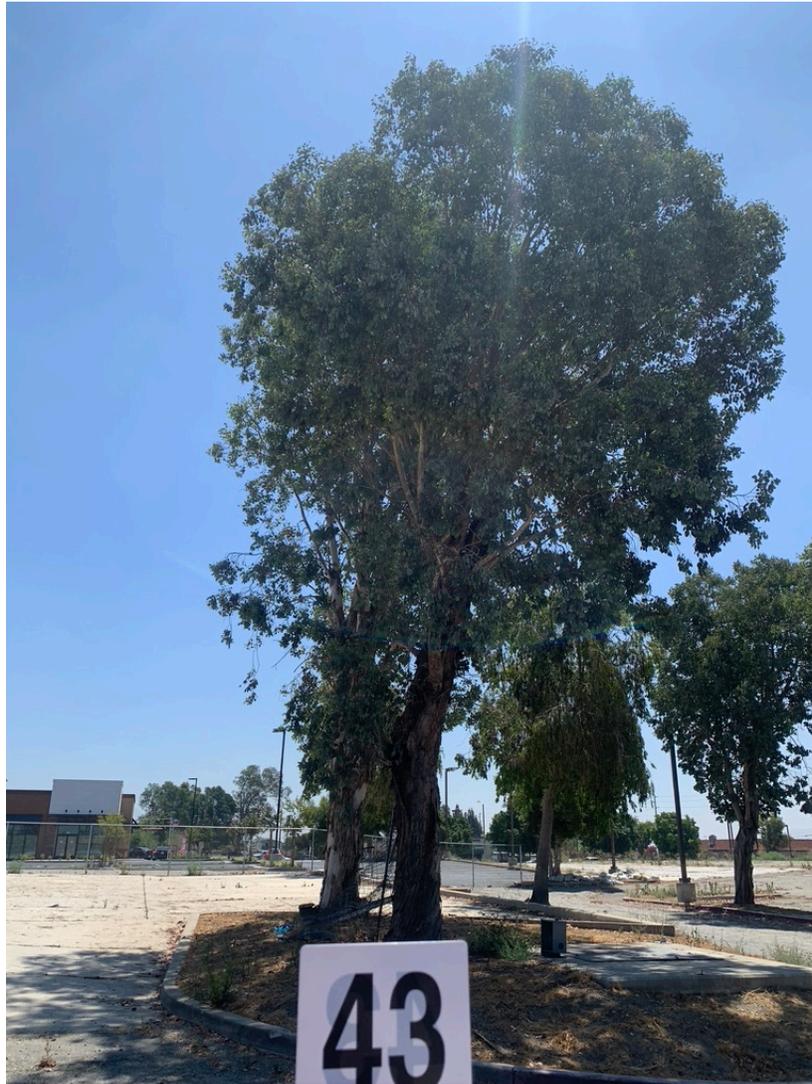
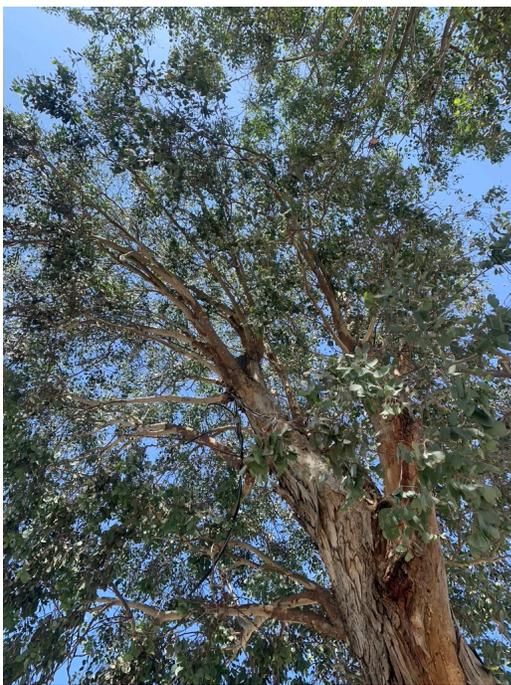
Tree 43 Silver Dollar Gum

Kino bleeding, topping damage (structure defective), electrical wires and chain linked fence embedded in tree. Condition 60%.
