APPENDIX H
ARBORIST STUDY

Mark Porter, California Arbor Care

**Inventory and Tree Condition Report Sierra Gate Center as per
Fontana Tree Preservation Ord 1126, § 1, 8-16-94**

Northgate Market Project Fontana, CA

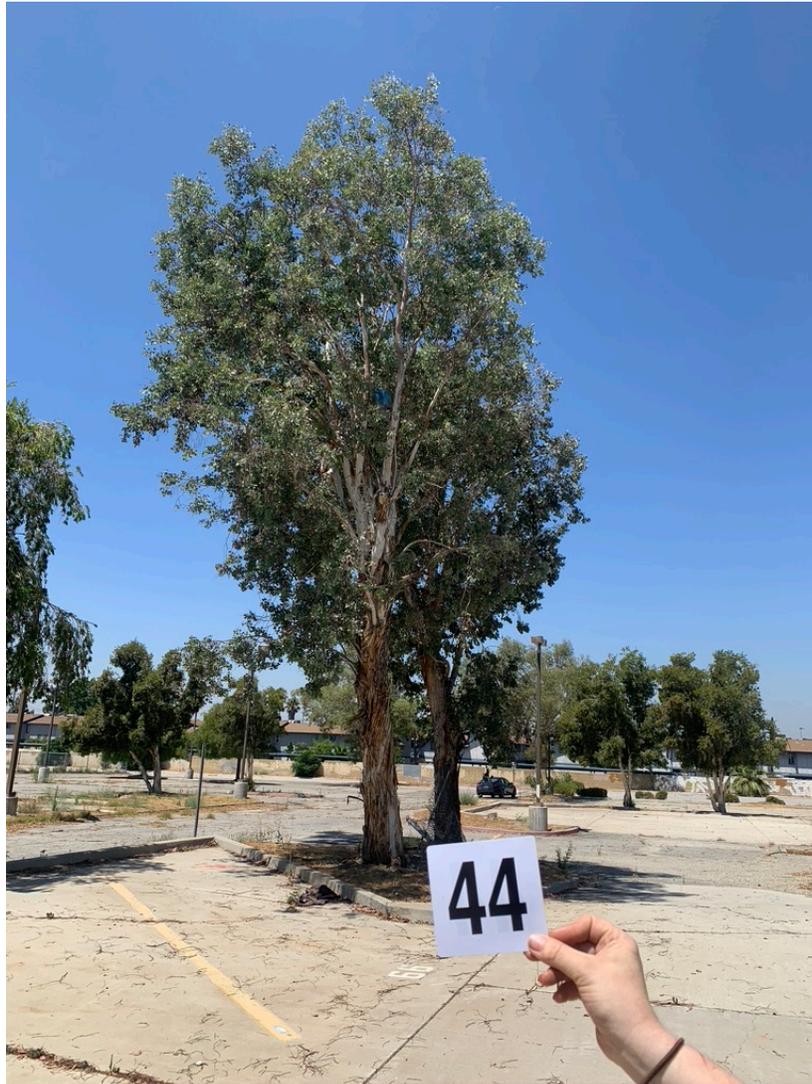
Tree 44 Silver Dollar Gum

Topping damage, poorly attached leaders, bark inclusion. Condition 65.

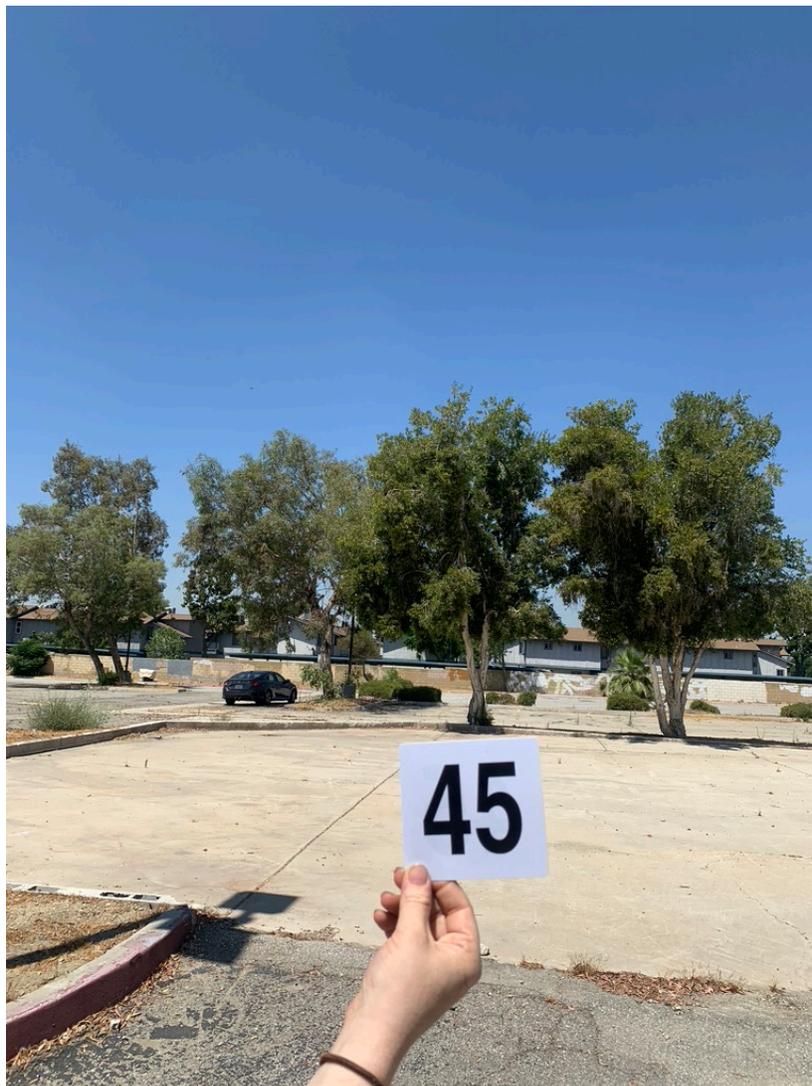
Tree 45

Codominant trunk, bark included, root compression, surface roots. Condition 65%.

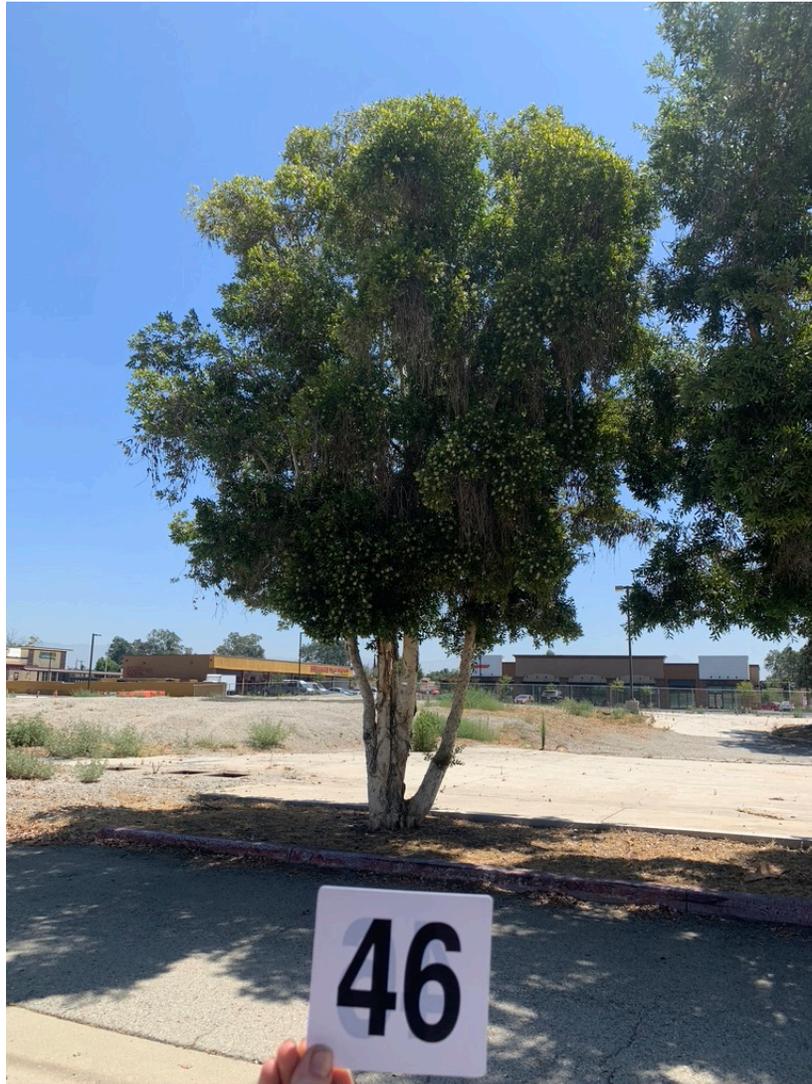
Tree 46 Flaxleaf Paperbark

Five codominant stems with bark inclusion, surface and kinked roots. Aesthetically pleasing, yet structurally defective. Condition 65%.

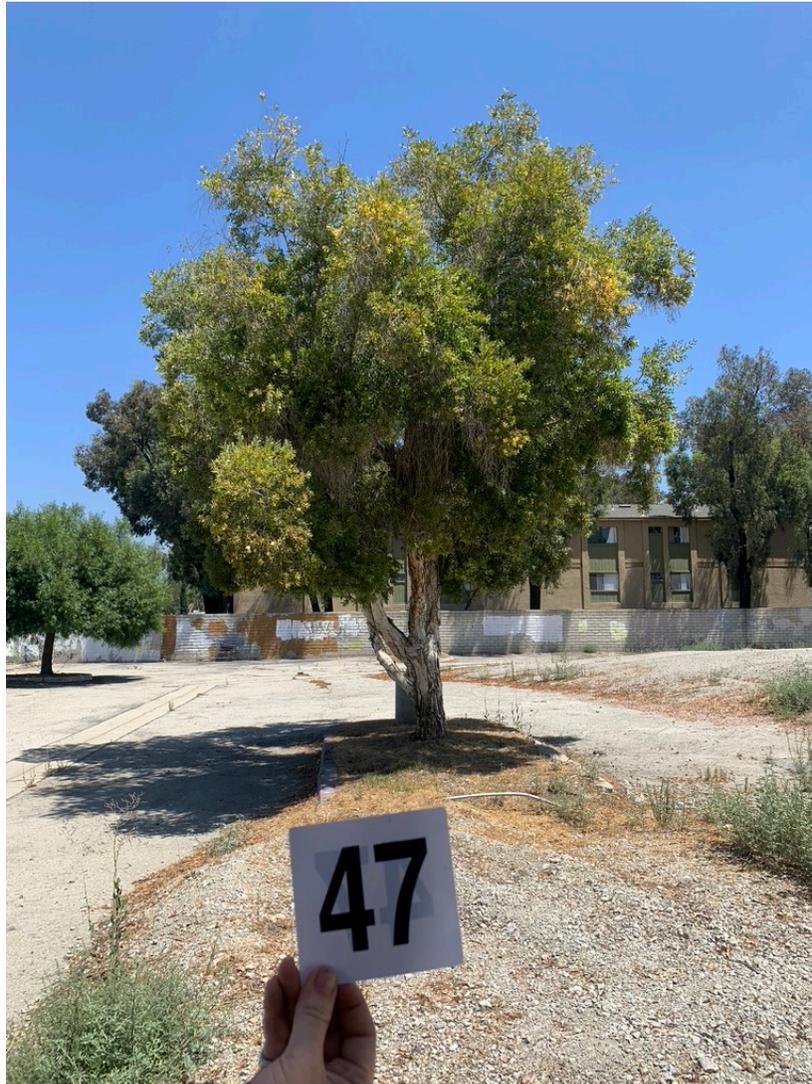
Tree 47 Flaxleaf Paperbark

Multiple failure points as tree matures. Defective structure (weal attachments, codominant stems with bark inclusion). Structural condition poor. Condition 65%

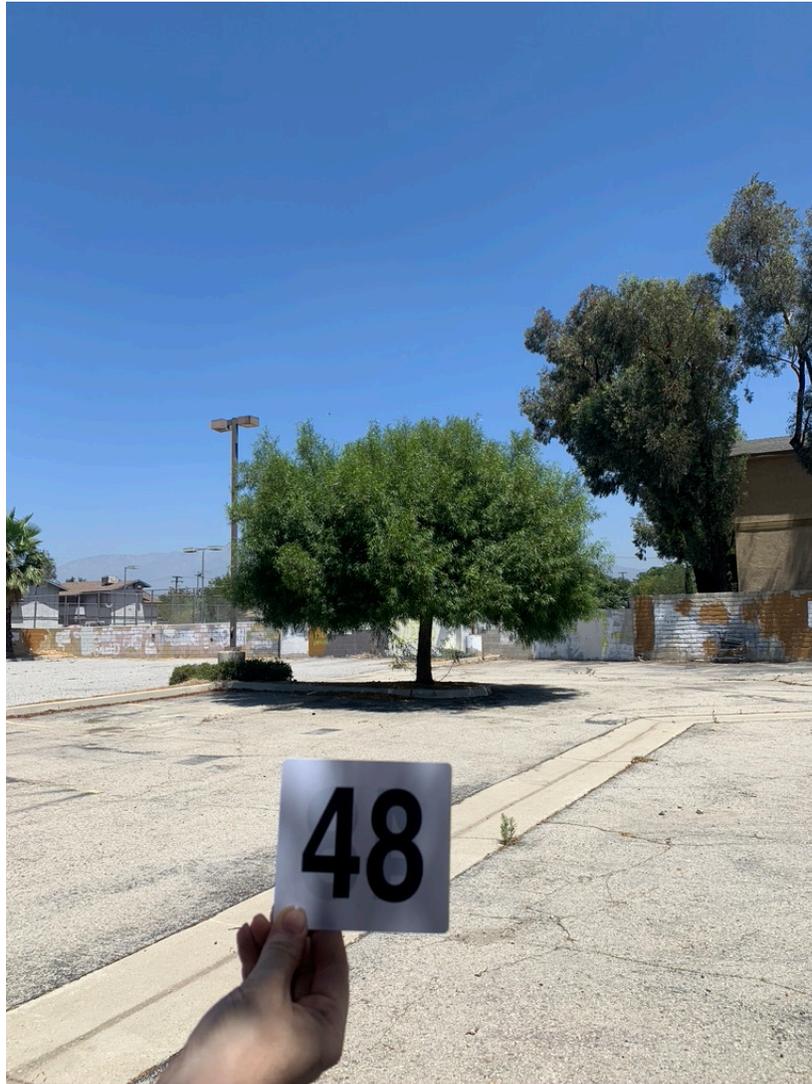
Tree 48 Australian Willow

Scaffold branch development not optimal, yet workable. root damage potential low, drought tolerant. Tolerates moist to wet soil. Resistant to Armillaria. Good species for area. Branch strength rated as moderate (UFEI). Condition 80%,

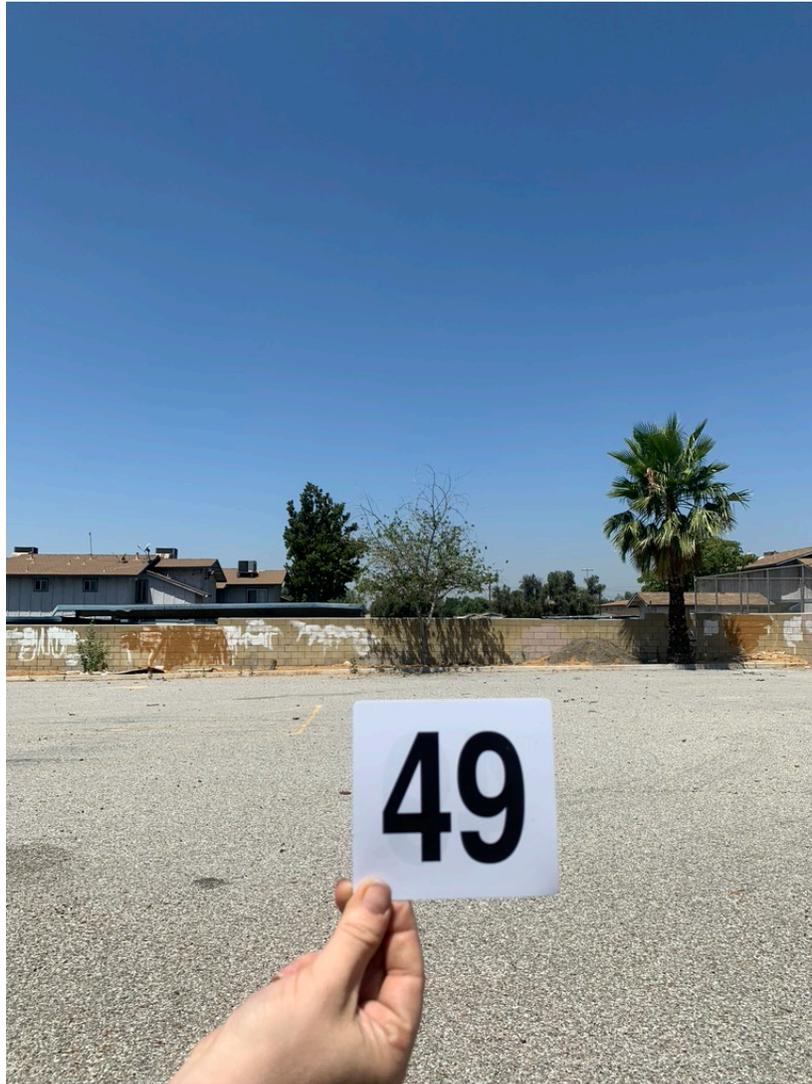
Tree 49 Fruitless Mulberry

Poor structure, foliage dwarfed, woundwood development poor, crown dieback.
Condition 50%.
